Learning Event

**Loss of
Containment**

WHAT ARE YOU DOING TO PREVENT CORROSION UNDER INSTRUMENT TUBING BLOCK CLAMPS?

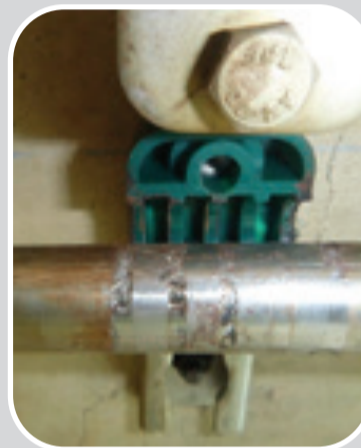
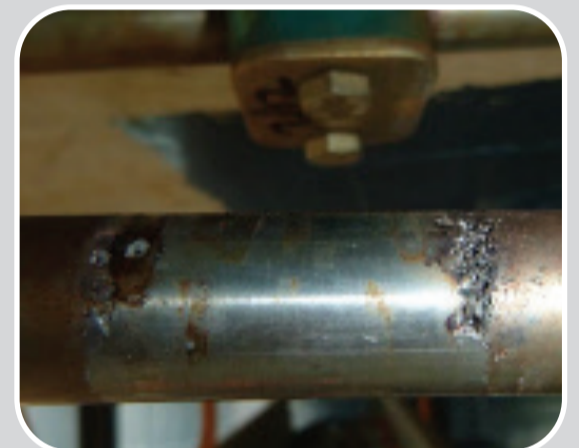
An LNG plant has recently identified instances of corrosion underneath instrument tubing block clamps. This corrosion has led to tubing failure and leaks. Examples include:

- a hydraulic oil leak on a loading arm hydraulic system.
- instrument leak on an ethylene compressor discharge line from a 1/2 inch stainless steel instrument tube. The pressure in the line at the time was 6.5 barg. The line can operate up to 9 barg.

A survey of similar installations across the facility found further evidence of corrosion particularly in marine environments.

These types of clamps are widely used across the Industry. As they are commonly perceived to reduce the risk of corrosion, inspection regimes do not usually require that they are removed regularly to check for corrosion.

- Identify similar clamps to those depicted in this Bulletin. Inspect clamp points regularly to ensure that corrosion is not accelerated at these points. Replace any corroded piping.
- Investigate replacing with anti-corrosion technology clamps where corrosion is identified.
- Report incidence of corrosion to equipment manufacturers to help identify patterns of corrosion arising from use of these clamps.
