SAFETY **ALERT**

Uncontrolled Decent of Crane Boom

Alert 7-20

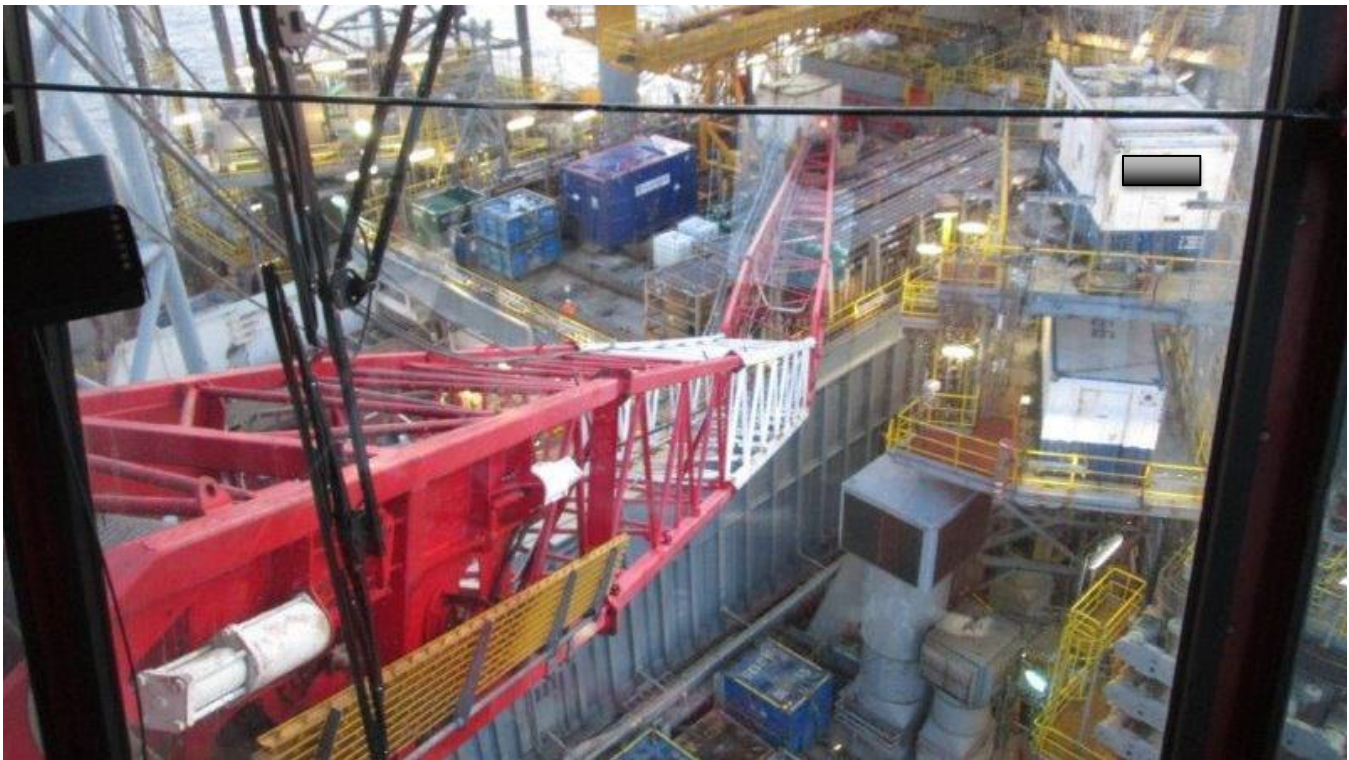
The operation involved offloading 9 5/8" casing from a supply vessel to the rig's cantilever deck. The crew was utilizing a main deck crane, operating on a single line ("whip line"). Two bundles with three casing joints each were in the process of being lowered on top of the casing already stacked on the cantilever deck. Suddenly, the crane boom wire parted causing the load and crane boom to drop and then come to rest on top of the casing stack on the cantilever. No personal injuries occurred as a result of the incident.

- It was determined that the boom wire rope was displaced from its sheave and had been running in between the sheaves which caused premature and undue wear of the boom wire rope. The primary cause is likely due to not maintaining sufficient tension in the crane boom wire during windy conditions while the crane boom is stored in the crane boom rest, or at higher angles allowing the wire rope to move off the sheave.
- Crane Operator did not use the company daily crane checklist, which includes the requirement to check the seating of wire rope over A-frame and boom tip sheave assemblies.

- When setting the crane boom in the rest, lower the boom until it barely touches the rest.
- DO NOT slacken the cables! Easing the cables risks "bird nesting" of the wire rope on the drum, or dislodging of the wire rope from its sheave.
- Reinforce the use of company-approved daily crane operator checklist and that no alternative checklist should be used without formal Management of Change.
