# Crane boom floodlight impact with scaffolding

**SAFETY ALERT**

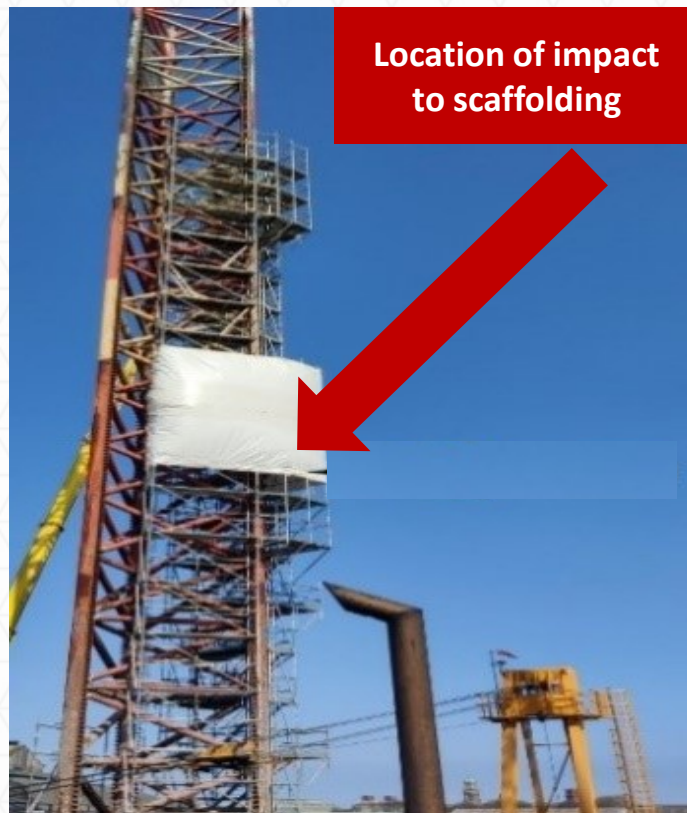
Personnel were conducting crane function tests at an opportune time, requiring movement of the crane boom. During the testing, the crane driver and two other personnel within the cab were distracted by a noise. A floodlight attached to the crane boom struck a scaffold structure at 38m elevation.

Minor damage was observed to the scaffolding component. No dropped objects or personal injury sustained, however in slightly different circumstances the incident could have resulted in one or more fatalities and serious asset damage.

- No hazard identification or Toolbox Talk conducted for the task
- The slew limits on the crane had not been adjusted to account for the temporary scaffold structure
- The crane boom continued to be moved as the driver was distracted

Location of impact to scaffolding

- Ensure a Toolbox Talk is completed before starting work
- Carry out a Dynamic Risk Assessment (DRA) before starting work – check for temporary equipment during DRA
- Ensure crane limits are set to reflect current conditions

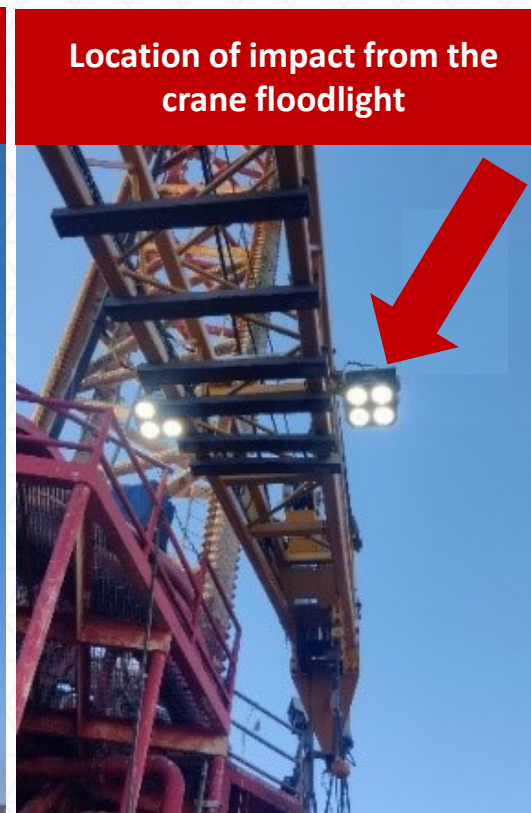
Location of impact from the crane floodlight
