HUMAN FACTORS

How to take the next steps

CASE STUDY 1 - People will put up with what they're given...

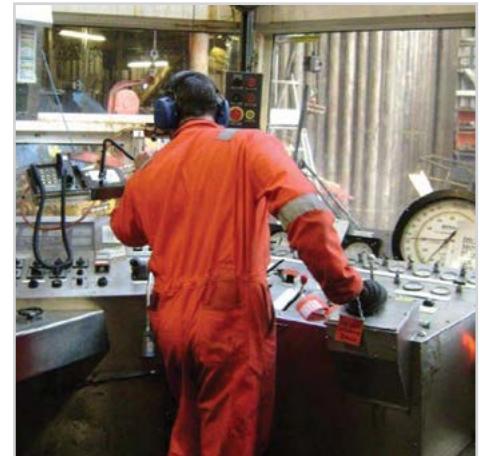
A driller was operating a top drive drilling unit. There was a stand of drill pipe clamped in the slips, and the top drive was raised and held on the brake. The driller saw a roughneck step into a hazardous area of the rig floor, and reached for the microphone to tell the roughneck to step back. As he did so he slightly released pressure on the brake. The top drive descended, bending the drill pipe which fortunately did not spring out. A 27kg pipe-guide fell 90 feet to the floor, narrowly avoiding the roughneck.

Investigation found that at the time the incident occurred, the driller had all four limbs utilised. To stop personnel from entering the drill floor, the driller had to lean towards the microphone, use his left knee to operate the talk-back system, use his right foot on the manual brake, whilst still trying to maintain control of the top-drive using the hydraulic brake. The brake did have a "dead-man" position that applied the brakes if the handle was released. However, simply easing off hand-pressure actually removed the brake. This was a counter-intuitive design. The system was known to be difficult to operate.

People accepted the poor layout and controls, and got on with the job. As different items of equipment were added, controls were placed wherever they could be, without considering how they would have to be used together. Many different people knew about the problems in the dog-house, but a "can do" attitude meant that people just put up with poorly designed equipment and controls.

The driller released hand-pressure on the brake control. If the brake-control had been entirely released the brake would have applied automatically. Unfortunately, a small release in hand-pressure was enough to remove the brake.

Keeping your arm steady during a task requires concentration and balance. Changing your position affects this fine-control. The movement towards the microphone reduced pressure on the brake and the top drive descended.

- Older equipment has sometimes been subject to incremental change, without any thought to how changes will interact. Apply a good quality management of change process to each change, to identify these interactions before they become a problem.
- Our ability to carry out physical fine-control tasks is influenced by our body position and balance, and requires concentration. An ergonomist can advise on what people will be physically capable of in different situations.
- People will put up with poorly designed equipment and make the best of it. Designers can't foresee all situations. Speak up if there is equipment which is difficult to operate.
- Get experienced end-users involved in the design and commissioning of equipment.

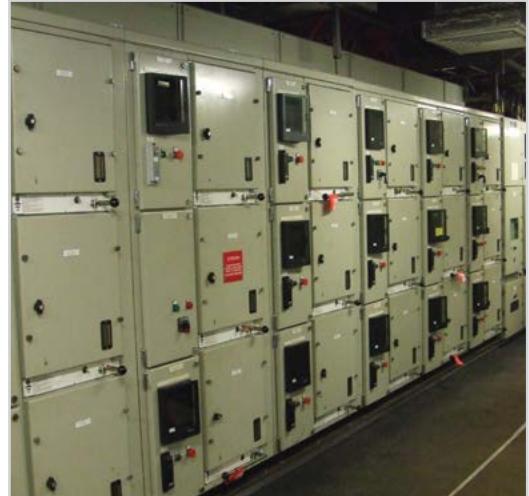
He took his permit, went to the switch-room and correctly identified the turbine to isolate. He was familiar with the switch-room and the layout of the turbine electrical systems. He began isolating the correct turbine.

He then received a call on the public address (PA) system to come to the galley, which he ignored because the job he was working on was important. A second announcement called him urgently to the galley. The electrician went to the galley where he found the chef standing next to an open fridge complaining that the fuse had blown. Annoyed that the chef had interrupted an important job with one that could have waited, the electrician replaced the fuse and then returned to the worksite.

He completed the remaining isolation points, but on the wrong turbine. The error was discovered days later when the electrician had left the installation. When he was told of the mistake he immediately offered his resignation, which was not accepted. An investigation found that the distraction during an important job had led to the error, which in this case was discovered before any harm was caused.

The electrician made an error - he performed the right action (applying isolations) on the wrong equipment. This was made more likely to happen because he was distracted during a complex job. Becoming angry at being called away may also have contributed to the error.

- Performing the right action on the wrong piece of equipment is a common problem in our industry.
- The most experienced and competent personnel are sometimes more prone to error because they can do things automatically without thought.
- When we get distracted we may forget things, e.g. where we were in a sequence of steps or a procedure. This can lead to mistakes with serious consequences.
- You can prevent this type of incident by double-checking against the permit or asking another person to confirm that you are working on the right equipment. When the job's complete, have it independently checked to detect errors.
- Supervisors can help by recognising those jobs which could have serious consequences if someone makes a mistake. Minimise distraction for those carrying out complex or critical tasks. Encourage people to have their work checked for errors.

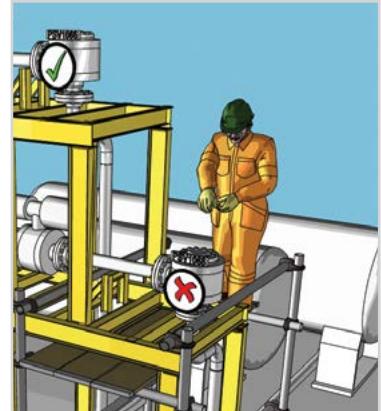
The permit listed four valves. When the work team went to the site they found scaffolding erected next to relief valve PSV1068. They believed this to be the correct valve. Unfortunately it was not - they were supposed to be removing PSV1066 which was on the deck above.

They attempted to remove the bolts from the live-side of the valve, but the high pressure in the vessel prevented the bolts from releasing. Instead they removed all of the bolts from the flare-side of the flange. Gas was released as they split the two halves of the flange. They tried to remake the flange but could not as the valve had become misaligned with the pipe.

The permit stated that all the valves were on the same deck. The scaffolding access had been erected next to this valve. Furthermore, the valve tag was similar, and difficult to read. This was enough to suggest to the work party that they were working on the right valve.

- Breaking containment on hydrocarbon systems is a high risk activity, involving people making judgements. Simple errors, assumptions or misjudgements can have disastrous consequences. Checking can catch errors.
- When breaking containment, you must confirm that you are working on the right equipment. You should also have a way of checking that the right steps have been taken before opening up the hydrocarbon system. When identifying equipment - walk - point - check!
- If something is not as you expected, step back and ask "why?". The difficulty in removing the live-side bolts should have indicated that something was wrong. Applying basic principles in breaking bolted joints could have recovered this situation.
- Changing conditions, scopes of work and responsibilities must be managed to ensure responsibilities and ownership are clear at all times.

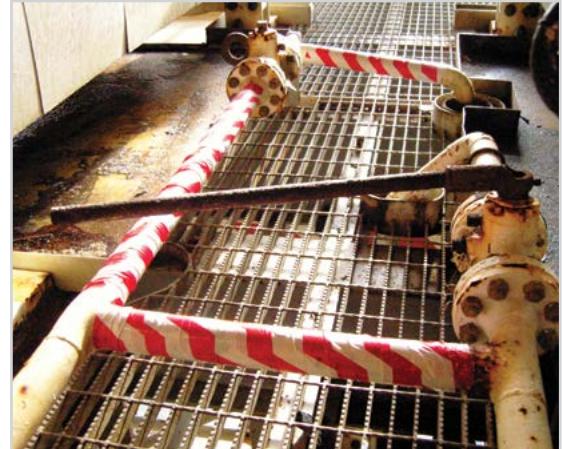
The work-team were using a high pressure water jet cutting system to cut redundant steelwork and pipework. The job was additional work that had been added to the scope after the team had arrived at the platform. The work-pack made only a general reference to removing equipment in the area. The team were instructed to "cut all material in the area" and the toolbox talk did not indicate which items should be cut or left. Various pieces of steelwork and pipe were marked with red-and-white tape.

The team began cutting steelwork and pipes away from the deck-plate. Shortly after cutting a pipe an oily smell was noticed and the team stopped work. The area authority confirmed that they had cut through a live drain line.

In the absence of any other indication, the team had assumed that the red-and-white tape marked the lines and steel which needed to be cut. In fact it marked trip hazards on the worksite.

- The operations team assumed people would understand that red-and-white tape marked trip hazards. This wasn't confirmed with the workparty.
- When we make decisions we interpret the information available to us. Our interpretation is influenced by what has happened before, and what we expect to happen this time. This sometimes leads to incorrect conclusions.

- A clear work-pack is a good start, and an effective tool-box talk helps to get everybody clear on what needs to be done. Talk about the job at the worksite. Walk, point and mark the plant to be worked on. Those doing a job should be able to explain the job and their role in it.

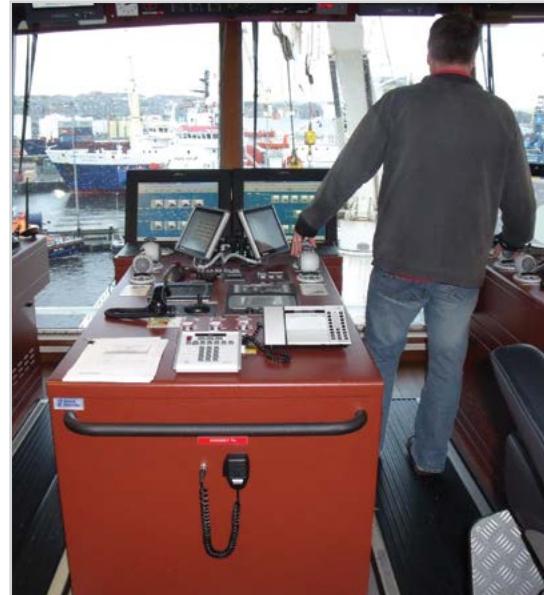
A new supply vessel was being delivered from its manufacturing shipyard in China to the North Sea. On its voyage across the ocean the crew discovered a quirk in the control system. Under manual control the ship's thrusters could be controlled using a joystick. However, the joystick had been configured to apply the thrusters in the direction that the joystick was pushed. This meant that if the joystick was pushed right, the thrusters were applied to the right, and the boat moved to the left. If the joystick was pushed left, the thrusters were applied to the left, and the boat moved to the right. Having discovered this, the crew decided this was acceptable and continued to use this control on several occasions throughout the voyage.

The ship was working off a fixed installation when it struck the jacket at some speed. The vessel had started to move towards the installation and the Master tried to move the vessel away by moving the joystick away from the vessel. Unfortunately this applied thrust in the opposite direction, accelerating the ship into the installation. The ship struck the installation leg, but no damage was caused.

- Well-designed controls should "map" onto the things they control. For instance, some cooking stoves have four rings controlled by a line of switches down one side. Others have the switches positioned in the same pattern as the rings so that you can easily see which switch operates each ring.
- Controls should make "natural sense". If you want it to go left, push the joystick left. In this case the joystick control did not map onto the direction that people would normally expect the control to take them.
- Operator interfaces are often the last things to be installed, and some suppliers have been known to cut corners in order to meet delivery deadlines. Clients should specify requirements for well-designed, usable operator controls in the contract, and ensure these are met in acceptance tests.
- Don't put up with non-intuitive controls, change them and apply management of change.

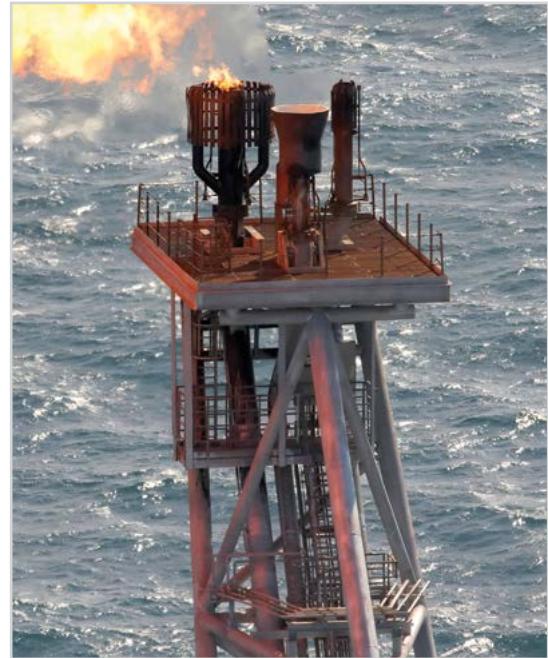
Burning fluids ran down the outside of the lit flare stack after a knock-out drum filled with crude oil.

While preparing for a shutdown, a drain valve was opened to depressurise a meter skid. The operator didn't realise that the meter skid was still connected to the process via an open skid discharge valve which he should have isolated. Crude oil flowed into the skid through the open drain valve and into the flare line. It overflowed the flare knock-out drum and passed on into the lit flare.

There was no procedure for draining the skid so the supervisor asked the operator to use a maintenance procedure. The steps required to isolate and drain the skid were in different parts of the document. The supervisor and operator discussed which parts of the procedure could be used. The operator misunderstood the instruction and started at the wrong step. He missed the step where the outlet valve was closed.

The high level trip on the drum should have shut down the process. Unfortunately the switch had been incorrectly calibrated, and allowed liquid into the flare where it was ignited.

- Procedures should be specific to the task being done.
- The sequence is vital, so anything which disrupts that sequence (such as jumping from one section to another) increases the chance of error.
- Where a procedure is not right, take time to amend it. Do a risk assessment to ensure that you know what hazards you need to control. Involve the people that have to carry out the job and technical staff who understand the process hazards that the procedure should address.
- Don't rely on automatic shutdowns to protect you. Safety systems can fail in all sorts of unpredictable ways - many associated with human error!

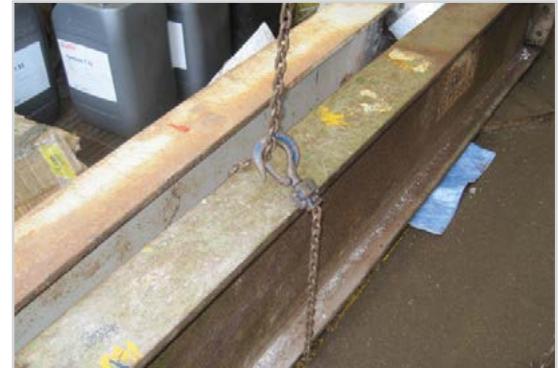
Work was stopped immediately and the load made safe. The supervisor highlighted that back-hooking was unacceptable practice and the work-party agreed. However, in their opinion, there was no other way to do the job. When they looked again at the job there were safer ways of completing the lift and these were written into a new lifting plan.

Had the hook released, one of the rigging crew could have been killed.

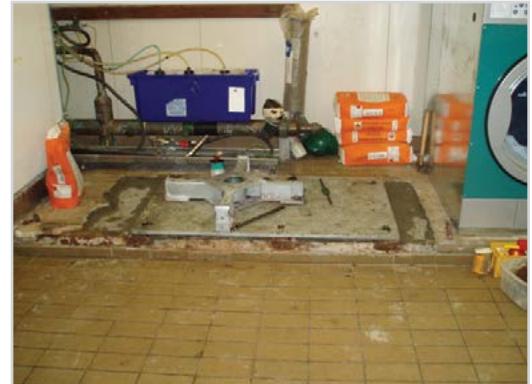
The hand of a member of the catering crew was badly damaged when it became trapped beneath a heavy steel plate.

An engineering contractor work party was working on fitting a new bed plate for an industrial spin drier in an installation's laundry. The team were lifting the heavy bed plate (weighing around 200kg) onto the six raised securing points. The work had been going on for two days, under a Work Permit. The catering crew were aware of the nature of the work and the need to take care in the vicinity.

One half of the plate was supported on stacked planks. The other half was being lowered onto the securing points by three of the work-party. The laundryman rushed forward to assist just as the plate was being lowered. His hand became trapped between the plate and the raised securing points. The crush amputated the laundryman's middle finger.
