Report Number: 15070698A

This report details the results of tests carried out on Pressed Double Couplers used for connecting steel tubes of 48.3mm outside diameter and of at least 3.2mm nominal wall thickness at a minimum in the construction of working scaffolds and falsework required for the construction, maintenance, repair and demolition of buildings and structures.

Pressed Double Couplers

The couplings have been tested in accordance with the relevant sections and requirements of EN 74-1 :2005.

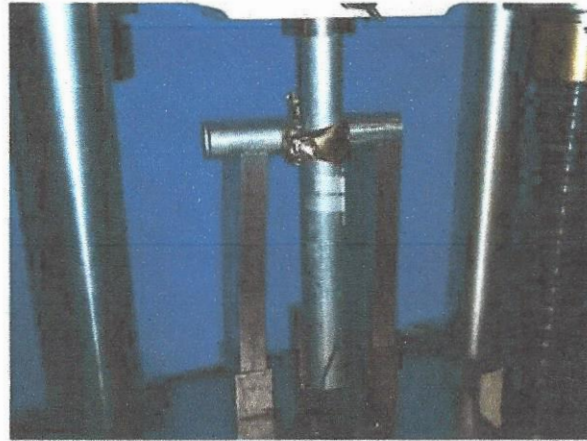
Photograph of Setup for Slipping Force

The photograph above shows the setup for slipping force but is not necessarily the coupler under test.

Slipping Force Tests, tested in accordance with Clause 7.2.1

From the results, the prototype is Accepted to Class A for slipping force

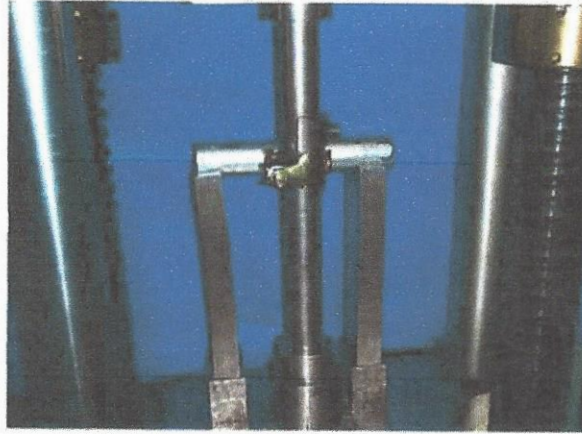
Photograph of setup for Failure Force

The photograph above shows the setup for failure force but is not necessarily the coupler under test.

Failure Force, tested in accordance with clause 7.2.2

From the results, the prototype is Accepted to Class A for failure force

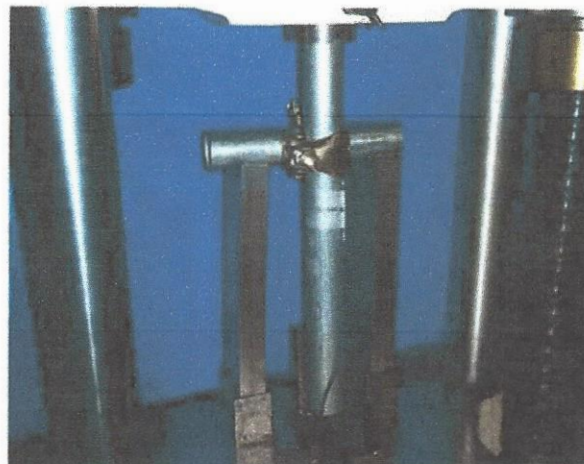
Photograph of setup for Indentation Check

The photograph above shows the setup for indentation check but is not necessarily the coupler under test.

Indentation Check, tested in accordance with clause 7.5

From the results, the prototype is Accepted to Class A for indentation check
