NDMA Macdonald NFI Warehouse Assessment report

3 June 2021

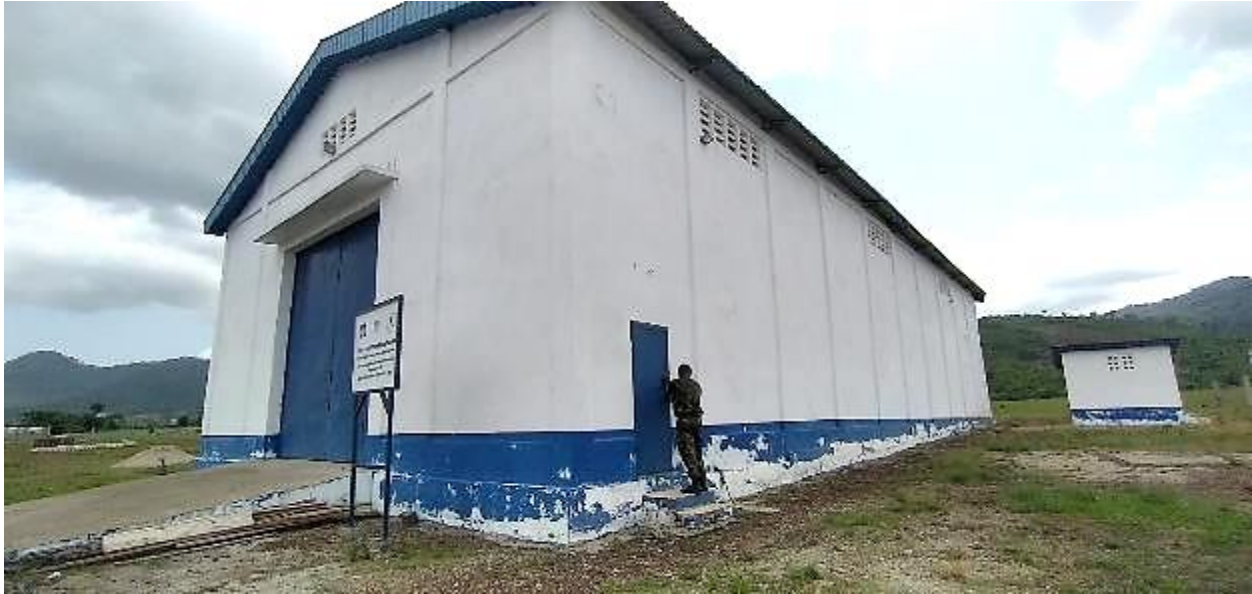
Security posts were built at the front and back but there is no perimeter fence to prevent access to the building. Concrete posts were built but not completed. A local person living in the area is a “caretaker” and keeps an eye on the building. **A perimeter fence with solar lights would improve the security of the valuable NFIs, particularly in the absence of security staff.**

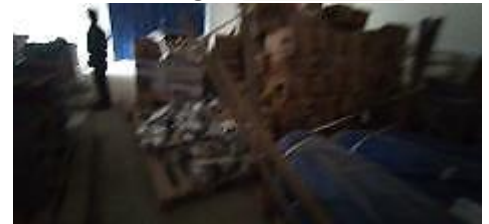
The building is sitting within a large land space with room for emergency outdoor storage such as shipping containers or large tents. There is sufficient room for parking and truck turnaround.

The entrance to the warehouse has been graveled but the rest of the land is grass. As the structure is in a flood prone area, the need for water diversion channels a few feet around the building should be investigated based on history of flooding in the area. The laying of gravel and digging of deep-water diversion channels will be required for any additional emergency outdoor storage.

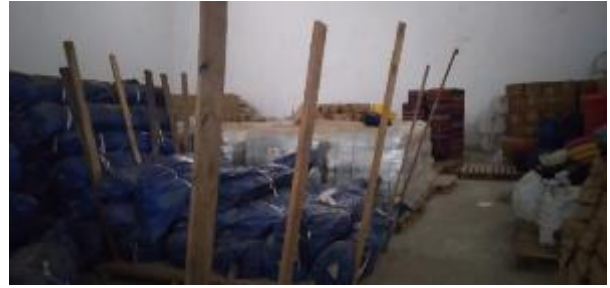
Good quality shelter and WaSH items are stored in the warehouse and stacked quite well on pallets. Some are dusty and have been there for some time. Shelter and WaSH items are mixed in different locations and could be set out better (e.g. all different tents are placed alongside each other, with sleeping mats and cooking items). It is not evident

from many of the boxes and packages what is inside them as there are no stack cards or labels. The quantity and size of items are unknown. **The NFIs need to be counted and re-stacked, with stack cards and labels so NDMA knows what is available and can find it quickly during an emergency.**

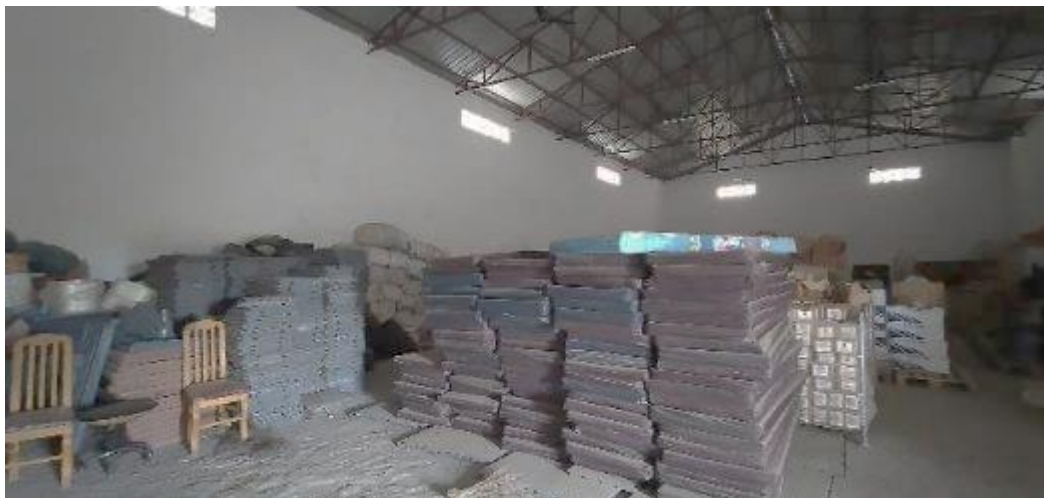
There is dust covering the sleeping mats and some other NFIs. During the re-stacking the mats and other NFIs can be cleaned and the floor swept out. **It would be useful to have plastic sheeting or tarpaulins to cover the mattresses and lay pest baits to prevent infestation during wet season from pests seeking shelter.**
