Crate Lid Dislodged Overboard During Heli Ops

SAFETY ALERT

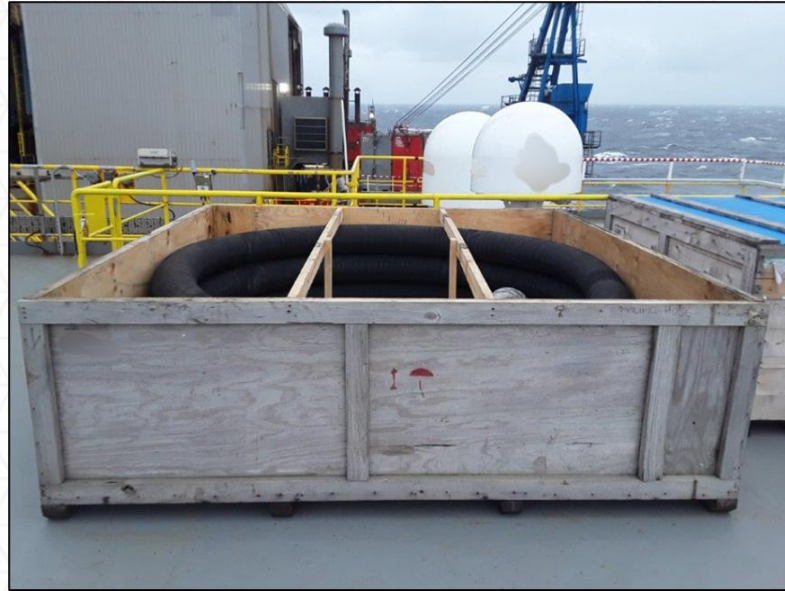
- **Securing Mechanisms Matter:** Factory-installed plastic banding and screws, originally intended for transport, can degrade over time due to environmental exposure, making them inadequate to withstand wind and helicopter downdrafts.

Crate containing air blower hose.
Note banding marks on right hand side and bottom left of crate

- **Environmental Forces:** Weather, wind and rotor downwash amplify the risk of unsecured items becoming Foreign Object Debris.
- **Storage and Security:** Evaluate storage areas near the helideck for suitability, ensuring they are used only for essential items. Relocate non-essentials elsewhere and secure any necessary items with approved mechanisms to withstand environmental stresses.

- **Regular Inspections:** Conduct routine checks of these securing systems, to identify and address potential risks.
- **Increase Awareness:** Identify hidden Foreign Object Debris risks by raising awareness about items or equipment that might not typically be recognized as a potential hazard.

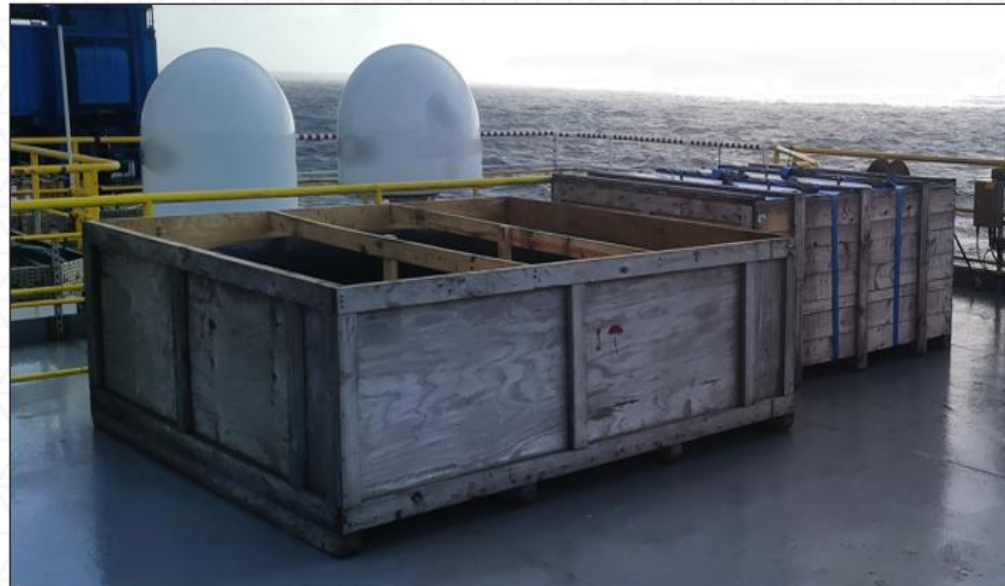
During helicopter operations on a UKCS drilling rig, a 3mx3m wooden crate lid weighing approximately 40kg, dislodged from a hose transport crate and blew overboard. While no personnel were in the area, the event highlights the risks associated with storage near helidecks.

Crate storage on port wing deck showing left hand crate missing lid and right-hand (previously opened) crate with lid secured by use of ratchet straps.
