Description of incident:

Findings:

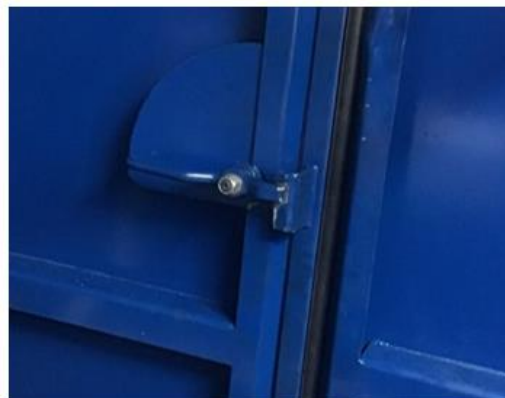
Locking device locks in the middle of the frame only, not to the top and bottom as required by the design standard

- The unit had passed a thorough inspection against EN 12079 1999 which requires the design standard to be headed on the container nameplate and double doors to have at least one locking device on each door, that locks directly to the top and to the bottom frame. Neither requirement was met.
- The door locking device was in the closed position prior to landing, with a single tie wire used as secondary retention. However, the locking device moved into the open position under the force of the landing. Weather conditions and sea state were within the acceptable limits.
- The landing area on the supply vessel was too small to land the unit with the open door. With the information the crane operator had at the time; they made the split decision to recover the container to the platform as they deemed it the safest option to take.

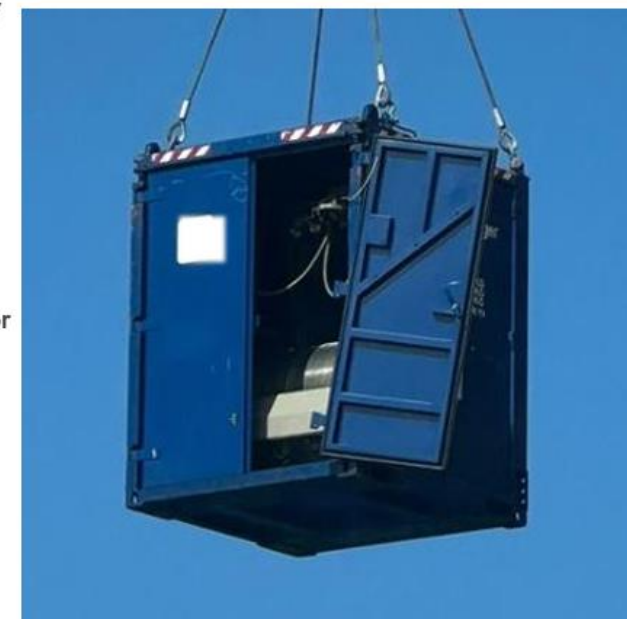
Image taken from supply vessel. Door is hanging on by a single hinge. Crane operator was not aware of the damage until the container was recovered to eye height.

Whilst backloading a container to a supply vessel using the platform crane, it touched down to the supply vessel deck, a secured door unexpectedly opened on the container and then the stern deck of the supply vessel immediately dropped. When the vessel came back up, the door impacted an adjacent pipe carrier basket on the vessel and damaged the hinges on the door. The unit was recovered back to the platform so it could be examined and made safe.
