Elevator Guide Roller Drops to Deck Below

SAFETY ALERT

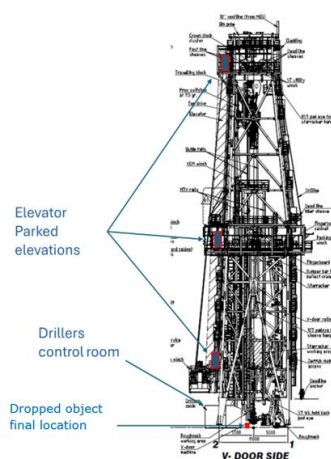
Derrick Elevator

The roller is normally attached to the derrick elevator. The elevator was parked at its lowest position of 10.5m at the time the object was found. The elevator can operate to a maximum height of 57.1m.

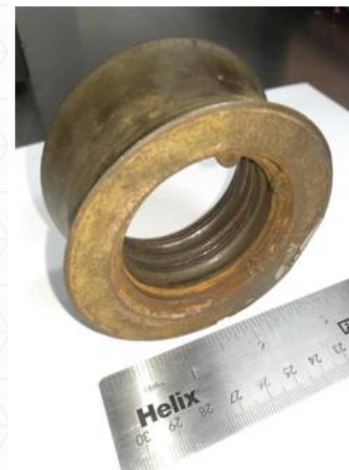
Image of dropped object:

A derrick elevator guide roller weighing 0.6kg was discovered on the drill floor in front of the drilling control room (DCR).

Severe corrosion of the elevator guide roller bearing allowed it to drop free of the assembly.

- Arrange a 100% change out of roller bearings for elevator, creating a base line for future maintenance.
- 6 monthly planned maintenance to de-load and inspect roller assemblies, including mechanic oversight of OEM roller inspections to verify bearing condition.
- OEM Inspection criteria and reports to contain adequate detail on inspection completed.
- Establish a 60-month life span for roller bearings which may be adjusted based on 6 monthly inspections.
- OEM to review design for secondary retention (consider all failure modes).
- Review maintenance learnings for other roller bearing assemblies (e.g. pipe handling, v door, bop trolley).

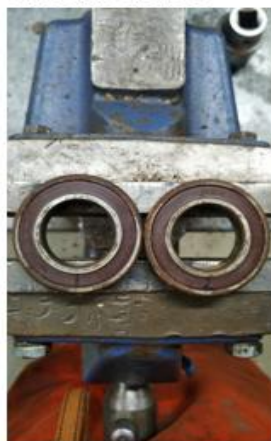
Roller 2 bearing shields side 1

During the inspections of the remaining roller assemblies, it was identified that a further roller assembly was not rotating freely, the bearings below were removed from the assembly for detailed inspection, one which was found to be in poor condition. Thus, highlighting the importance of not relying on visual inspection only.

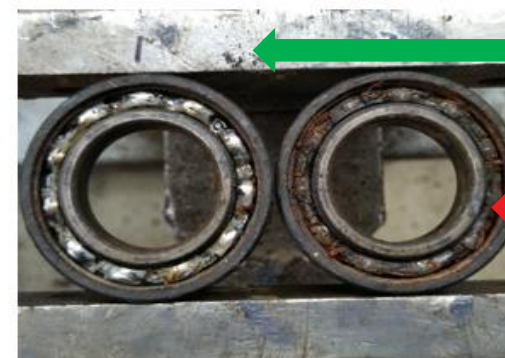
Internal condition

Pair of bearings from 1 roller:

Left indicates “good” condition

Right clearly indicates poor condition

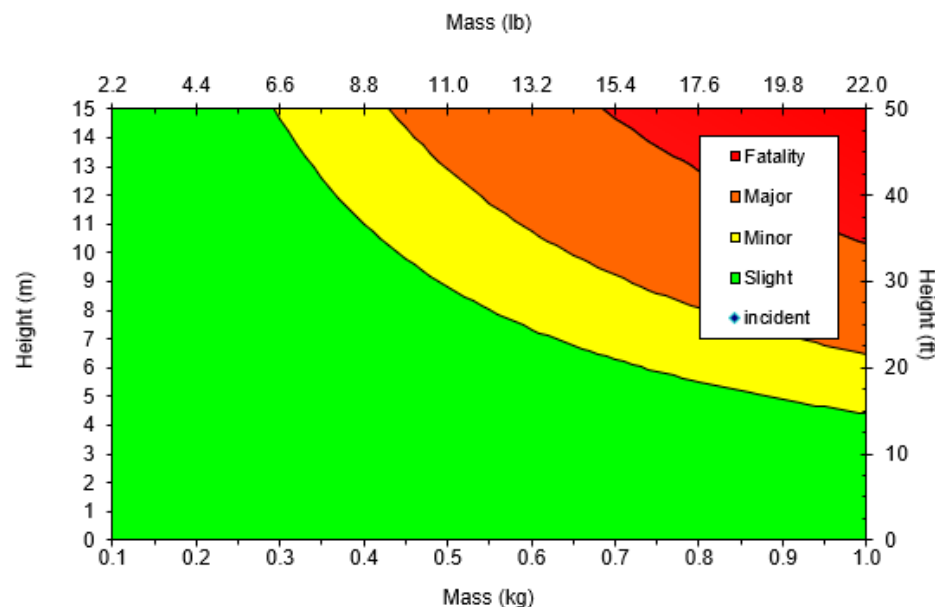
Derrick Elevator Guide Roller Drops Calculation:

Outcome Calculator		
Height	10.5	m
Mass	0.608	kg
Outcome	Minor	62.61 Joules

NOTE: The graph above displays an 'incident' icon for visual purposes only and the axis is restricted to 15m / 10kg. The OUTCOME CALCULATOR panel at the top of the page displays an accurate outcome for all input values
