Learning Event

WORKING ON / NEAR FIXED EQUIPMENT

WHAT ARE YOU DOING TO MINIMISE LINE OF FIRE RISK DUE TO DROPPED OBJECTS FROM EQUIPMENT AWAITING DECOMMISSIONING?

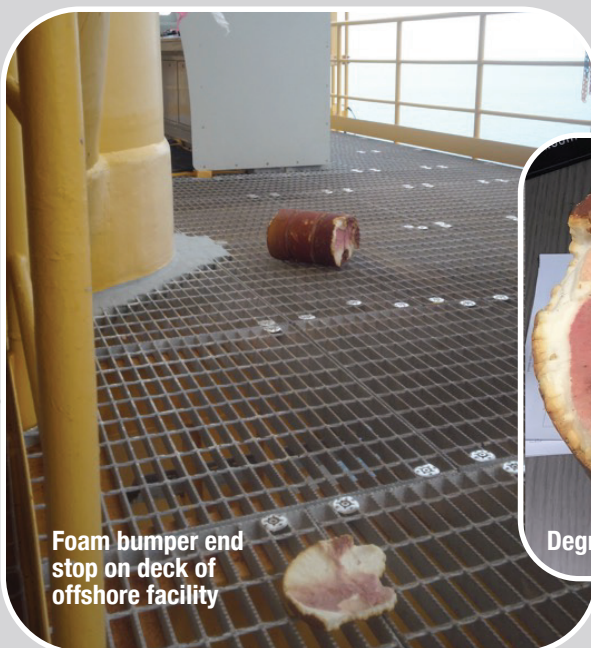
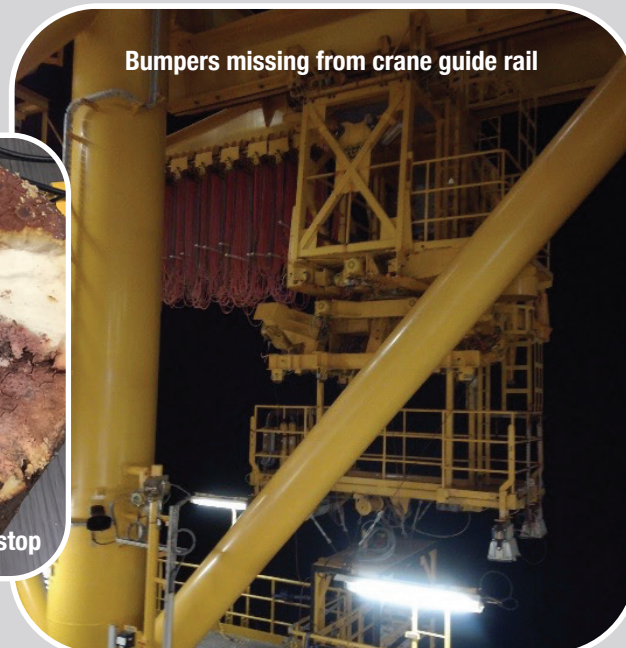
A polyurethane foam bumper end stop from a maintenance crane was found on the deck of an offshore facility. The bumper weighed about 5 kg and had fallen approximately 9 metres from the work basket guide rails of the crane.

Subsequent inspections revealed that a second bumper on the aft side of the same guide rail was also missing.

- The bumper had remained in-situ and out of service since it was installed in 2017.
- The fallen bumper had become brittle due to prolonged exposure to the sun (ultraviolet light). The strength of the bumper material was degraded and insufficient to resist the bumper's own weight, resulting in detachment from the assembly plate. Strong winds may have contributed to detachment.
- A decision note prepared in 2019 to decommission the crane by 2023 included recommended actions to make the crane safe in the interim period. Actions to inspect the crane for any loose objects were outstanding.

- Proposed actions from the crane decommissioning decision note could not be traced to a structured maintenance program or executable work order. Technical recommendations need to be translated into execution actions.
- Existing risk-based inspections or pre-start-up inspection programs do not mandate the inspection of equipment that is not scheduled for commissioning. These inspections are focused on safety critical lifting & hoisting equipment, or equipment that will be commissioned.
