MAIB: Step-ladder failure (LTI)

Safety Flash Published on 6 February 2025 Generated on 3 March 2025 IMCA SF 02/25

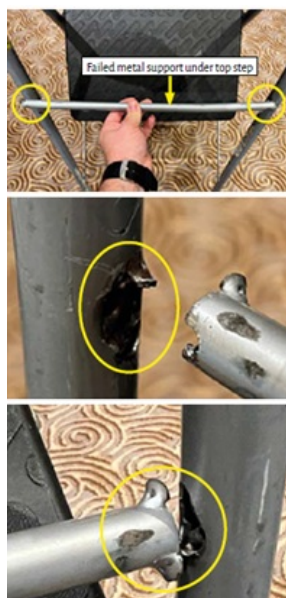
A crew member was working while stood on the top step of a small folding stepladder when the step gave way, causing the crew member to fall to the ground. The impact resulted in back and head injuries, leading to a brief loss of consciousness and severe back pain. After medical attention on board, the crew member was deemed to be unfit for work for 72 hours. The crew member was subsequently transferred to hospital for further comprehensive medical evaluation.

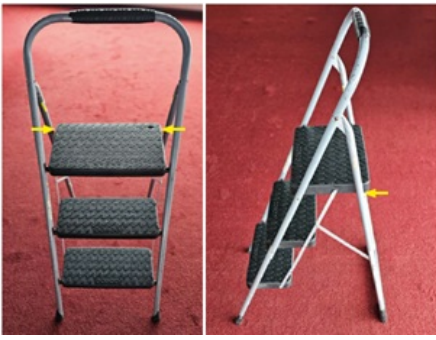
Investigation established that the incident was caused by the failure of the welds securing the stepladder's top step supporting rod to the frame.

MAIB considered it unlikely that the weight of the crew member would have been sufficient to cause the catastrophic failure of a metal support on a new stepladder. The stepladder used in this incident was of an indeterminate age but was not being overloaded so it is almost certain that the damage to the metal support was pre-existing.

Stepladder, showing the location of the failed metal support

- Check and inspect equipment thoroughly before use. Work equipment should also be maintained in good repair and, where applicable, with maintenance and inspection logs kept up-to-date.
- Accidental damage to equipment can sometimes occur. A just culture working environment balances fairness, learning and shared accountability and supports staff to adopt an open and honest approach to reporting incidents. Where damaged equipment could affect the next user, a just culture is essential to understand why the failure occurred and how to prevent it happening again.
