What happened?

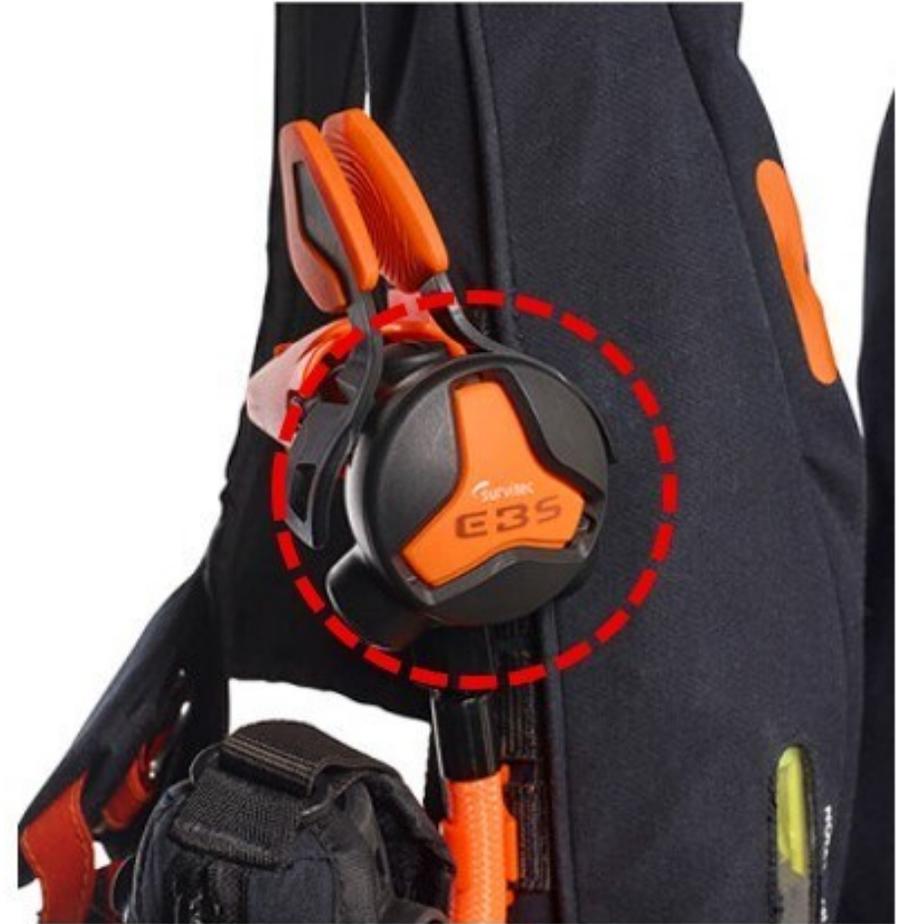
These caps are fitted when they are in the transport bags and have the potential to interfere with operation of the purge button if required in an emergency.

Purge button cover cap is placed over purge button during transport in flight bag and should be removed before issue to passenger

- Helideck crew should inspect lifejackets before issuing to passengers
- Each individual user should perform pre use checks and visual inspection before use of lifejacket
- Passengers should perform a visual "Buddy check" before boarding helicopter
