Property Damage – Scaffolding Lifting Frame

SAFETY ALERT

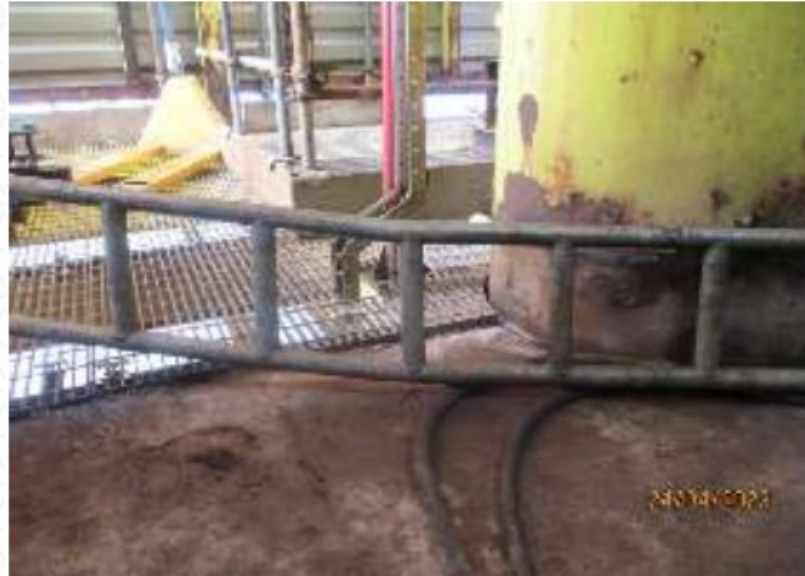
An establishment were requested to erect scaffolding at the request of the platform to support another contractor with operations to pull out a seal that was stuck on a wellhead.

A rigging arrangement was applied to the scaffold lifting frame and a scaffold ladder beam failed and bent during lifting operations.

Inadequate job planning – The lifting frame constructed was for 1 tonne only. However, the rigging arrangement was for 3 tonnes.

The Scaffolding Manual was not consulted for the lifting frame and it cannot be said that the structure was in accordance with the requirements put in place.

- No job is ever too important for Safety. Take the time to ensure all the correct processes have been followed and documentation is in place.
- The scaffolding structure was dismantled post-incident. In the event of an incident, the scene of an incident should be preserved to enable appropriate evidence gathering (e.g. photographs)
