# Shutter panel dropped whilst lifted by tower crane

Safety Alert

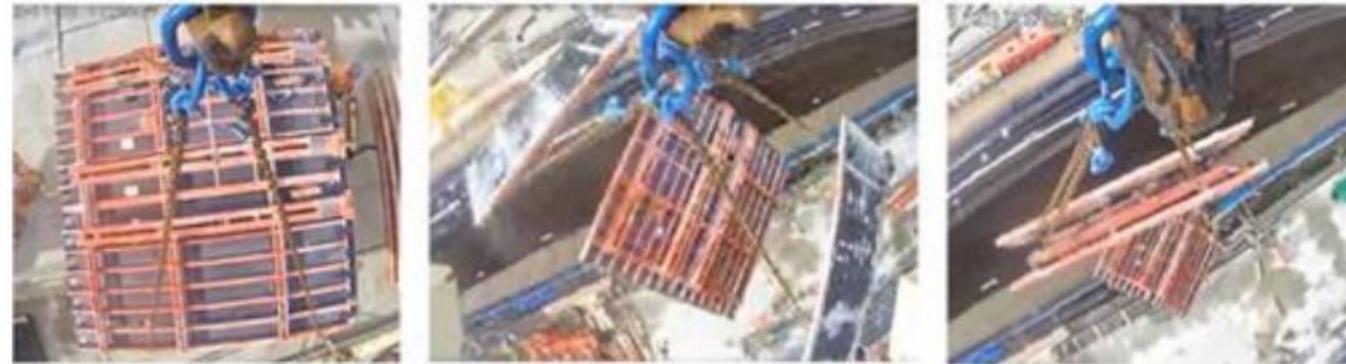
During the lifting of 2 stacked formwork panels by a tower crane, the lifting chains were connected to the lower panel.

As the load was being moved towards the landing area, the lower panel split, releasing the unsupported upper panel to fall approx. 10metres to the area below.

Load at start of lifting

Lower panel splits

Panel falls to the ground

- > **Each** lifting operation should be **planned and recorded** on the **lift plan** and **risk assessment specific to the task**
- > Lifting operations should be appropriately **supervised** to ensure the lift is carried as **per the plan**
- > Lifting operations should be **carried out as per the task lift plan** – if anything changes, **STOP the job**, revisit and update the lift plan and risk assessment as required

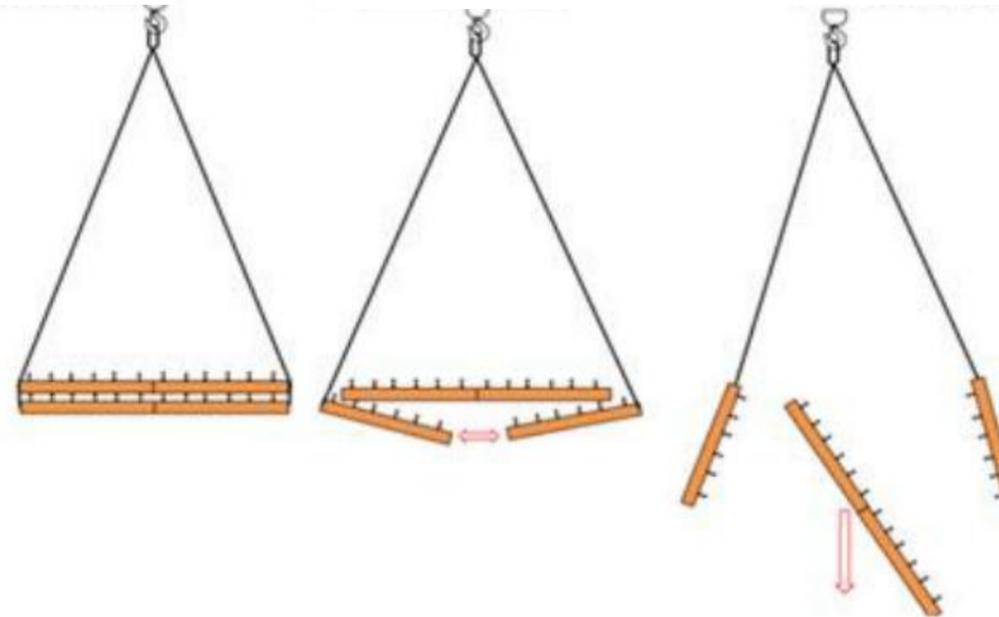
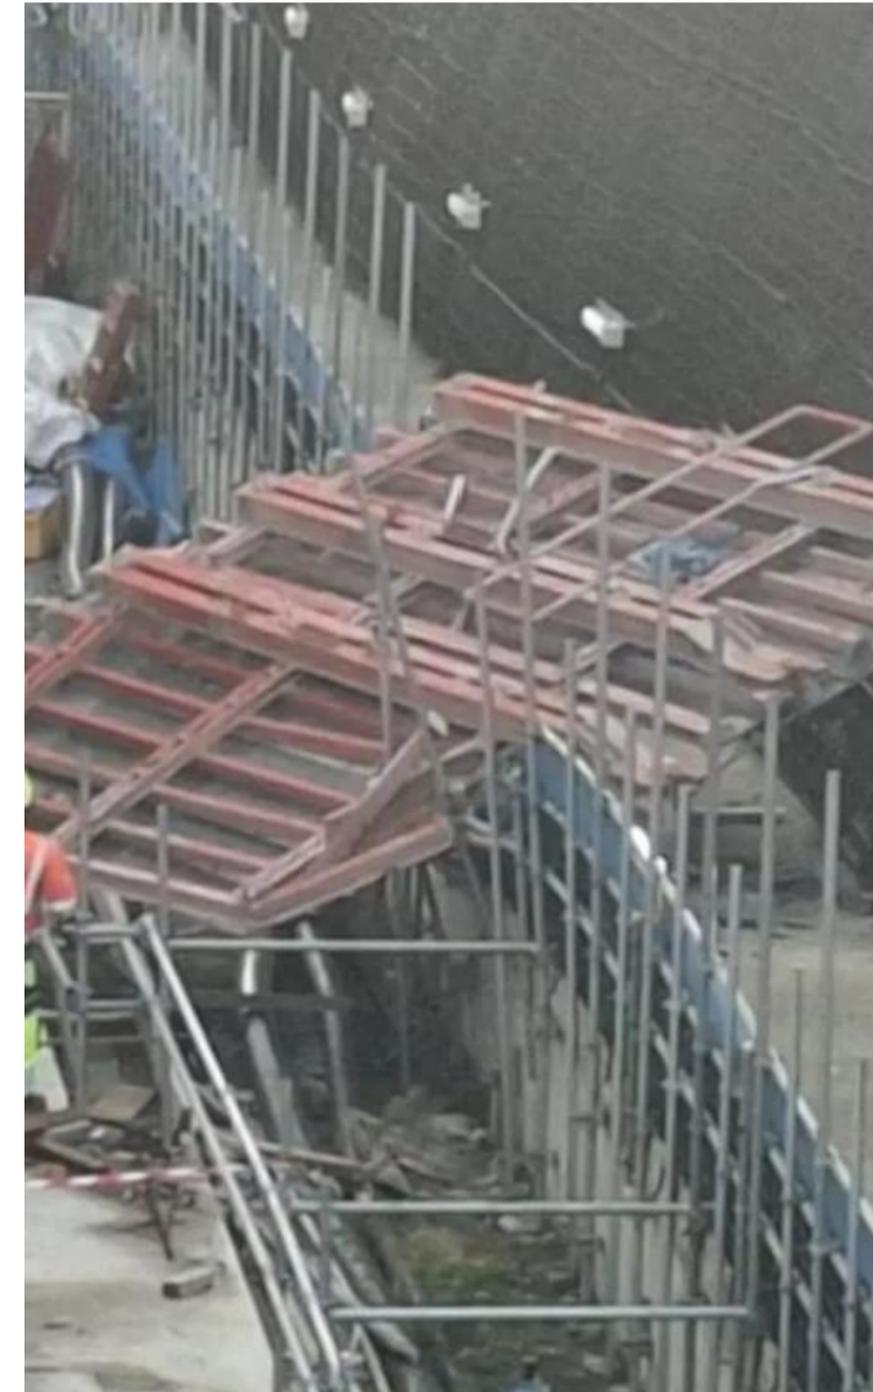
The panel fell onto a scaffold, causing severe damage to both the scaffold and formwork.
