Safety Alert

Number: 25-11

Subject: Dropped Object – Satellite Antenna

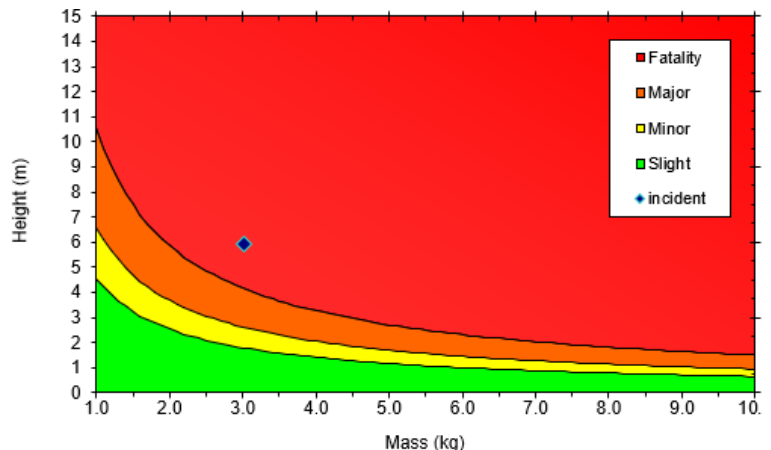
The Drops calculator has been used to plot the potential outcome of this as shown.

Outcome Calculator	
Height	6 m
Mass	3 kg
Outcome	Fatality 176.52 Joules

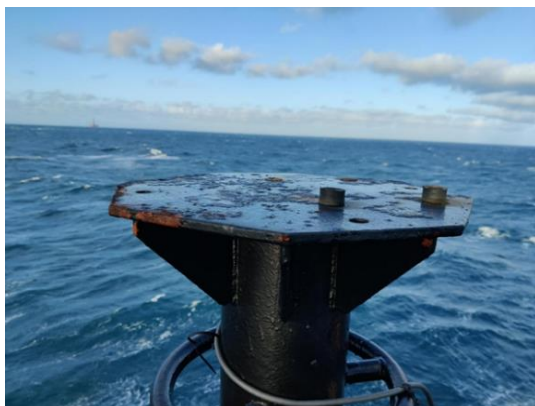
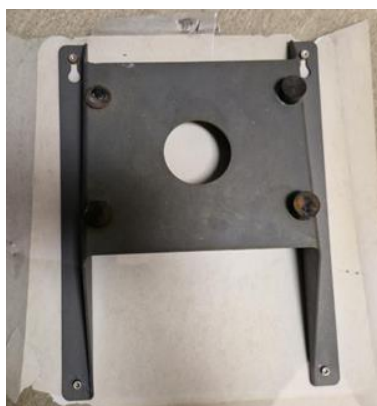
Photographs / Supporting Information

An investigation has revealed that the satellite antenna was mounted on a foundation with rubber compensators like the example shown below. Over time the rubber was not strong enough to hold the antenna and subsequently failed.

The antenna fell down during a period of severe weather whilst the vessel was at sea. The rough weather may have been the final cause for the rubber compensators to break.

All of the members vessels were requested to check for similar issues and that their antennas are fastened sufficiently.

The brackets mounted on the antennas must be fastened to a foundation with bolts going through, and a means of secondary retention in place.
