# 14 August 2021 M7.2 Haiti Earthquake. Preliminary Satellite-Based Comprehensive Damage Assessment Report

Grande'Anse, South, and Nippes departments of Haiti

The 27th of August 2021

Prepared By  
United Nations Satellite Centre (UNOSAT)

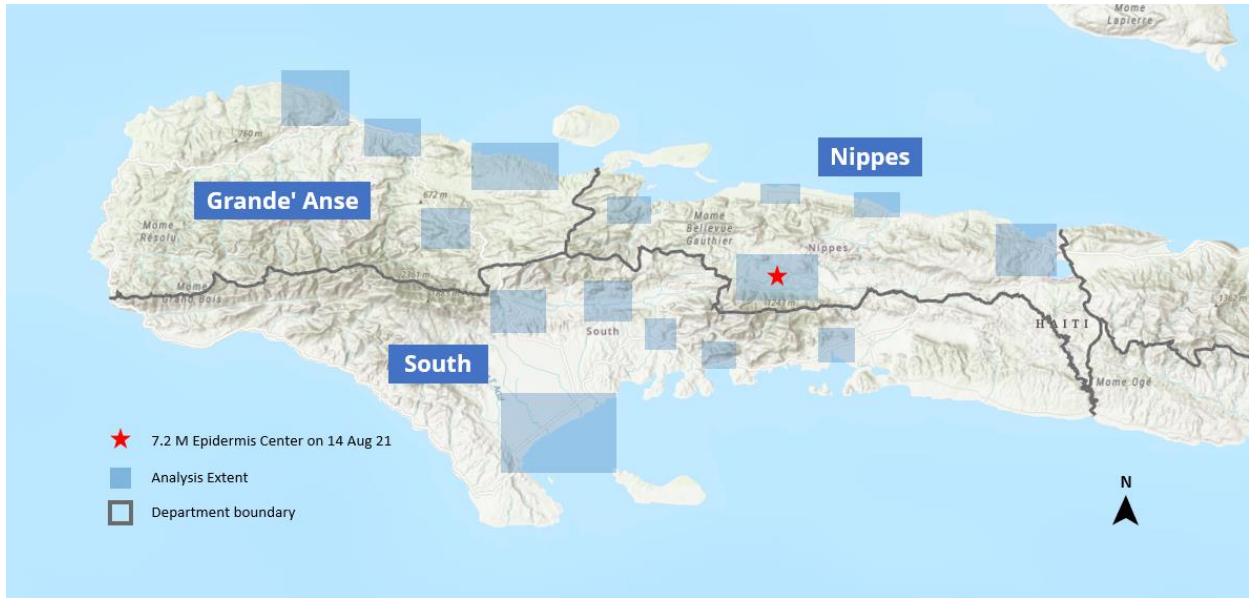
Figure 2. This map depicts the analysis extents in the Grande' Anse, South, and Nippes departments of Haiti examined by UNOSAT, SERTIT, and Copernicus EMS to determine infrastructure damage caused by the M7.2 earthquake on the 14th of August 2021. The map also identifies the earthquake epicentre in the Nippes department.

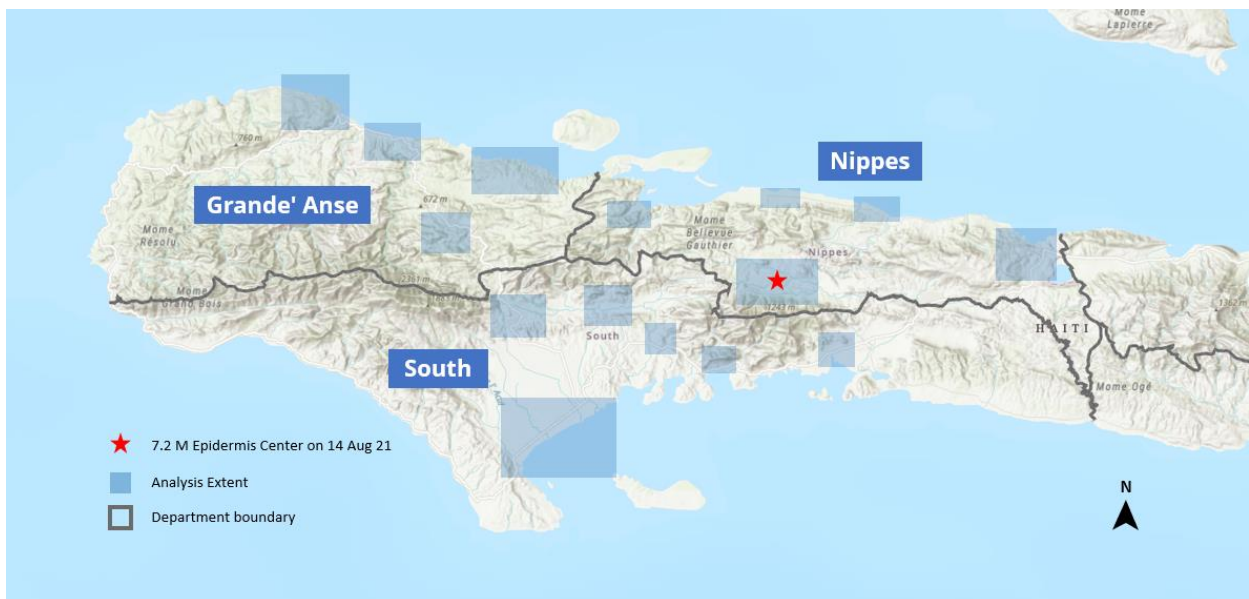
The preliminary analysis extent within South, Grande' Anse, and Nippes departments identify a total of 1,842 buildings/structures with visible damages and approximately 130 locations with visible road obstacles and/or access constraints.

Figure 3. This map depicts the analysis extents in the Grande' Anse, South, and Nippes departments of Haiti examined by UNOSAT, SERTIT, and Copernicus EMS to determine infrastructure damage caused by the M7.2 earthquake on the 14th of August 2021.

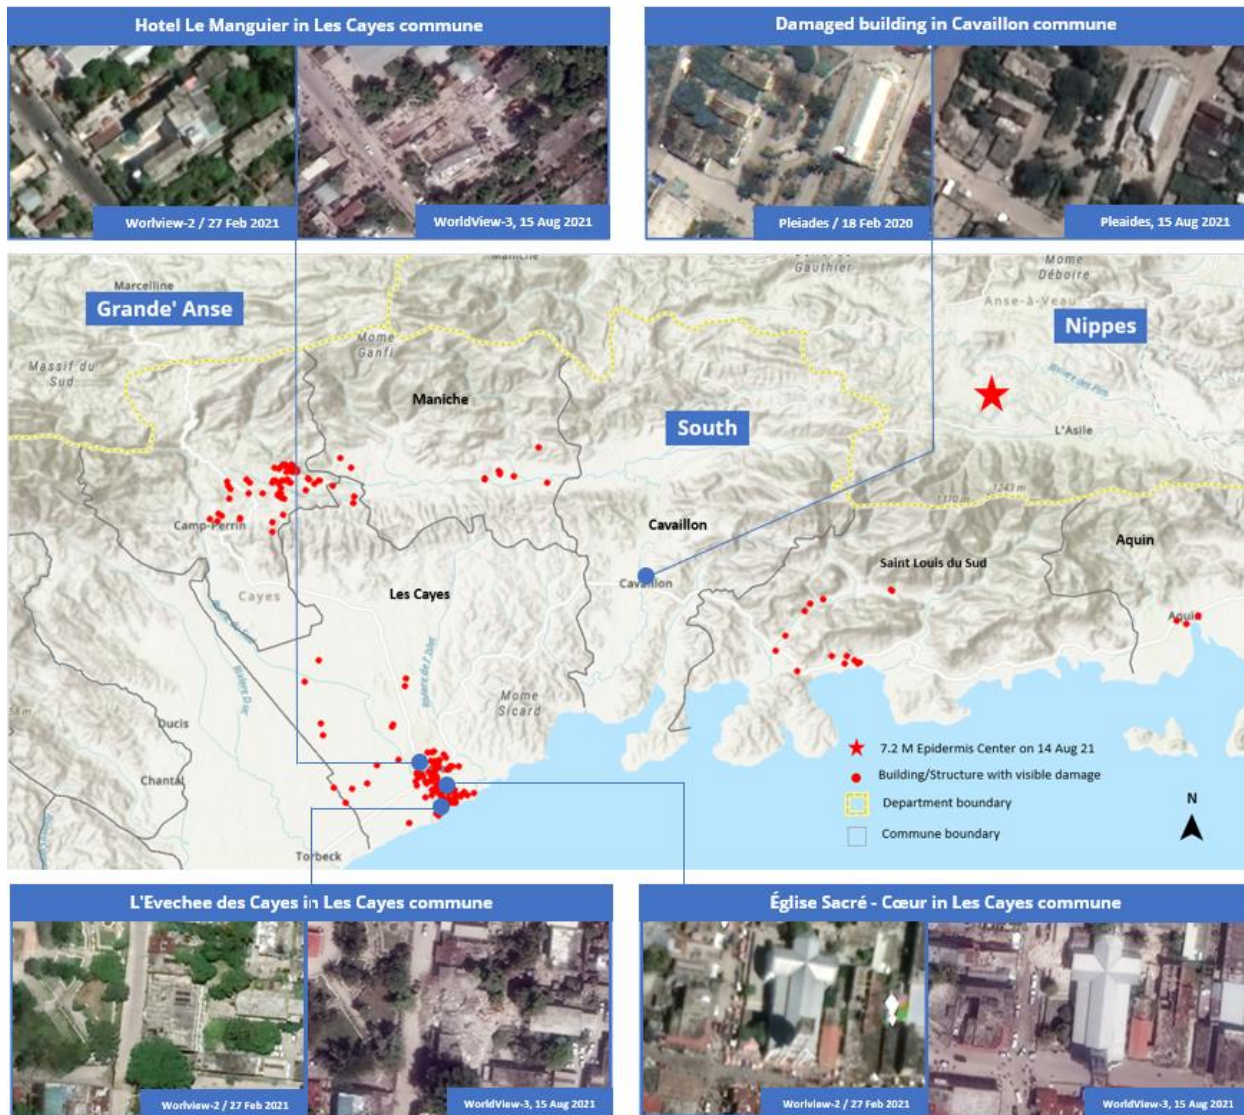
Preliminary building/structure damage assessments were conducted through visual interpretation by UNOSAT and partners, utilising before and after very high-resolution satellite images. The post-disaster satellite images were acquired after the earthquake on the 14th of August 2021, along with available pre-disaster images. A total of 581 buildings were identified with prominently visible damage within the analysed areas. Les Cayes commune had the highest number of affected buildings, with over 340 damaged buildings detected.

Figure 5. This map depicts the extent of damaged buildings in the South department of Haiti, specifically in the Les Cayes, Cavillon, Camp-Perrin, Maniche, Saint Louis du Sud, and Aquin communes. Additional inset images from WorldView-3 and Pleiades satellite acquired on the 15th of August 2021 highlight and visualise the extent of damage to buildings within Les Cayes and Cavillon communes.

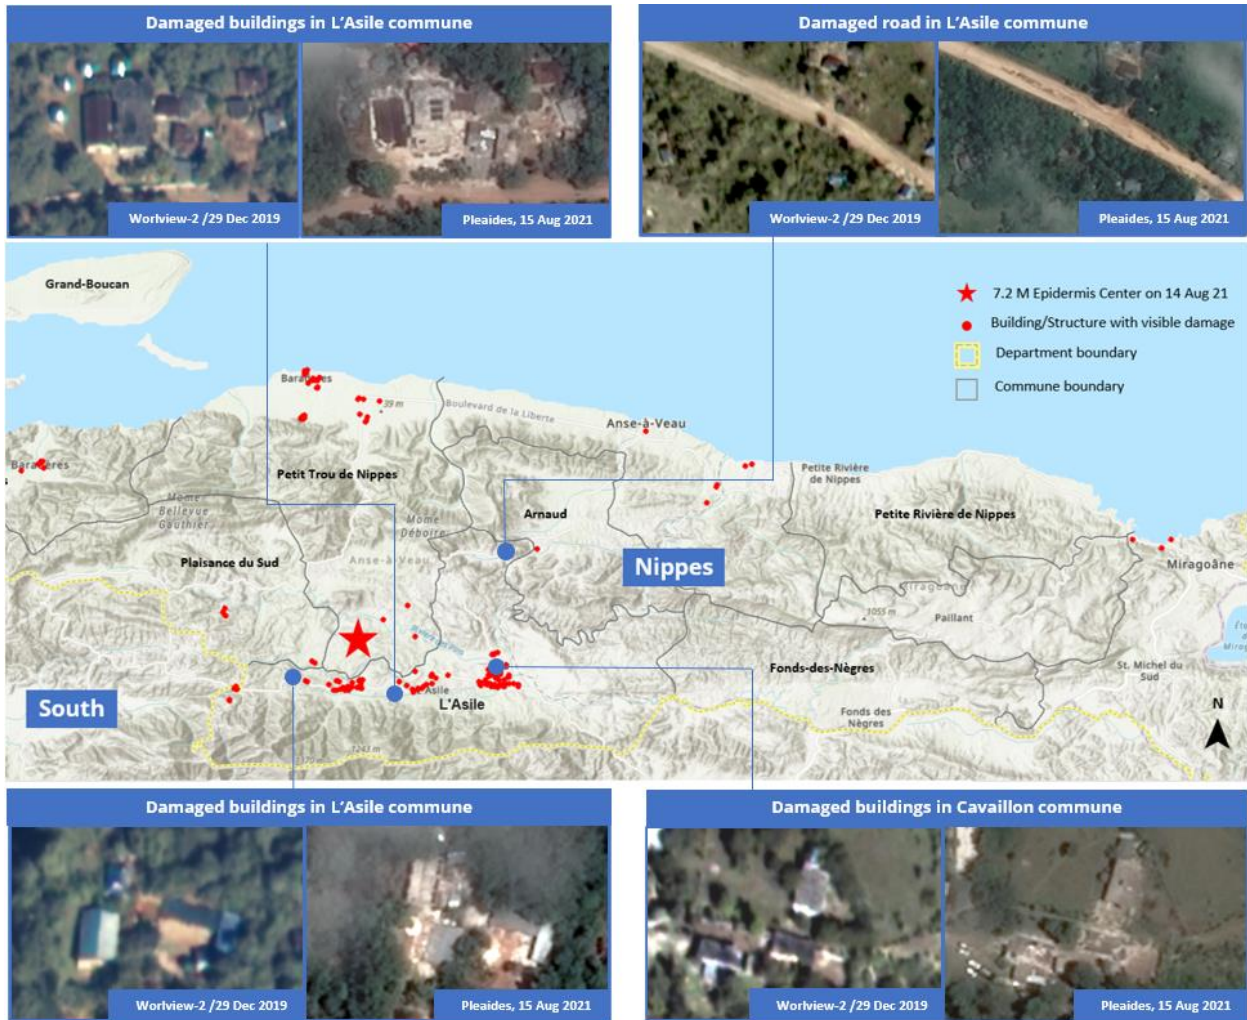
Preliminary building/structure damage assessment was conducted through visual interpretation by UNOSAT and partners utilising before and after very high-resolution satellite imagery. The post-disaster satellite images were acquired after the earthquake on the 14th of August 2021 with available pre-disaster images. A total of 562 buildings were identified with prominently visible damage within the analysed areas. L'Asile commune had the highest number of affected buildings, with over 300 damaged buildings detected.

Figure 9. This map depicts the extent of damaged buildings in the Nippes department, specifically in the Baradères, Plaisance du Sud, Petit Trou de Nippes, L'Asile, Arnaud, Anse-à -Veau and Miragoane communes. Additional inset images from the Pleiades satellite acquired on the 15th of August 2021 highlight and visualise the extent of damage to buildings within Les Cayes and Cavaillon communes.
