# COMMUNITY-BASED SHELTER RESPONSE IN THE CONTEXT OF THE GAZA CRISIS

Technical Guide for Responding to Damaged Buildings  
**Household Interventions for Adapting Partially Damaged Buildings into Livable Spaces Using  
Alternative and Reclaimed Materials**

OCTOBER 2025  
**PALESTINE SHELTER CLUSTER**  
Gaza Local Coping Strategies TWG

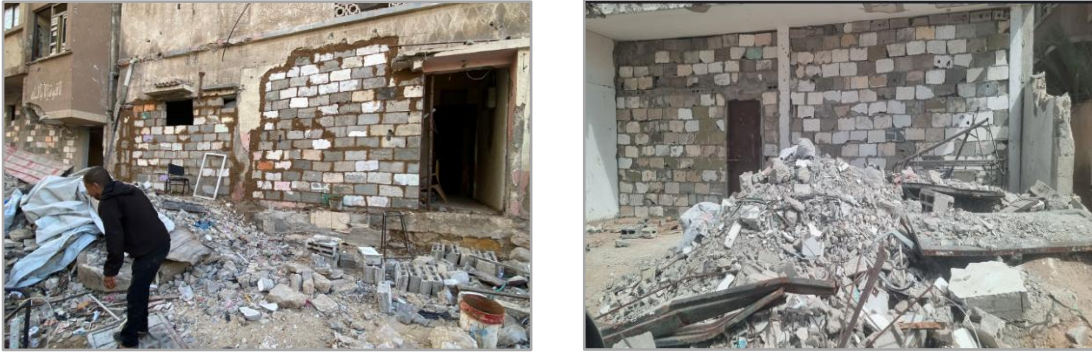
- **Small cracks and holes:** These are generally left as they are due to the high cost of cement, and is considered a low priority in comparison to more significant damage in a building.
- **Large gaps or partially collapsed sections:** The collapsed parts of the building's external facade are rebuilt using reclaimed cement bricks, using cement if available, or alternatively, using a mixture of clay and straw as a substitute for cement mortar.

Figure1 Sealing off missing wall parts with reclaimed cement blocks to close the openings

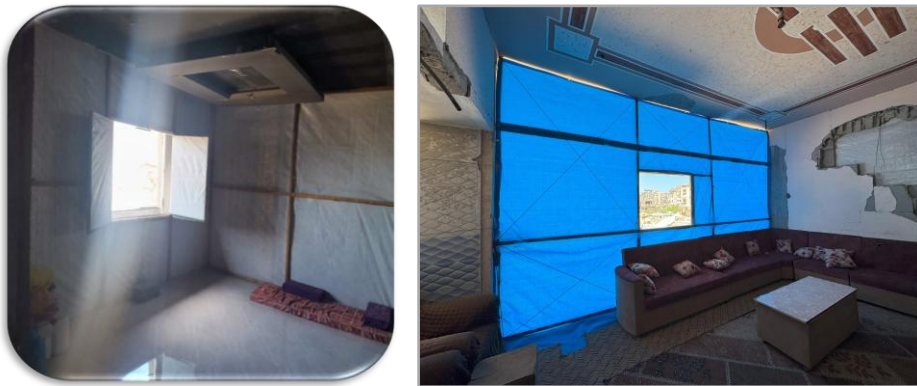
If bricks are not available, gaps are filled using wooden boards, zinc sheets, or fabric tightly secured to a simple wooden frame or directly to the edges of the openings. Practices has shown for better reinforcement the lower part of the external wall on the upper floors of the building, two courses of reclaimed bricks or a horizontal zinc sheet has been used.

Figure2 Examples from Gaza of closing wall openings with tarpaulins

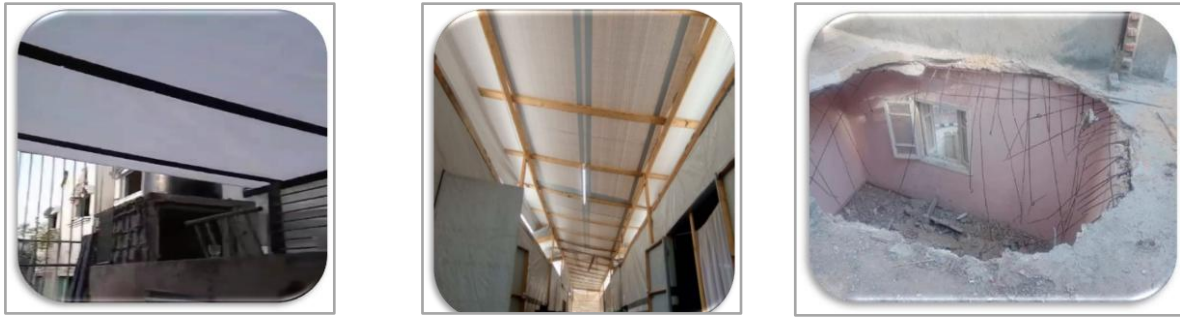
Openings in roofs are usually seen to be repaired using reclaimed metal sheets (zinc) or multiple layers of tarpaulins (plastic sheeting), which are securely fastened with adhesive (after cleaning the surfaces to ensure proper bonding) or nails with washers. Adequate overlapping with adjacent surfaces is maintained to prevent leakage. For larger openings, vertical wooden supports with horizontal crossbeams are sometimes constructed to cover the gap, after which the tarpaulin or plastic sheeting is laid over and tightly secured using ropes and wires. Residents primarily use tarpaulins to protect exposed areas from sun and rain while ensuring a minimum level of privacy.

Figure3 Different examples of openings in ceilings and their treatment

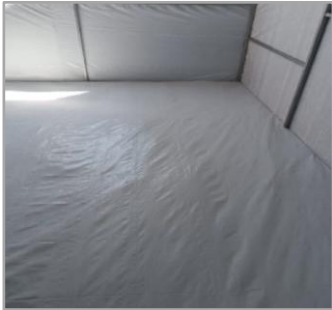
- Thick nylon sheets or used carpets were laid over broken areas to reduce dust and improve hygiene.
- In sanitary areas, reclaimed tiles (ceramic, marble, or interlock) were used to create durable, moisture-resistant surfaces.
- Plastic sheeting was installed in sleeping areas to provide insulation and enhance comfort.

Figure6 Covering the floor with plastic tarpaulin

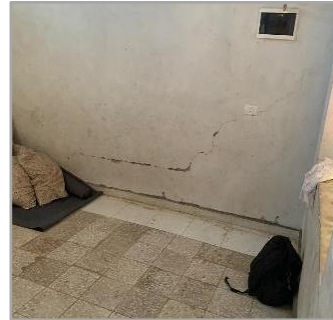
Figure5 Replace the damaged area with reclaimed tiles

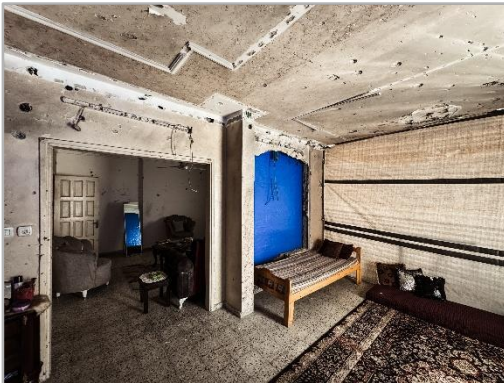
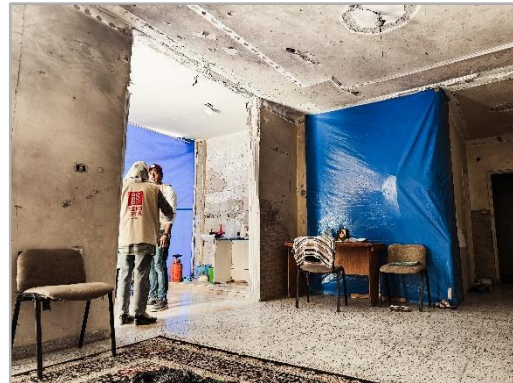
To provide some privacy or to separate different usage areas within damaged spaces, fabrics, wooden boards, or tarpaulins (plastic nylon sheets) were used to create temporary internal partitions.

Figure7 Interior sealing off to walls inside the housing unit (source HEKS/EPER July 2025)

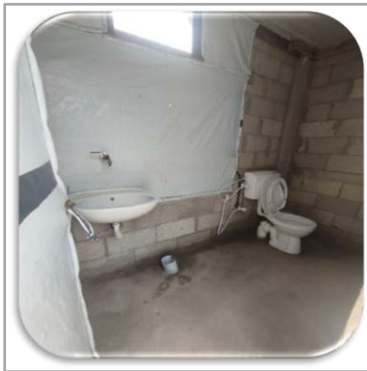
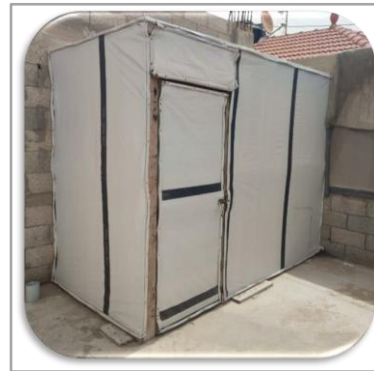
- Temporary privacy was ensured by covering bathroom and shower openings with tarpaulins or blankets.
- In cases of severe damage where households do not have other alternatives and choose to stay in the same location, an internal space was designated and privacy was ensured using tarpaulins or blankets. Attempts were made to repair existing plumbing installations or to create new ones using reclaimed plumbing parts and materials in good condition.
- In cases of minor damage, repairs were carried out using available materials such as tarpaulins, covers, and reused plumbing accessories, including used but functional toilet seats, sinks, and faucets.

Figure8 Sealing off sanitary facilities in Gaza housing units (Source: MAAN, July 2025)

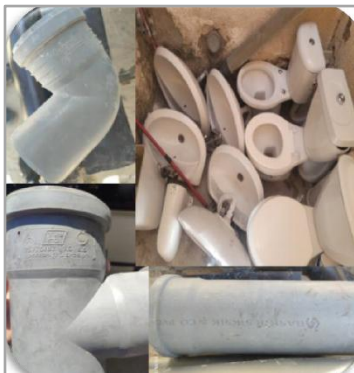
- Toilet seats salvaged from debris were reused when in good condition.

Figure 10 Accessories recovered from debris

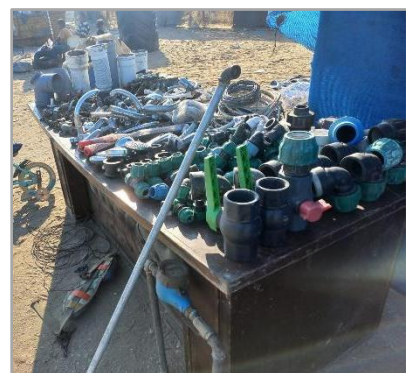
Figure 12 Reclaimed plumbing fixtures at a second sale point

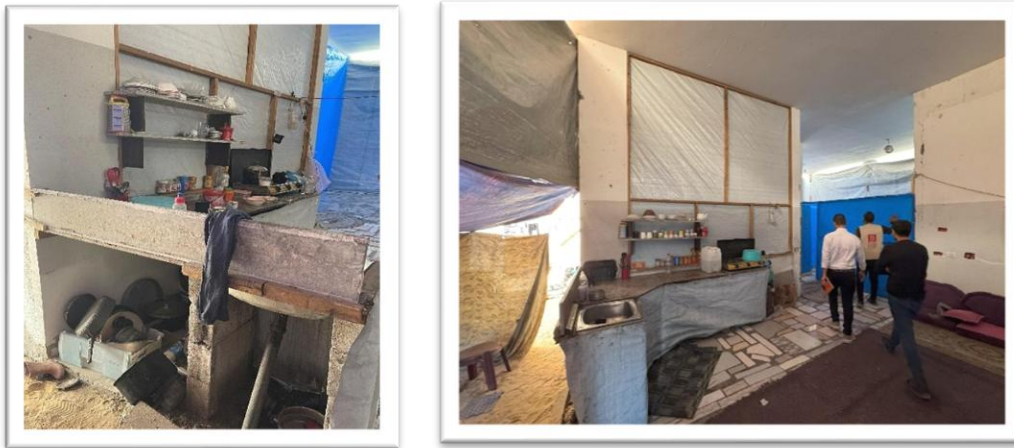
Many residents have created cooking corners using reclaimed materials. Blocks are used to build bases for the washing basin (sink), while wooden boards, reclaimed tiles, or old marble pieces serve as countertops, sometimes covered with a layer of nylon. The cooking corner's location is carefully chosen to be isolated and away from flammable materials. For the washing basin, an opening is made in the countertop to install a reclaimed sink. Alternative solutions have been recorded, such as using large plastic water containers (16 liters), which are cut and fitted with drainage holes. Simple hanging shelves, similar to those used in tents, are also constructed to store lightweight kitchen utensils. This approach is applied in both shelter models under study (temporary shelters and rehabilitation of existing buildings).

Figure 10 Kitchen corner made from reclaimed materials (Source: MAAN June 2025)

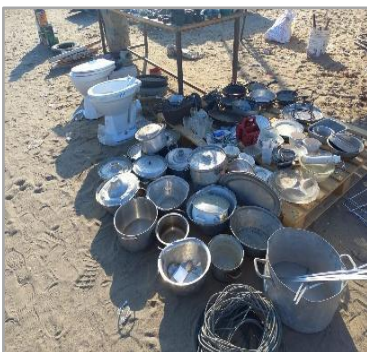
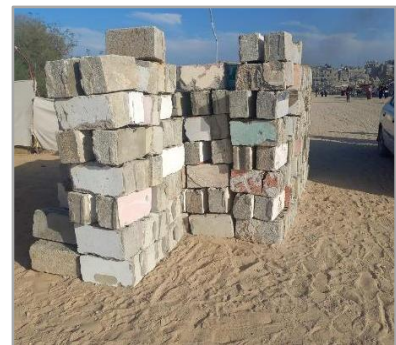
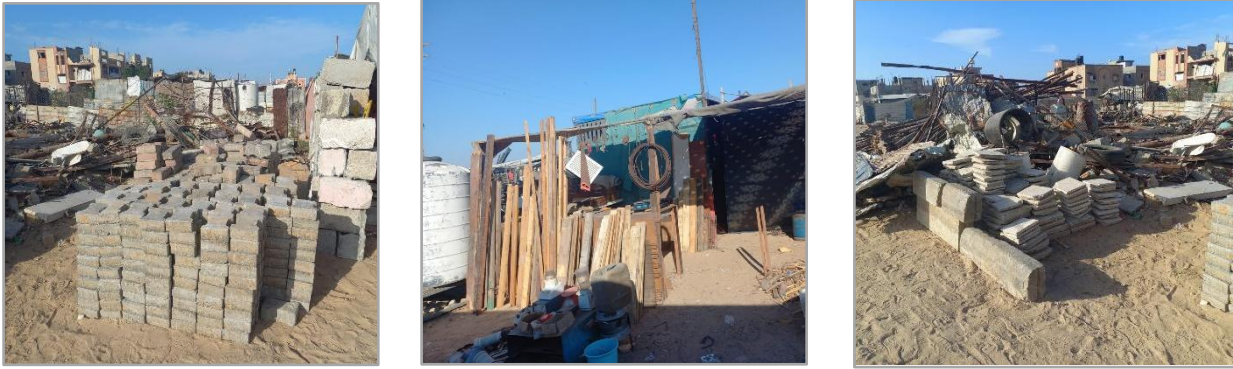
In Gaza, where access to new materials is severely constrained, communities have developed adaptive practices of **reducing, reusing, and recycling**, optimizing available resources, repurposing debris and household items, and transforming waste into functional materials.

Figure 11 Samples of recovered materials at second sales point in Khan Yunis (source HEKS/EPER, April 2024)
