## **SHELTER IN URBAN CONTEXTS: 10 Relevant Case Studies**

*CASE STUDIES OF HUMANITARIAN SHELTER AND SETTLEMENT RESPONSES IN URBAN SETTINGS*

## Shelter Projects - Shelter in Urban contexts: 10 Relevant Case Studies

Released in January 2018 by the International Organization for Migration (IOM), on behalf of the Global Shelter Cluster.

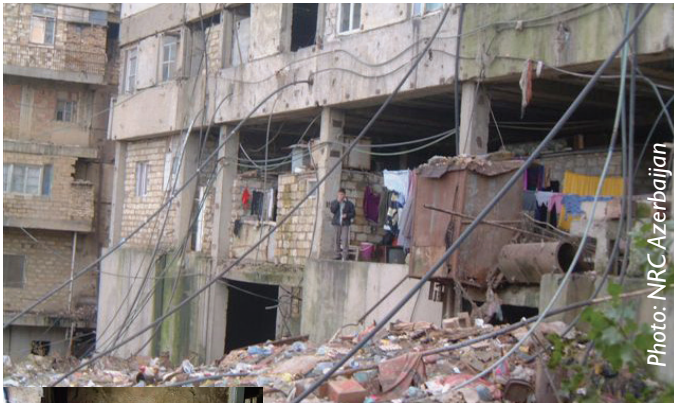
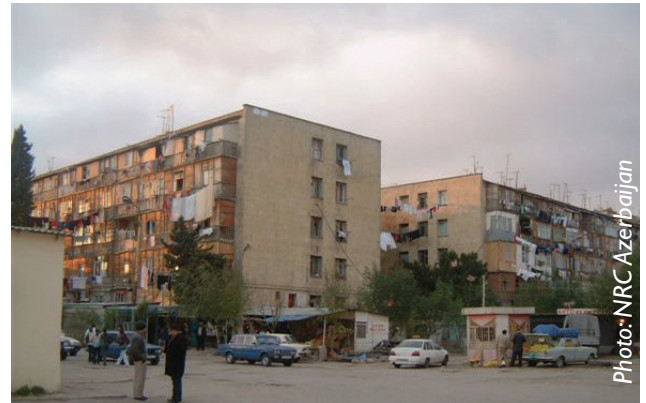
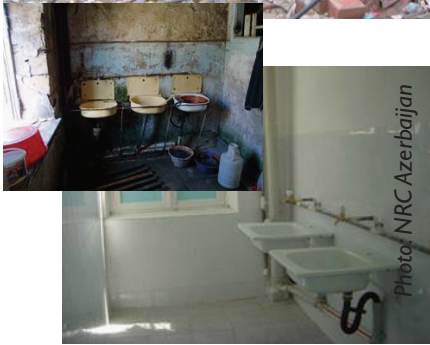
Bathrooms before and after upgrade

Inhabitants saw broken sewerage as the greatest problem in the buildings. Other common problems included shortage of water, leaking roofs and dampness. As a result, plastering, floors and ceilings in toilets and bathrooms were damaged in most buildings.

- rehabilitation of the shared areas - toilets, bathrooms, washing rooms, kitchens and corridors;
- infrastructure repairs - electricity, sewerage, water and sewerage pipes;
- repair of roofs;
- installation of new water heaters, sinks, stoves, faucets, showers, light bulbs, circuit breakers, switchboards, windows and doors;
- installation of electricity transformers (this was not costly but served a large number of IDPs).

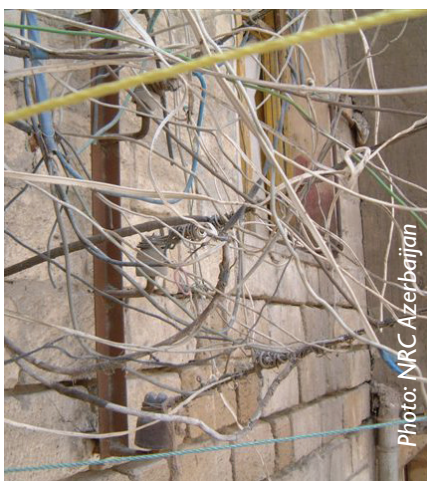
Wiring before upgrade

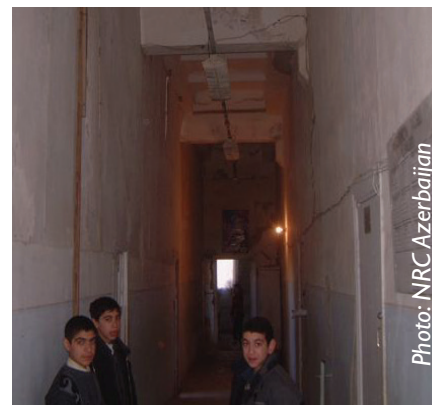
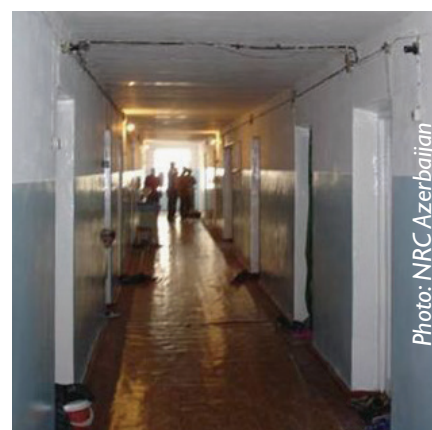
Corridors before and after upgrade

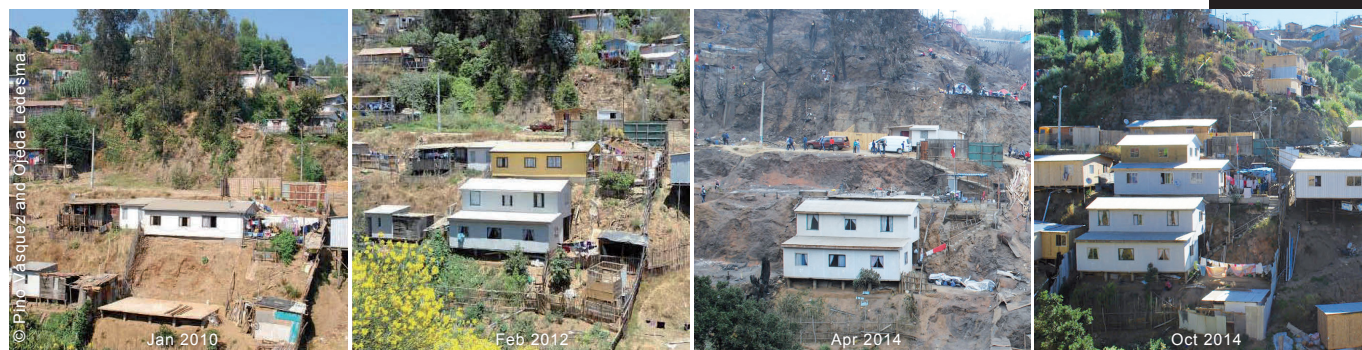
Houses were often built in clusters by families in the ravines of Valparaiso. These typical “Kinship-based Residential Complexes” were heavily affected by the fire, but people started rebuilding almost the next day. From left to right: January 2010; February 2012; April 2014, just after the fire; and October 2014, only six months later.

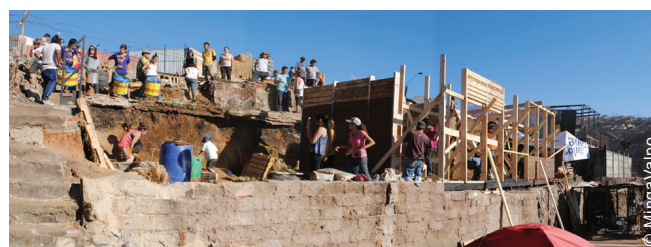
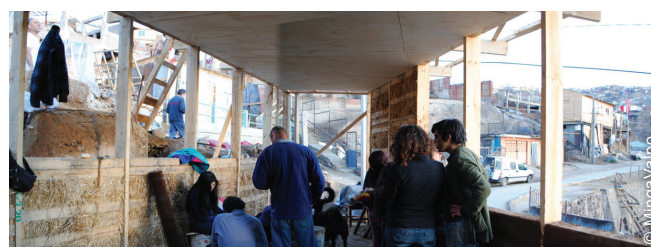
Local groups of architects organized building workshops to rebuild some of the houses affected by the fire on the Quebradas.

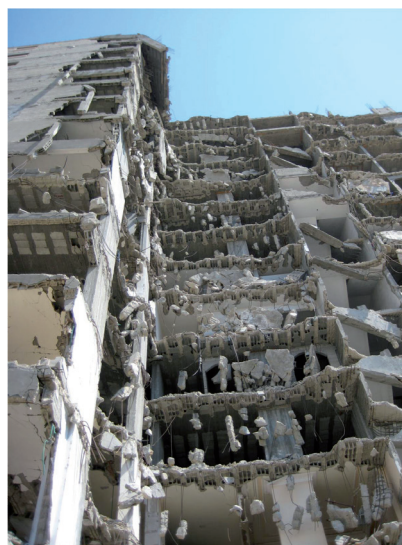
Where buildings had many tenants  
- different apartments were assessed  
separately from the building  
Photo credits: CHF

The organisation reviewed approximately 29,000 grant applications and assessed the homes of 12,000 people. Entering assessment forms into a database with linked GPS data, and an overall cost for required repairs was computed for each home.

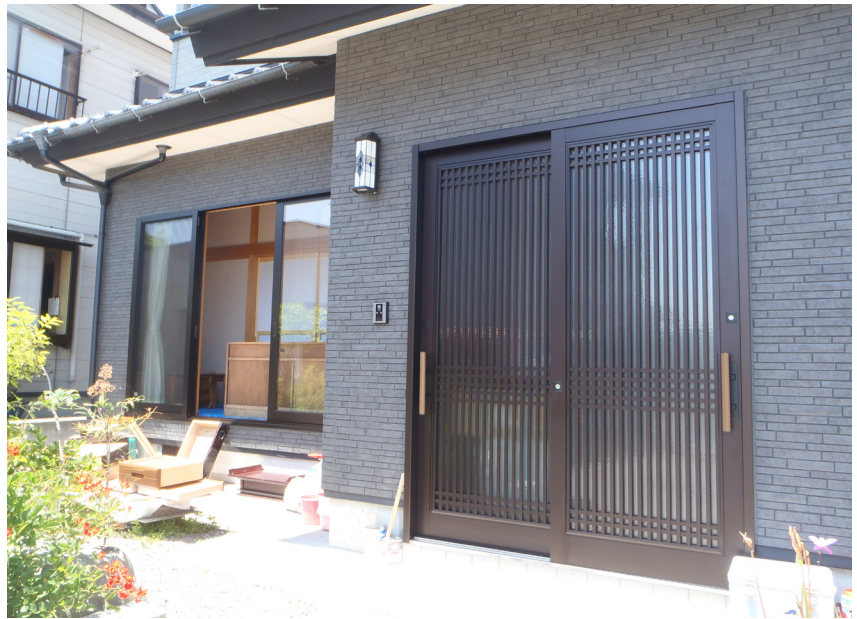
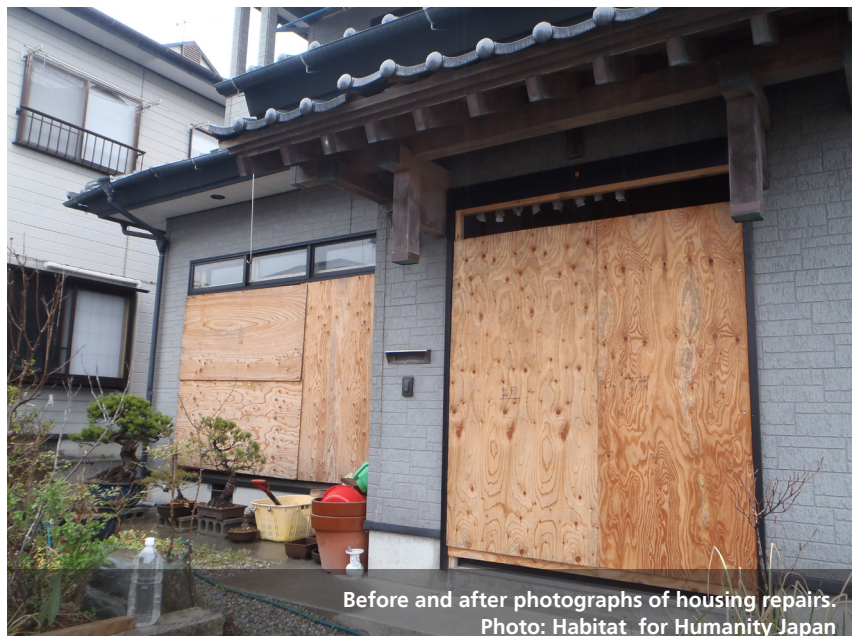
Before and after photographs of housing repairs.  
Photo: Habitat for Humanity Japan

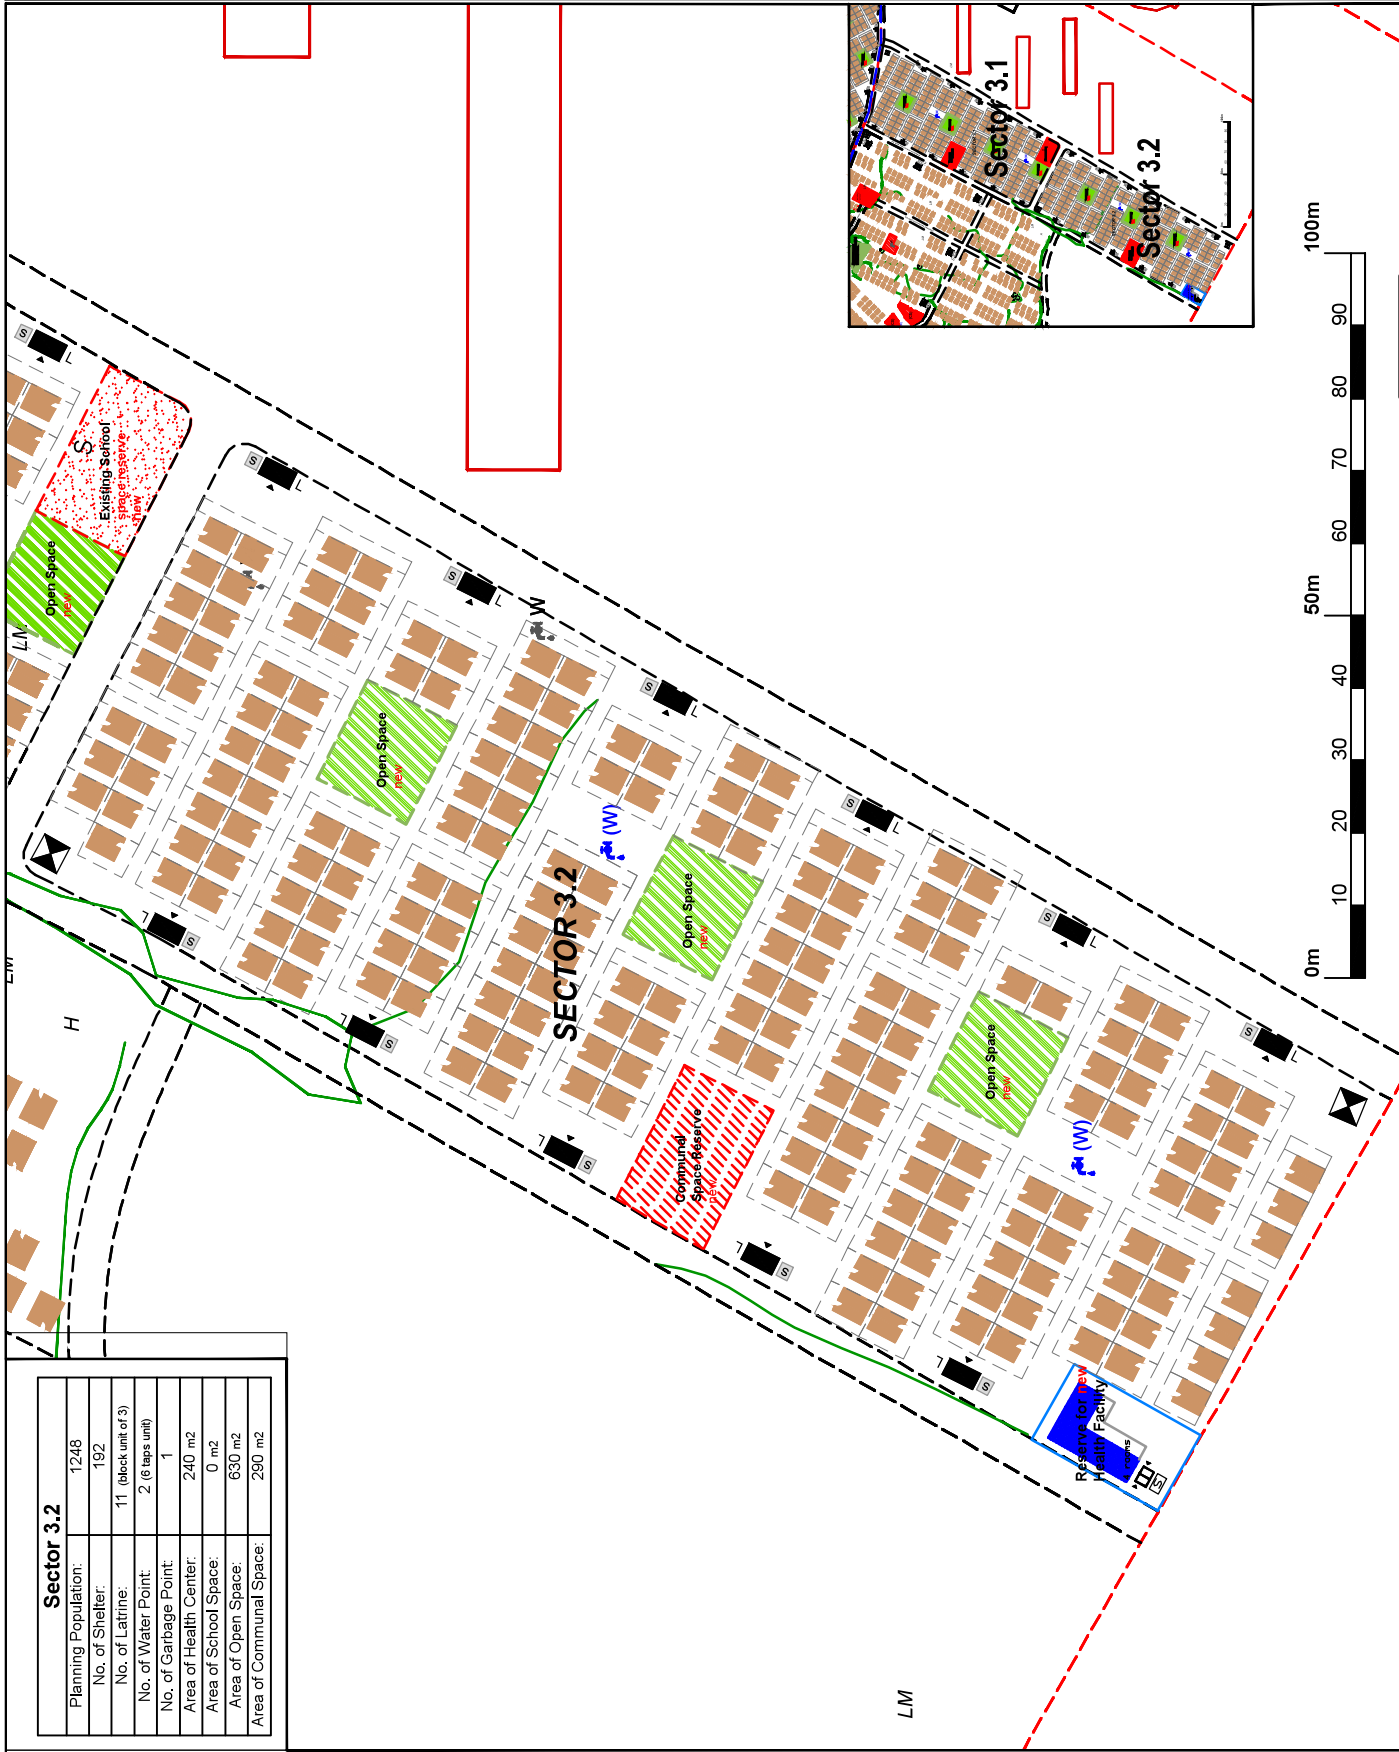
Sector 3.2	
Planning Population:	1248
No. of Shelter:	192
No. of Latrine:	11 (block unit of 3)
No. of Water Point:	2 (6 taps unit)
No. of Garbage Point:	1
Area of Health Center:	240 m <sup>2</sup>
Area of School Space:	0 m <sup>2</sup>
Area of Open Space:	630 m <sup>2</sup>
Area of Communal Space:	290 m <sup>2</sup>
