RAPID ASSESSMENT...
HOW FAR WAS THE
SURGE...
DRONE AND VIDEO
DATA...

GBPA / NEMA
2nd Oct 2019

GBPA BDS Rapid Assessment

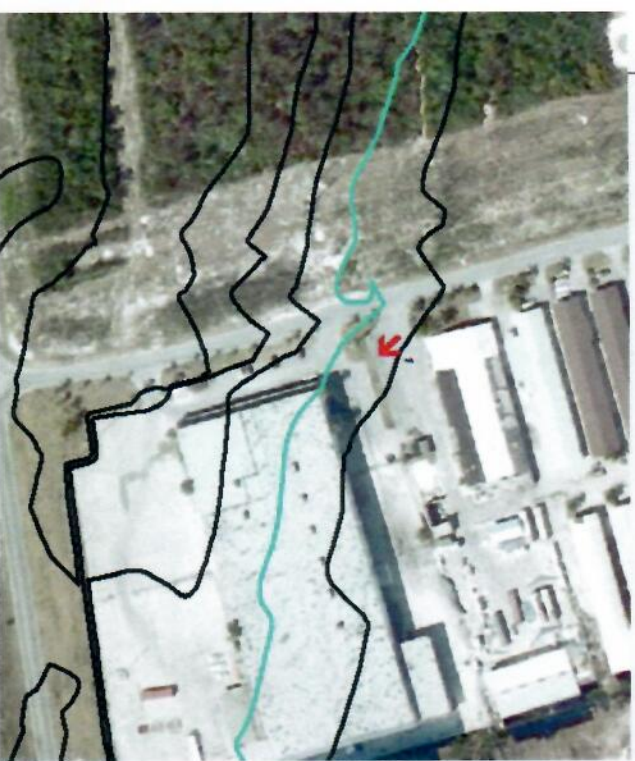
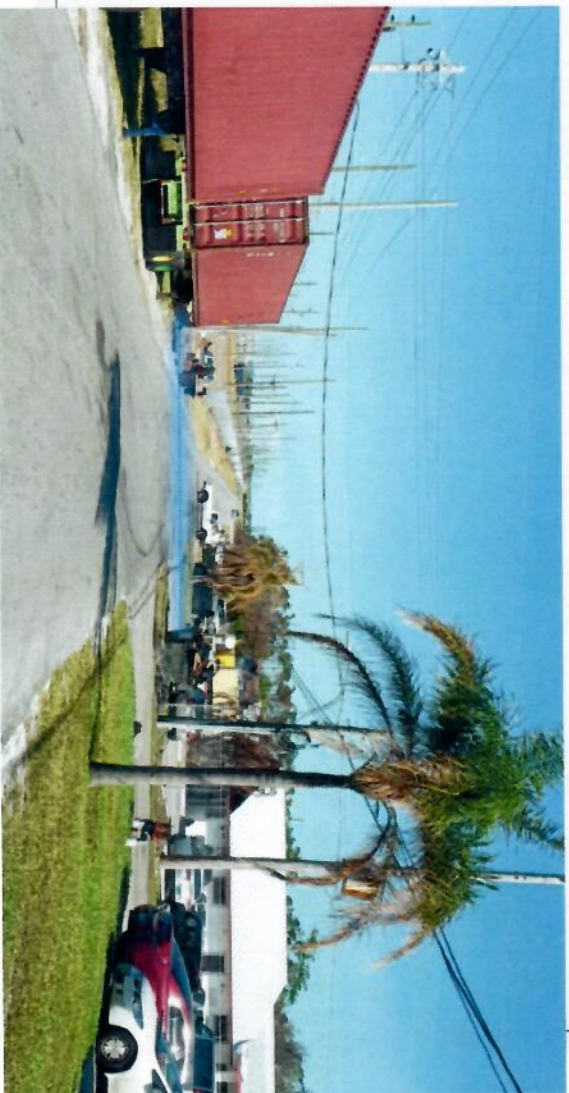
GPS ID 1 - Heavy Industrial Area (West)

GPS Location fell between 10 and 12 foot contour

Spoke to Local Business Place (Right Bld)

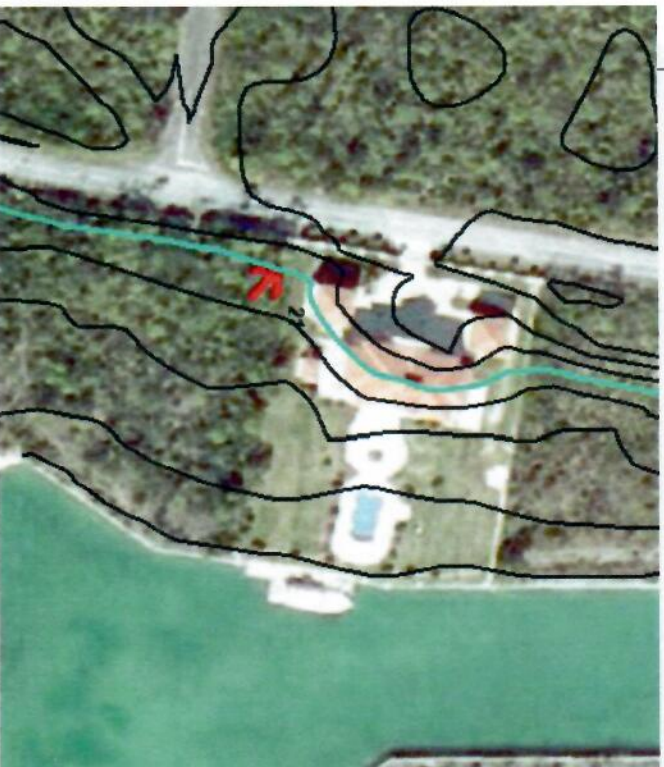
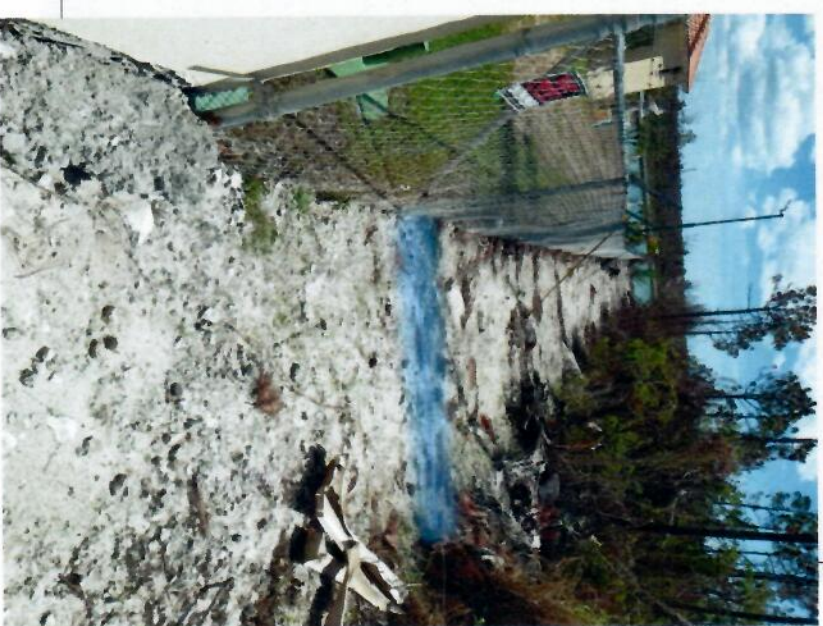
GPS ID 21 - Pearl Bay (East)

GPS Location fell just on the 14 foot contour

Spoke to resident who witnessed the surge and pointed out the limit

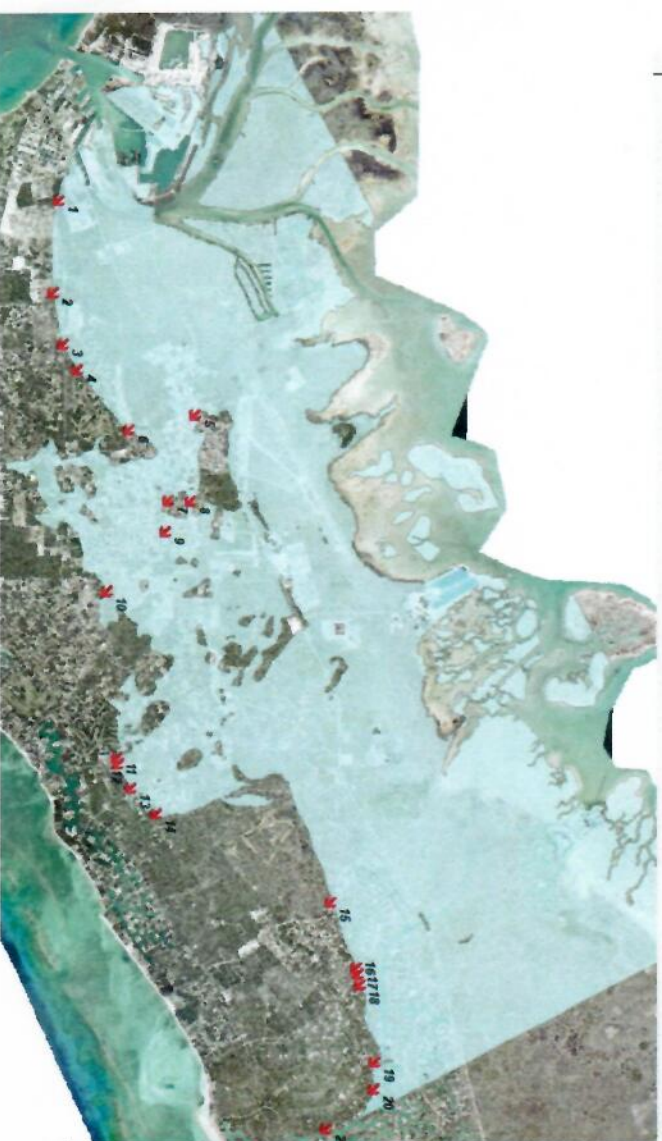
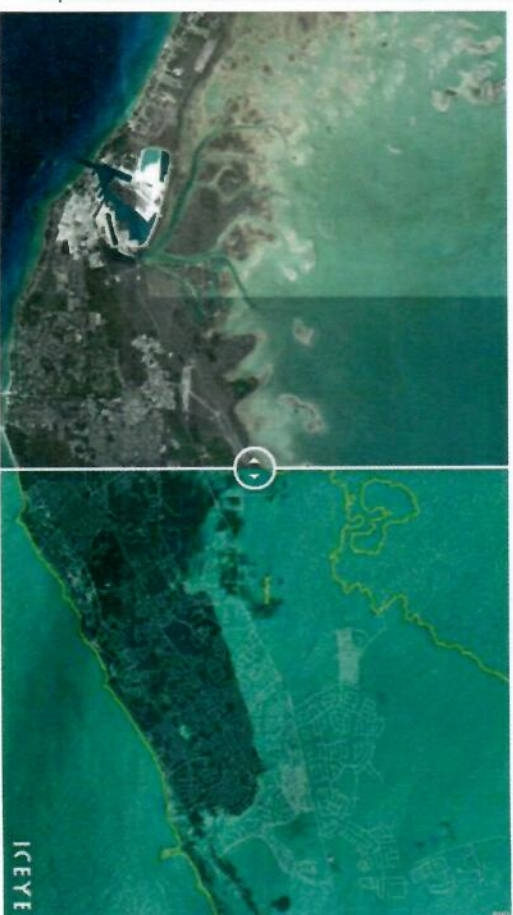
An Approx. Estimation of the Surge Limit

Image shown using the 15 foot contour and sample points (left)
CNN Reported Flood Map (right)

(CNN) — A striking satellite image of Grand Bahama Island shows vast areas of the island under water after Hurricane Dorian passed through the region on Monday.
For comparison, we've included an image that shows the same regions of the island prior to Hurricane Dorian

- From West to East – the observed water limit from 21 observed locations ranged from the min. 10-12 foot contour to max. 18 foot contour, within the Freeport Area of GBPA...before the Salt Water Canal
 - everything on the other side was impacted
- Surge was worse than reported by CNN report
- Matthew in 2016 caused a storm surge of ~ 8 Feet, Dorian increased the storm surge limit to 18 feet at max height – double that of Matthew
- The surge came from the north, thankfully the ridge limited its destruction to the island and those who reside on the south side
