SOME STRENGTHS OF LOCAL CONSTRUCTION

PROTOCOL; A pilot phase with CADECOM / CRS / CARDS; then consolidation with support of the TWG and others Malawi Partners

4. OVERALL DESCRIPTION OF LOCAL HABITAT

4.6. LOCAL HOUSING TYPES AND LOCAL AFFORDABLE OR SELF-BUILT HOUSING

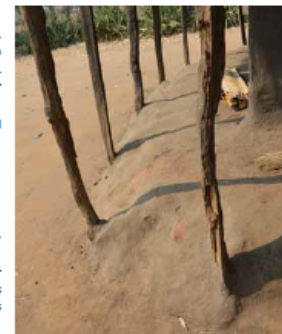
When wooden poles are in direct contact with the ground and are not regularly treated or replaced, they are vulnerable to rising damp and decomposition. Veranda in Lifizi, Salima. © Jon Twigg

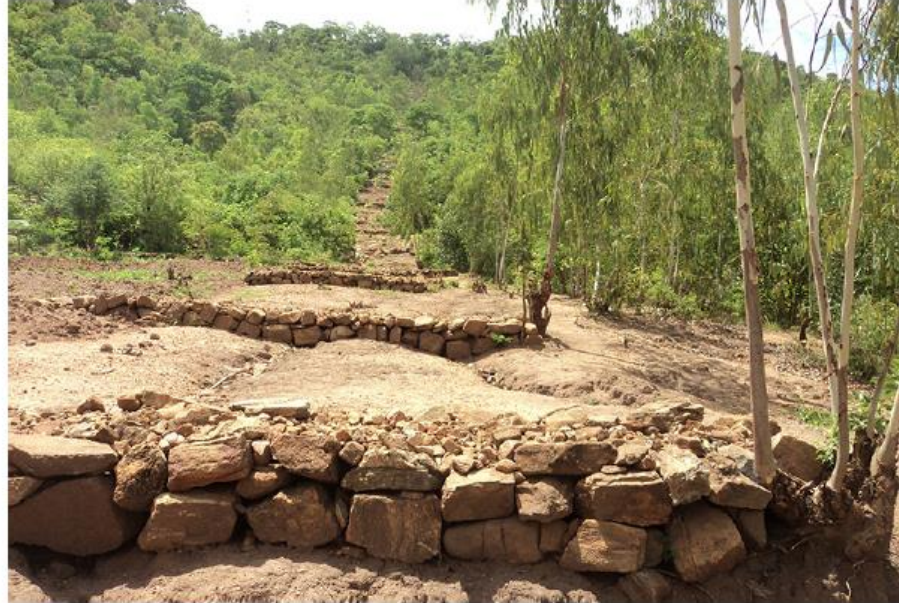
Stone bunds are a solution to reduce the speed of surface water and promote the penetration of water into the soil, thus avoiding erosion. Example of stone bunds built by Khole community in Machinga district.

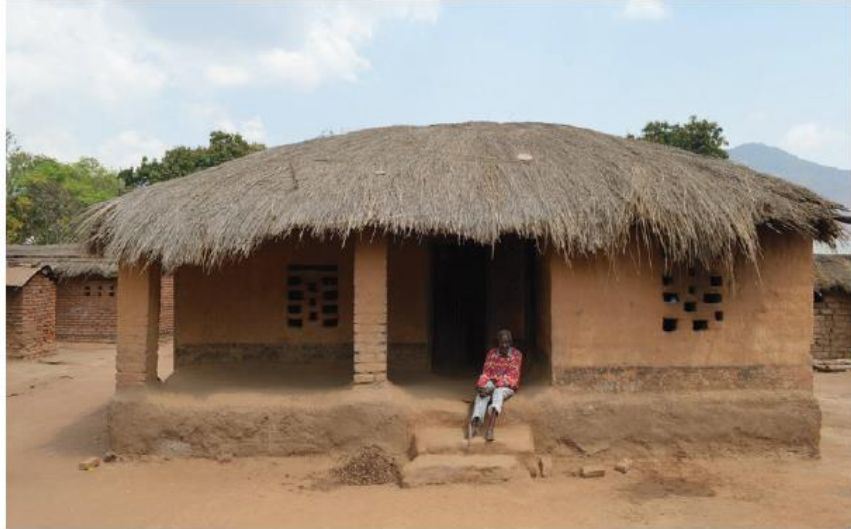
Houses constructed using adobe bricks, render and earth mortar like this one (Chisoka, Rumphi District) responded well to the important floods in 2015 (CRS, 2020) as the design developed over centuries provides protection from the elements. Other than some minor repairs, some of these houses were in good condition and allowed the families to return to their homes once the floods had subsided. © Jon Twingi

Houses constructed using adobe bricks, render and earth mortar like this one (Chisoka, Rumphi District) responded well to the important floods in 2015 (CRS, 2020) as the design developed over centuries provides protection from the elements. Other than some minor repairs, some of these houses were in good condition and allowed the families to return to their homes once the floods had subsided. © Jon Twigg

Many traditional houses had survived the floods with little or no damage, even after weeks of standing water, including those constructed using earth brick and render. This was because these houses had raised platforms that protected the core structure from erosion, and the veranda and large roof overhangs ensured that the gables and walls were protected. This design, developed over centuries, provided protection from the elements and, other than some minor repairs needed for the veranda and walls, allowed many families to return home once the flood water receded.

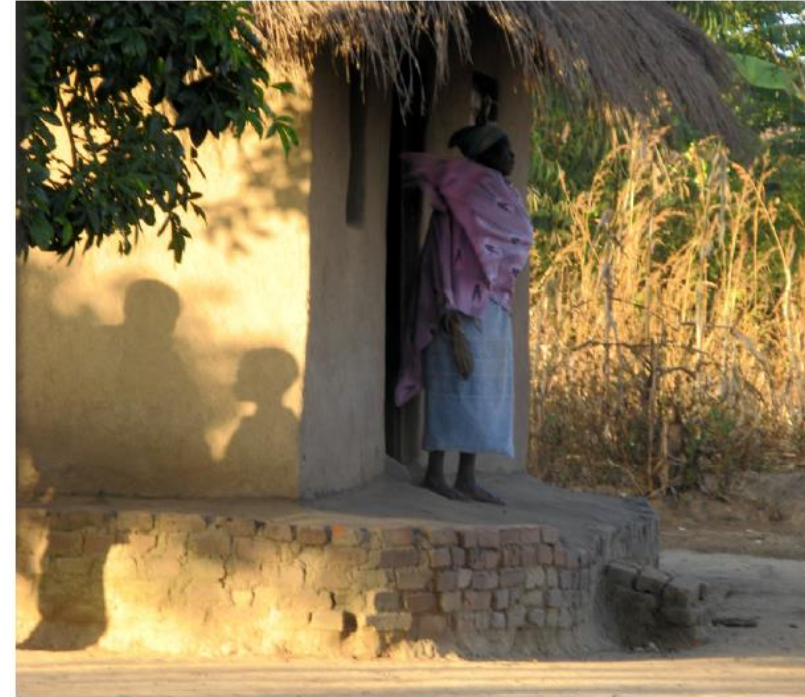
Some families protect the ends of the raised earthen mound with fired bricks or stones. House in Mtetera.

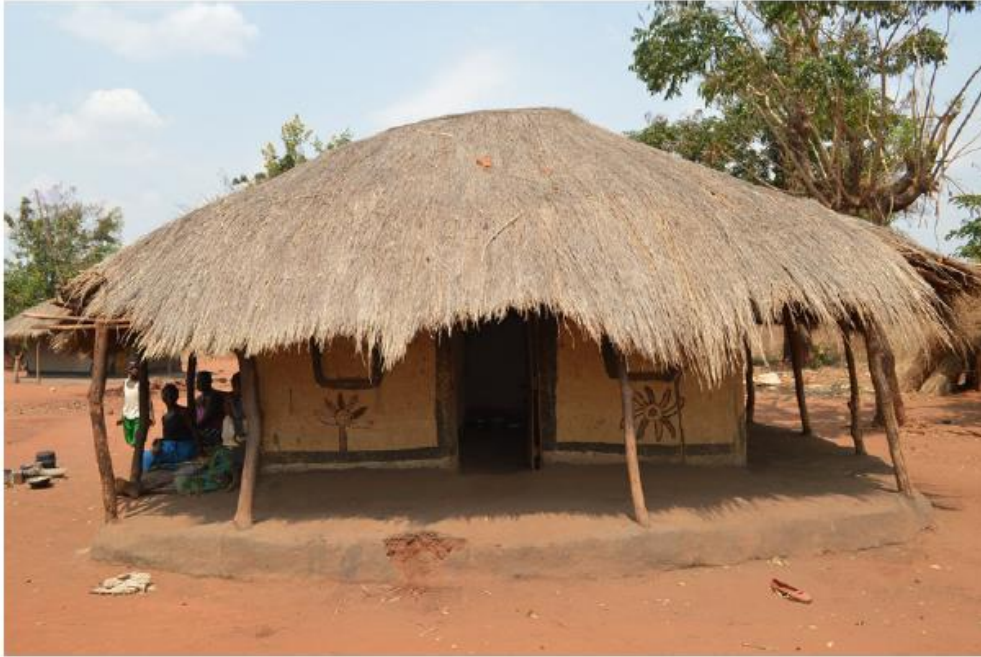
Verandas and large roof overhangs between the interior earth wall and the exterior avoid the risk that changes in humidity associated with rain will swell the soil under the walls. House in Simwaka, Nkhotakota.

This solution is particularly relevant in flood prone zones, but also in Black Cotton Soil zones where a conventional foundation would not solve the problem.

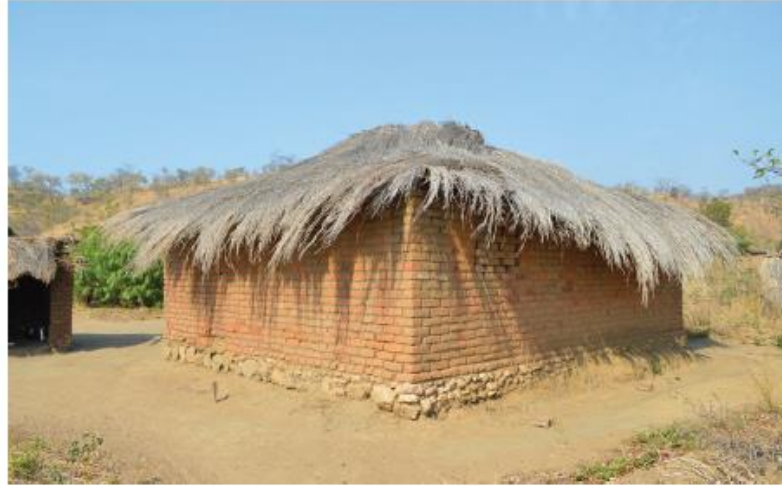
Stone foundation and plinth (Chimwendo, Karonga) protecting the walls from humidity and floods.

Stone foundation and plinth (Chimwendo, Karonga) protecting the walls from humidity and floods. © Jon Twigg

- Constructions sometimes present deep and water resistant foundations and elevated plinths built using burnt bricks or stones and cement mortar. Water resistant plinths should be built at least above the average level of floods.

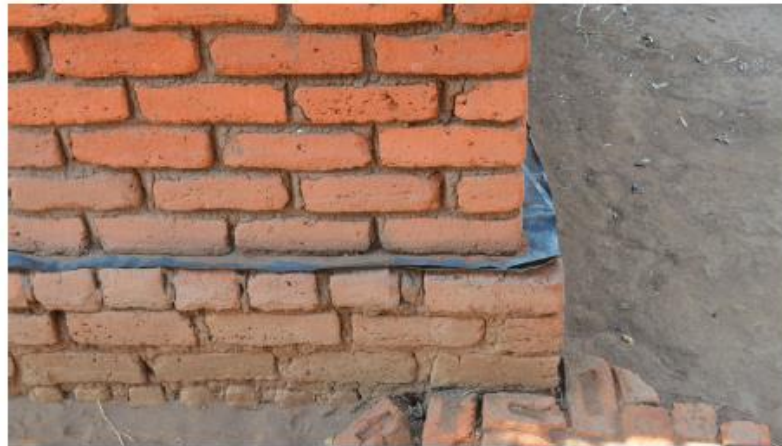
Plastic membrane protecting the wall from humidity in Masako, Dowa (bottom). © Jon Twingi

Plastic membrane protecting the wall from humidity in Mazako, Dowa (bottom). © Jon Twigg

- Rising damp (water from the soil) can weaken the base of the walls and floors. Some houses have plastic sheeting or other waterproof materials as a barrier above the foundation or plinth, and less usually a damp proof membrane below the floor as well (Shelter Cluster Malawi, 2015). These barriers are useful to fight against rising damp.

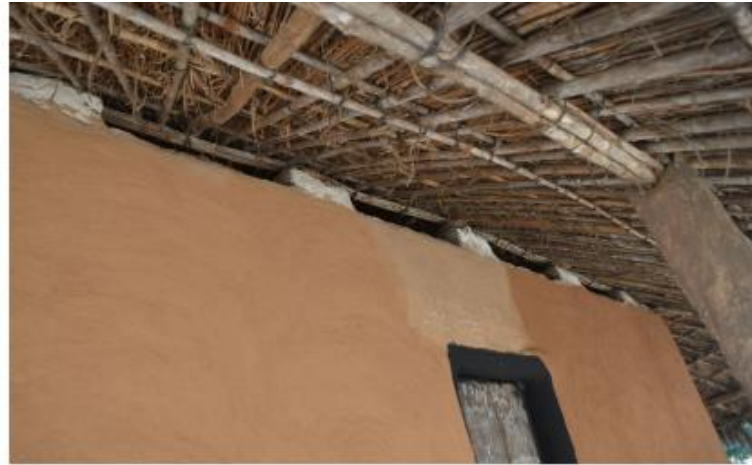
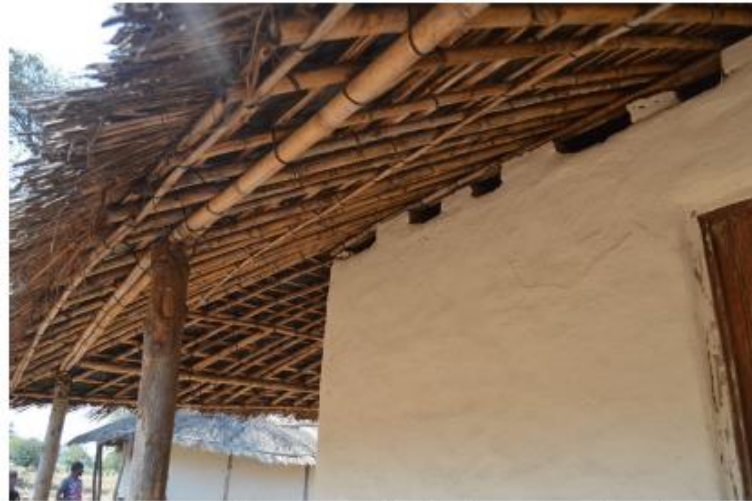
House in Mpale, Mangochi (top). House in Dzipusile, Ntcheu (bottom). These two houses have a contact surface between the wall and the roof structure which is minimised using only some bricks to sustain the framework. This permits ventilation, but also allows for a better visual detection of termites paths and thus a better control of their attacks. © Jon Twingi

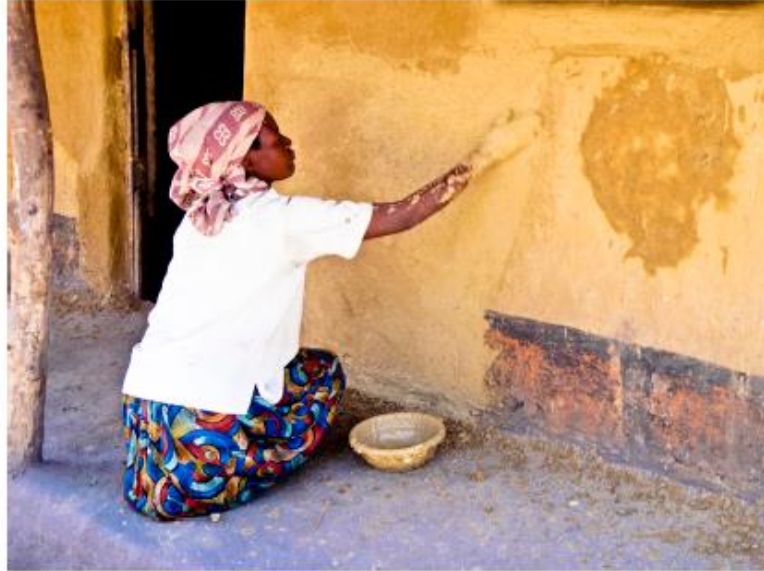
Woman cladding a wall with earth plaster. CC- Gregory S.

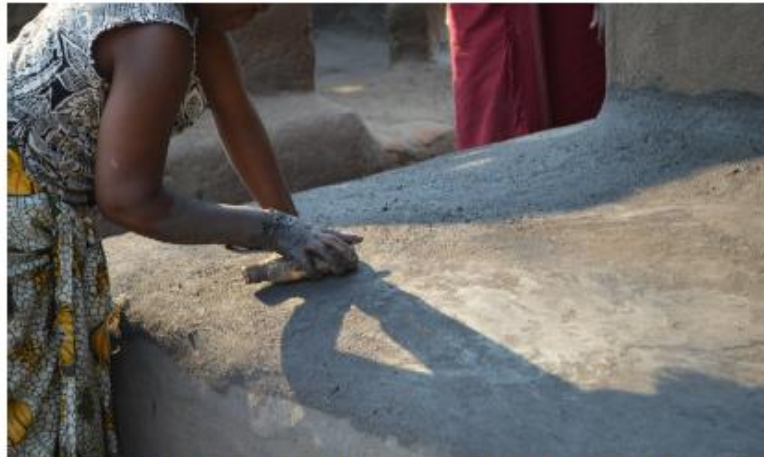
Woman plastering a floor in Mawudzi, Salima.

- Plastering is one of the works that is done more regularly, in walls, floors and verandas, particularly in earthen houses. Plaster in the walls protects the building against erosion and moisture, and plaster in the floor provides better conditions of use and hygiene.

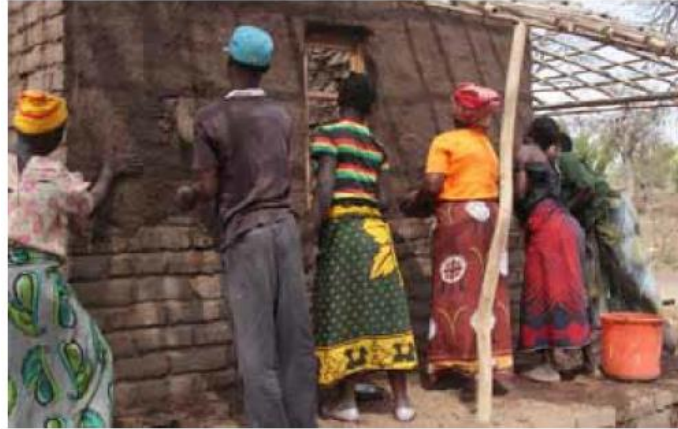
Rendering a house in a training by CRS. © CRS

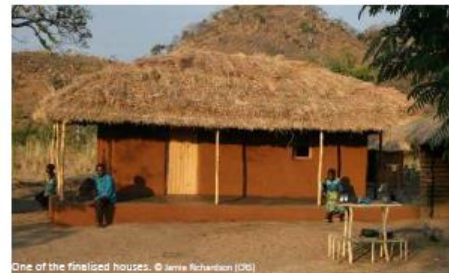
One of the finalised houses. © Jamie Richardson (CRS)

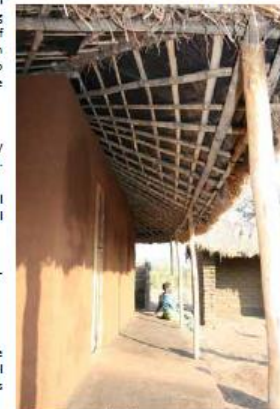
One of the finalised houses. © Jamie Richardson (CRS)
