# KEY TECHNICAL MESSAGES

Earthquake Response Khost & Paktika

**Shelter Cluster Afghanistan**  
ShelterCluster.org  
Coordinating Humanitarian Shelter

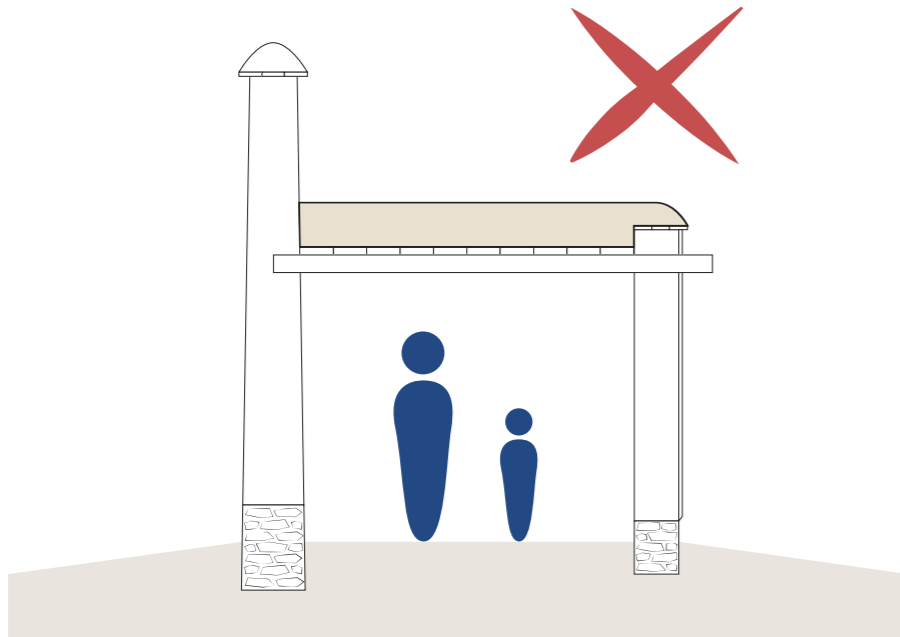
### Cause: Too thick and heavy roof

Risk: Collapse during earthquake; avoid overloading the roof

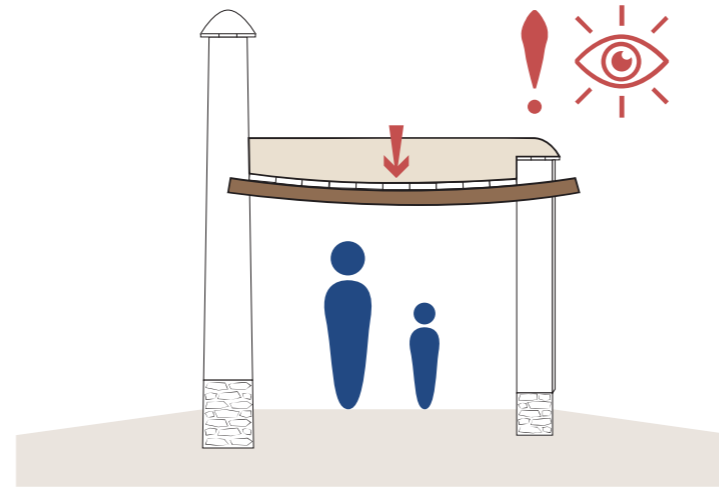
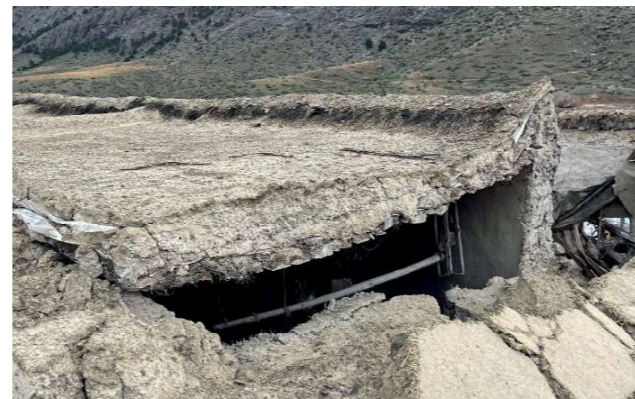
A beam that bends down may mean the roof is too heavy, pay attention!

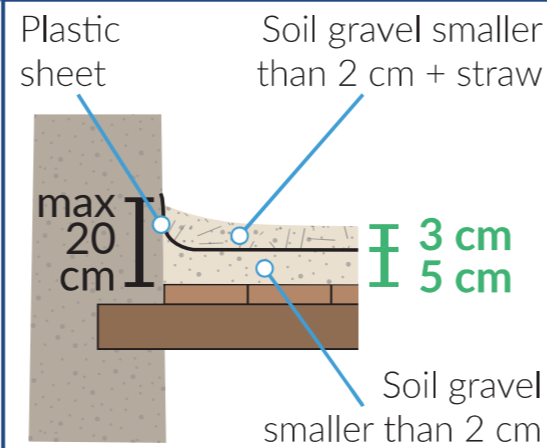
### Roof soil cover

Common practice is to not have roofs thicker than 8 cm total along the thinnest part. Edges for drainage go up to max 20 cm

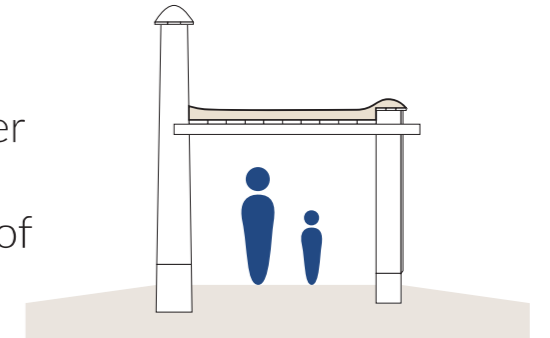
It is a good practice to maintain the water proofing and thermal capacity of the soil cover

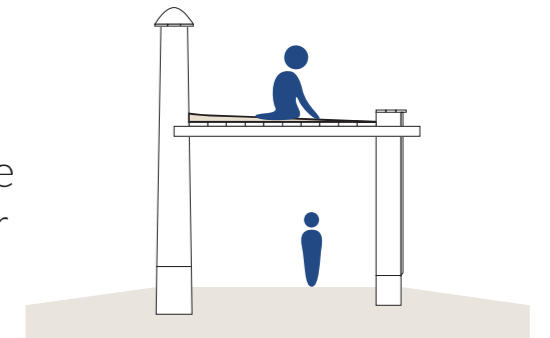
Before adding a new layer, remove the previous layer

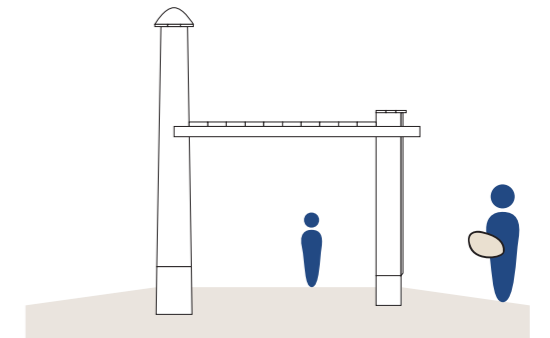
Workwell the soil and avoid using the top layer soil

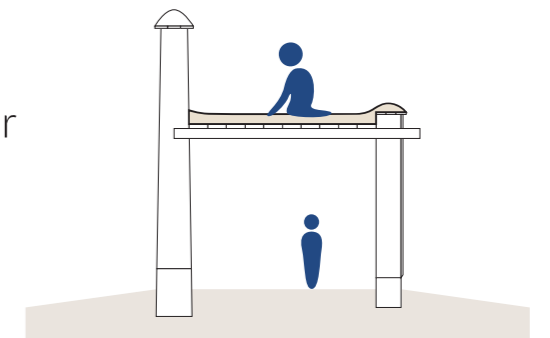
Add the new layer of soil, with a good draining system

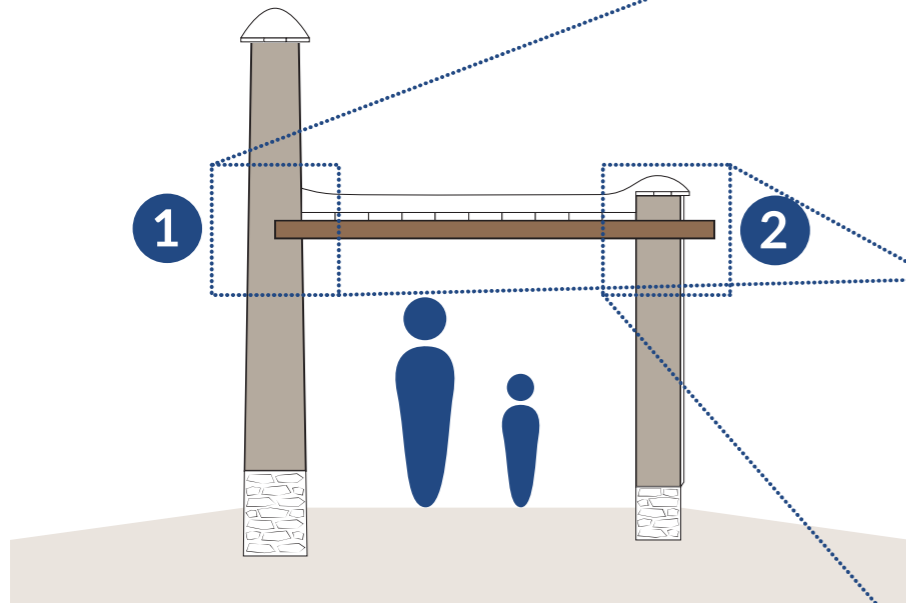
### Cause: Unstable connections to walls

Risk: Collapse during earthquake

Do not firmly attach the rafters to the beams (e.g. with nails) or to the wall to ensure free movement!

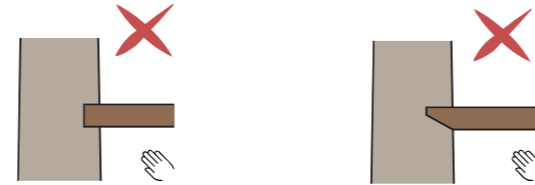
- 1 The beam should have a stable connection to the compound wall

- 1 Check that the beam sticks halfway into the compound wall

- 2 The beam should stick through and out of the internal wall

- 2 Check that the beam sticks out of the internal wall

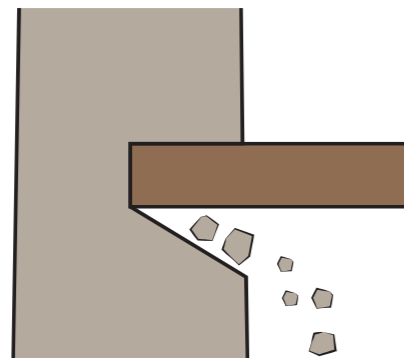
### Cause: The hole in the wall supporting the beam has become too big

The wall no longer supports the beam properly because some of the clay under the beam has fallen away

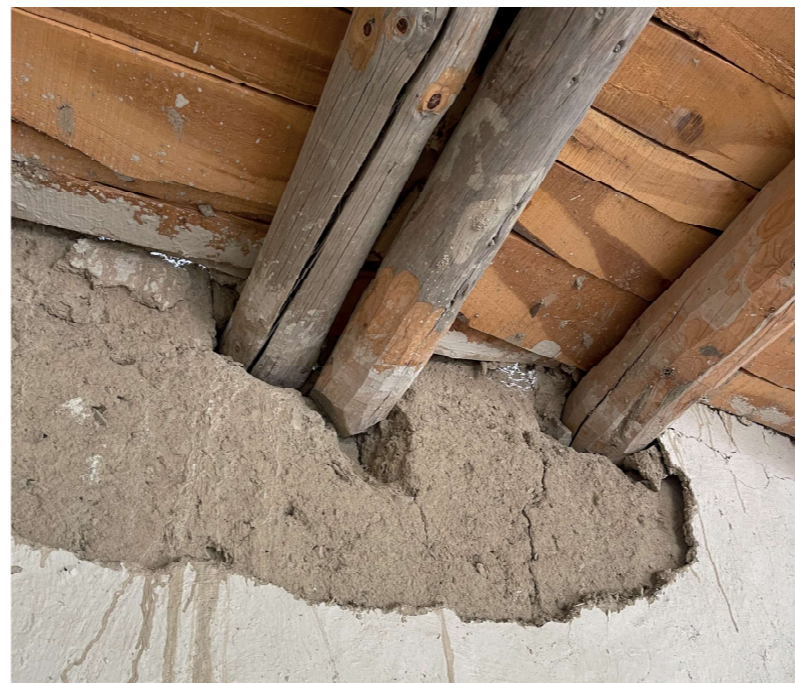
- 1 Remove some soil to level the hole
- 2 Use a stone or piece of wood to support the beam from below evenly
- 3 Refill the rest of the hole under the stone or wood with new soil

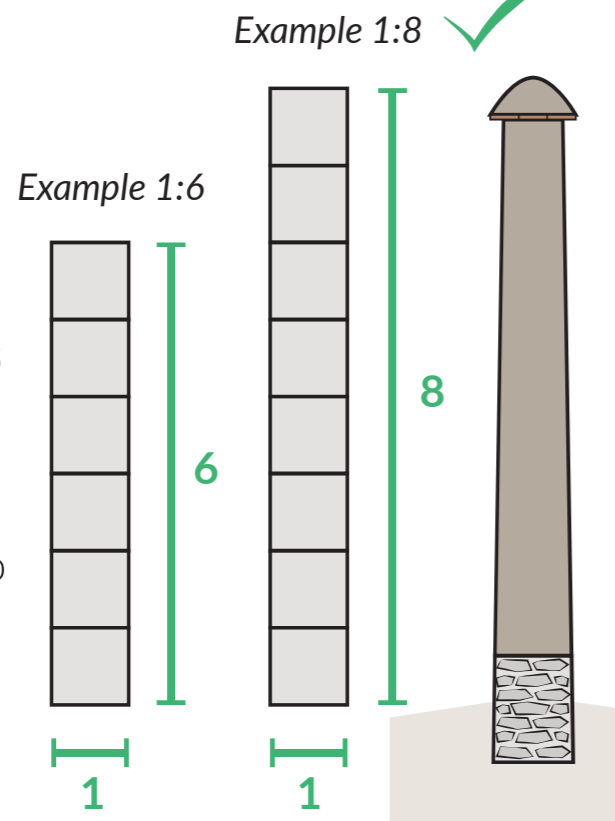
### Cause: The wall is too tall/too thin, not appropriate height versus thickness

The best height versus thickness of the wall is to make it between 6 to 8 times as tall as it is thick

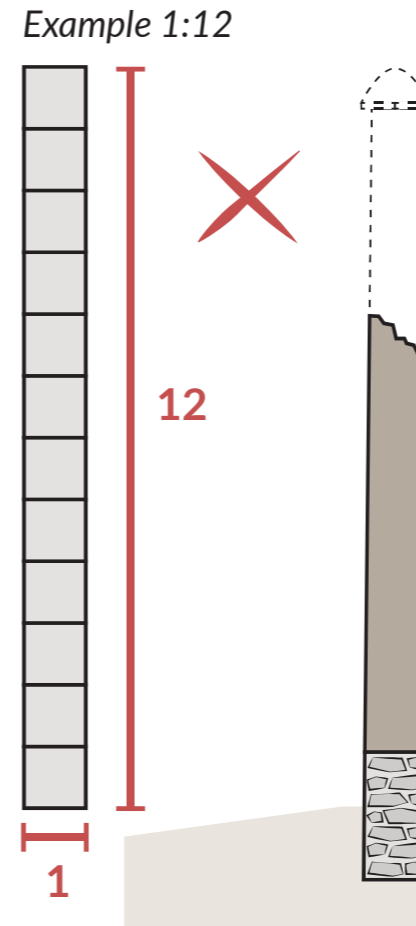
Often the top of a wall may have broken off because it was too thin and tall.

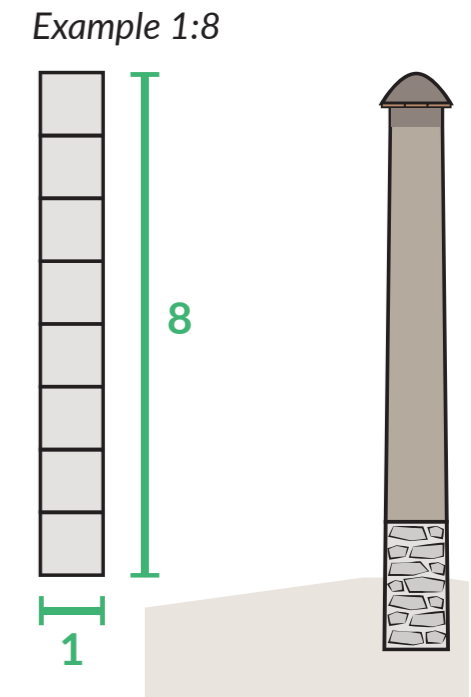
Level out the broken part and reconstruct with a better proportion between the height and thickness, such as 1:6 to 1:8.

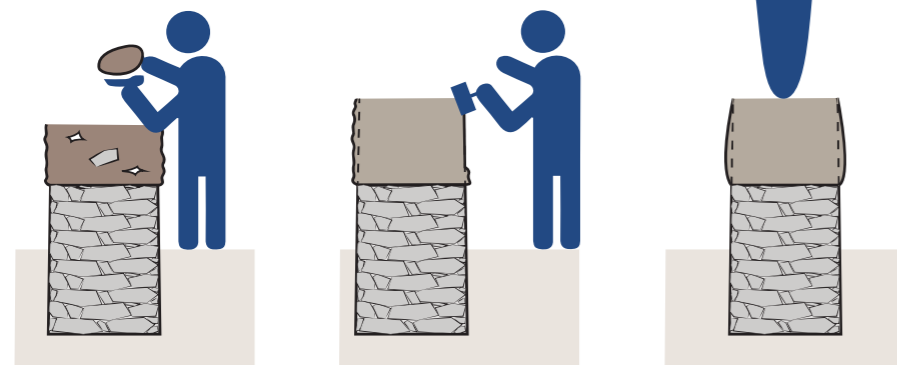
### Pakhsa walls: Control tests

Pack the pakhsa well without air bubbles or big stones too close together

When cutting off the outer side layers, check if the pakhsa has dried underneath

If the pakhsa responds to weight as below, it has not yet dried enough

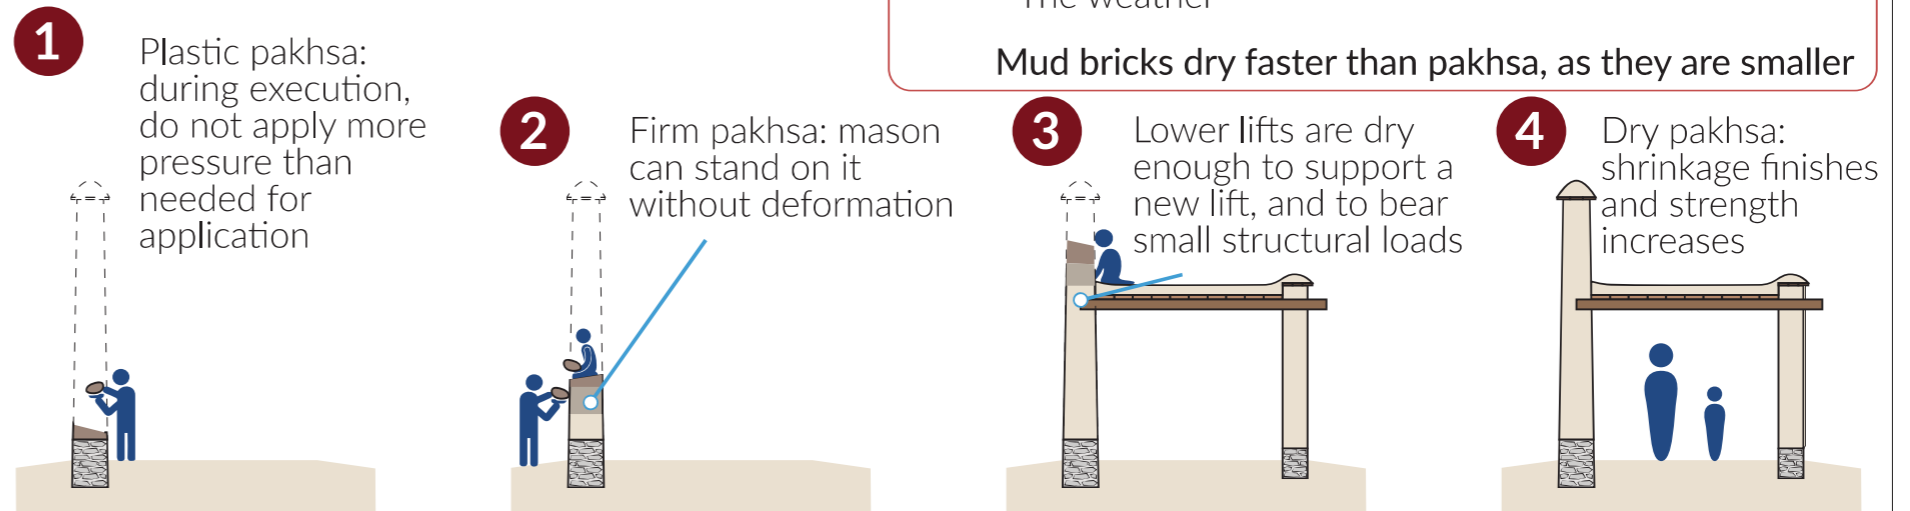
### Pakhsa walls: water content and strength

Evolution and states of pakhsa:

**!** Pakhsa drying time varies greatly depending on:

- The type of soil
- The water content
- Thickness of the wall
- The weather

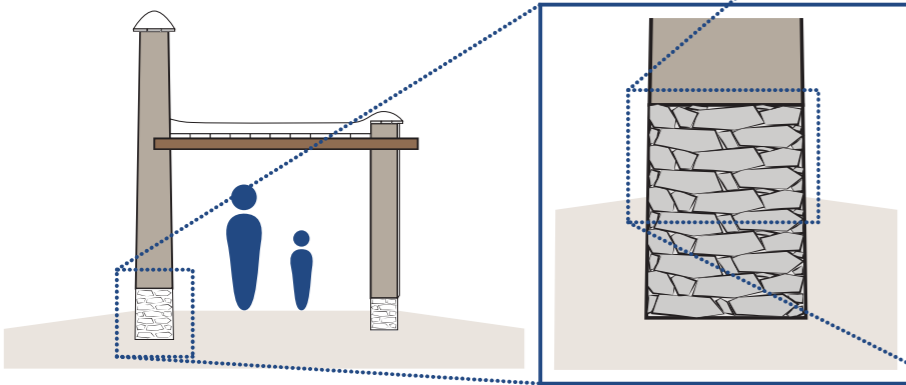
### Cause: Detachment of the stem wall stones

Risk: Collapse during earthquake

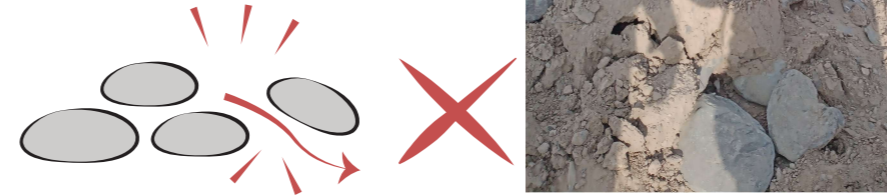
Rounded stones are not stable in dry wall construction

Use only angular stones for dry stone construction

Find stones that fit well together and fill the gaps with small stones

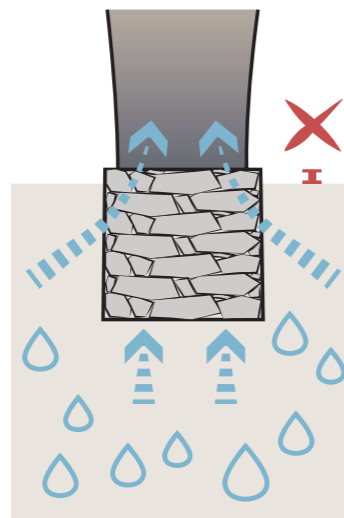
### Cause: Stem wall is not high enough

Risk: Moisture gets into the walls, affecting the clay composition and destabilising the wall

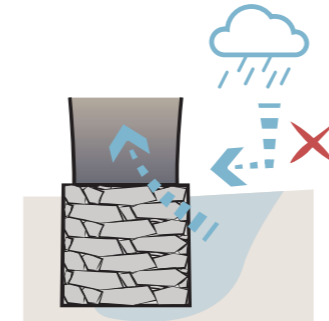
Vegetation or rubble sand may collect along the stem wall, facilitating moisture to reach the wall

Bad drainage away from the stem wall

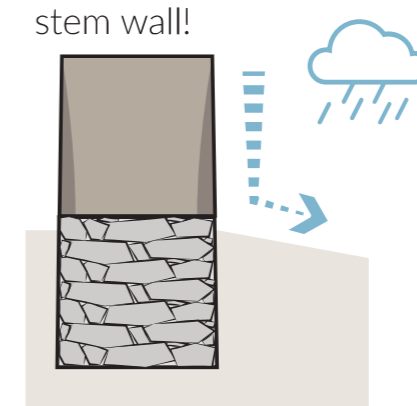
When repairing, use new soil where it was eroded. Pay attention to good drainage away from the stem wall!

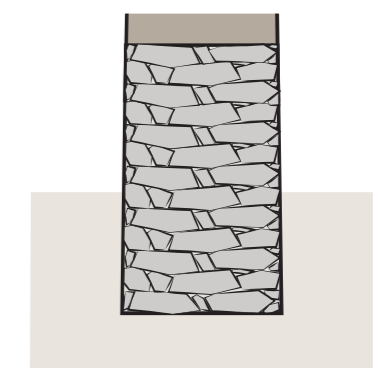
If building a new wall, construct a higher stem wall in more humid areas

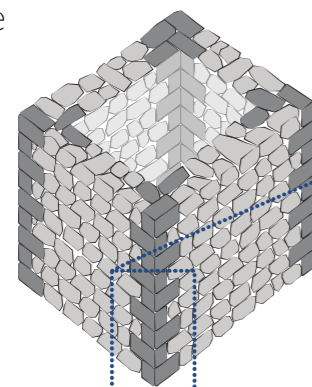
The ratio for stone walls is 1:3 or 1:5, if a secondary top timber structure is used

Make sure to cross-lay the corners with big stones for stability!

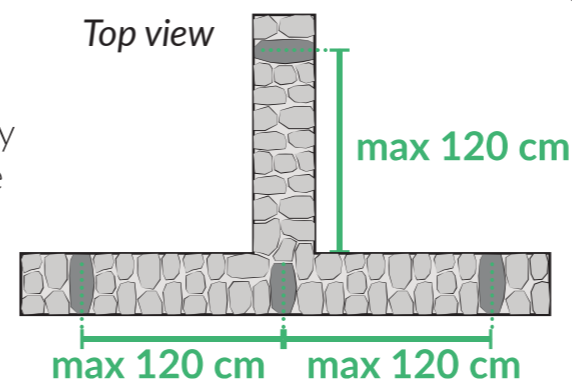
When large stones are available, regularly use these to bind the foundation together by placing them through (max every 120 cm)

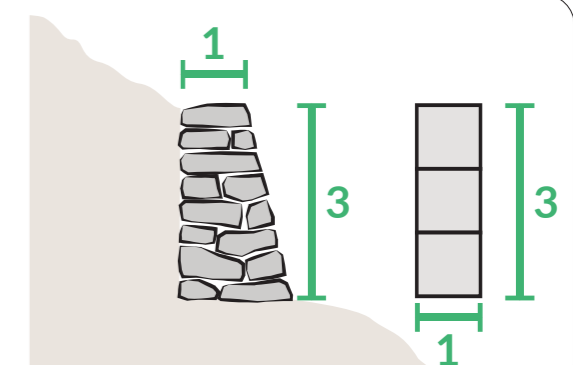
The ratio for a stone retention wall is 1:3, as counted from the top, narrower side

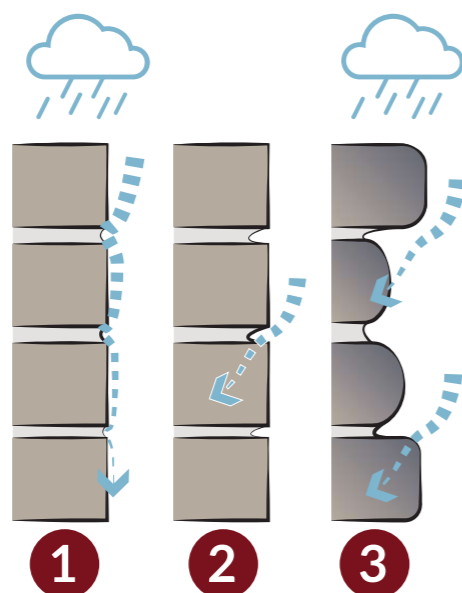
Uneven erosion changes the center of gravity, leading to instability of the wall

This risk is more common with non-plastered khama-khasta (mud brick) walls

- 1** Rain flows along the wall, seeping into the joints
- 2** Over time this washes away the mortar, leaving bigger spaces between the bricks
- 3** Over time this allows rain to flow in and weaken the mud brick from inside

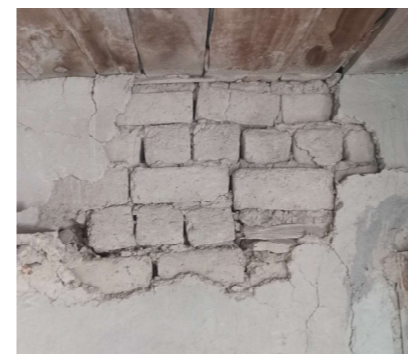
Possible water leaking. Plaster peeling and eroded joints between the mud bricks.

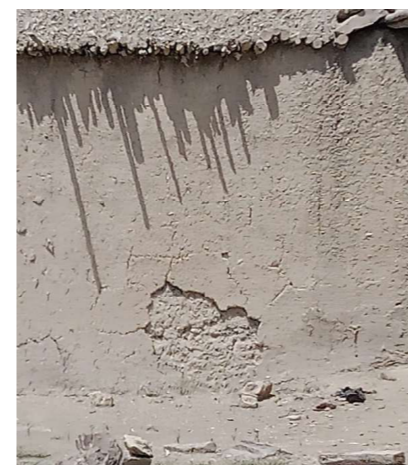
Issues due to water capillarity. Plaster layer peeling off

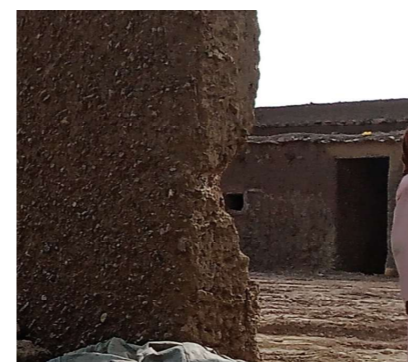
Irregular width erosion on pakhsa walls

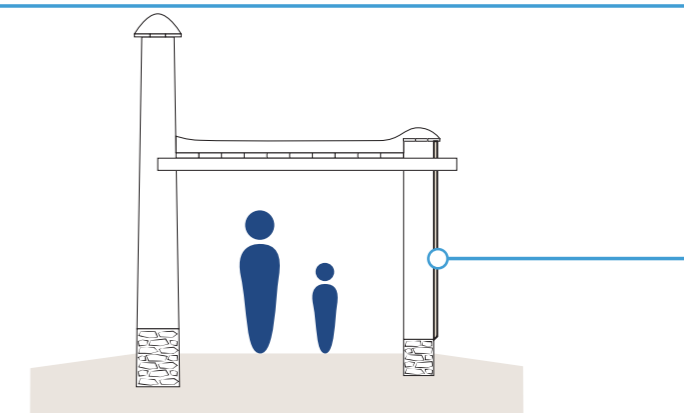
2-3 cm of plaster;  
a mixture of soil and straw

Important! Use earth-based plaster to allow perspiration!

Be sure to remove stones bigger than the thickness of the plaster before making the mixture

Prioritise the outer side of the inner walls

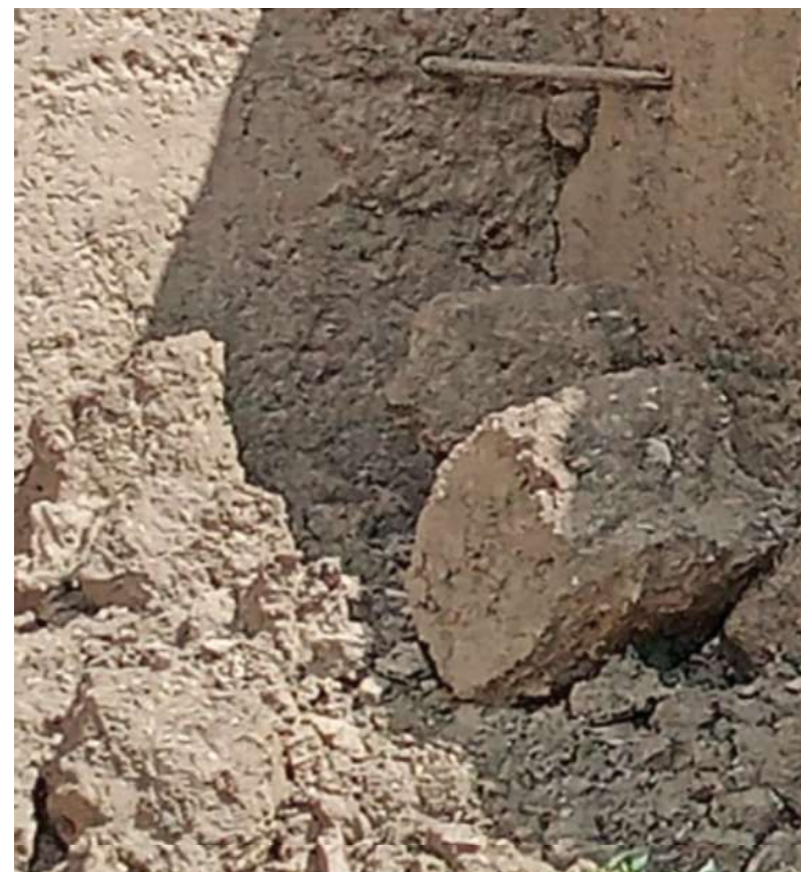
Although the soil in the area has a very good composition for the construction techniques used for soil cover, pakhta and khama khashta walls, a bad work of the soil and the use of top soil layer can lead to bad behaviour of construction elements

Collapse of wall elements during earthquake

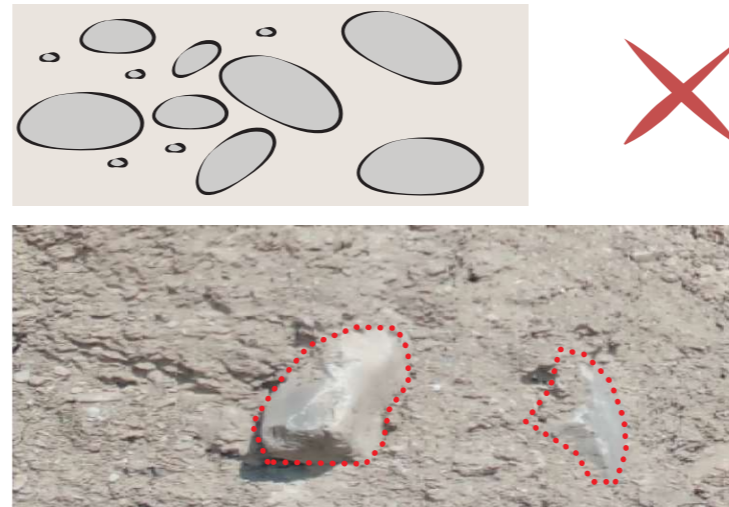
Use very large stones very close to each other

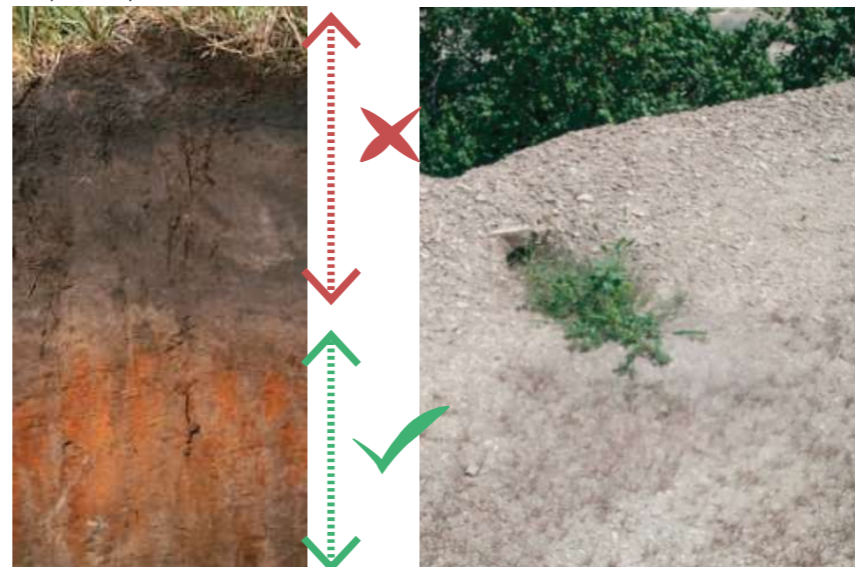
Use of the top soil layer can cause problems in the built structure due to high amount of organic matter and not enough clay and aggregates

Lower soil layers consist of good clay and good aggregates that give the good mechanical and elastical capacity

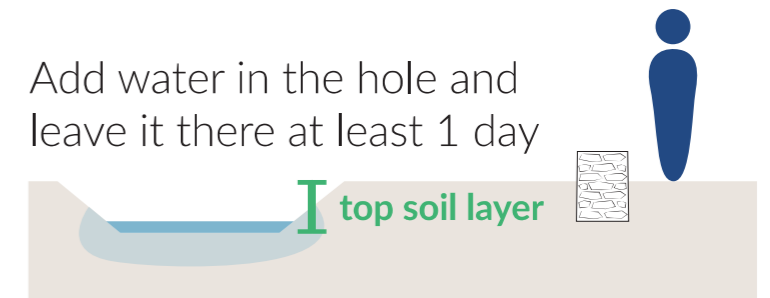
- 1 Dig away the top soil layer
- 2 Add water in the hole and leave it there at least 1 day
- 3 Trample and mix the soil and water very well
- 4 Making pakhta or khama-khasta (mud bricks), make sure to leave it to dry as long as it needs

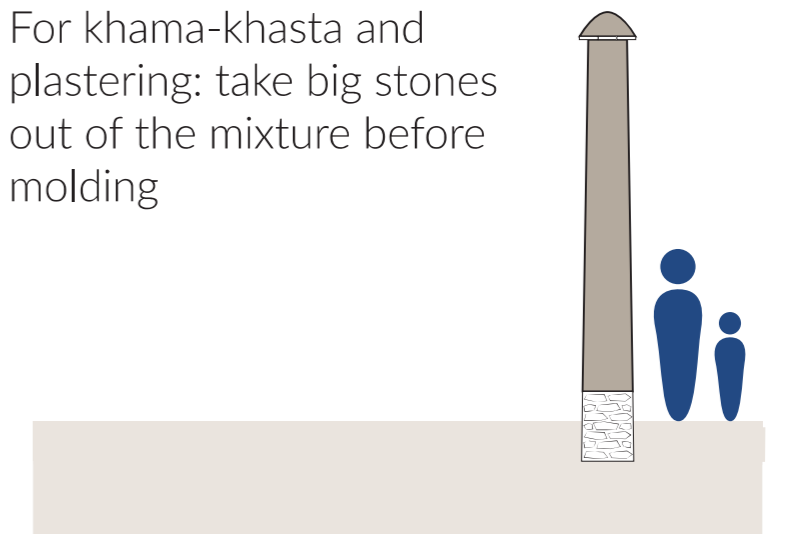
- \* For khama-khasta and plastering: take big stones out of the mixture before molding
