Conducted by HEKS/EPER team, with contribution of MA'AN
June to July 2024

Identify the shelter conditions and socio-economic vulnerabilities of IDPs (in Deir El Balah in particular)

At 2 sites in Deir El Balah

Social and Shelter Vulnerability Assessment Tool

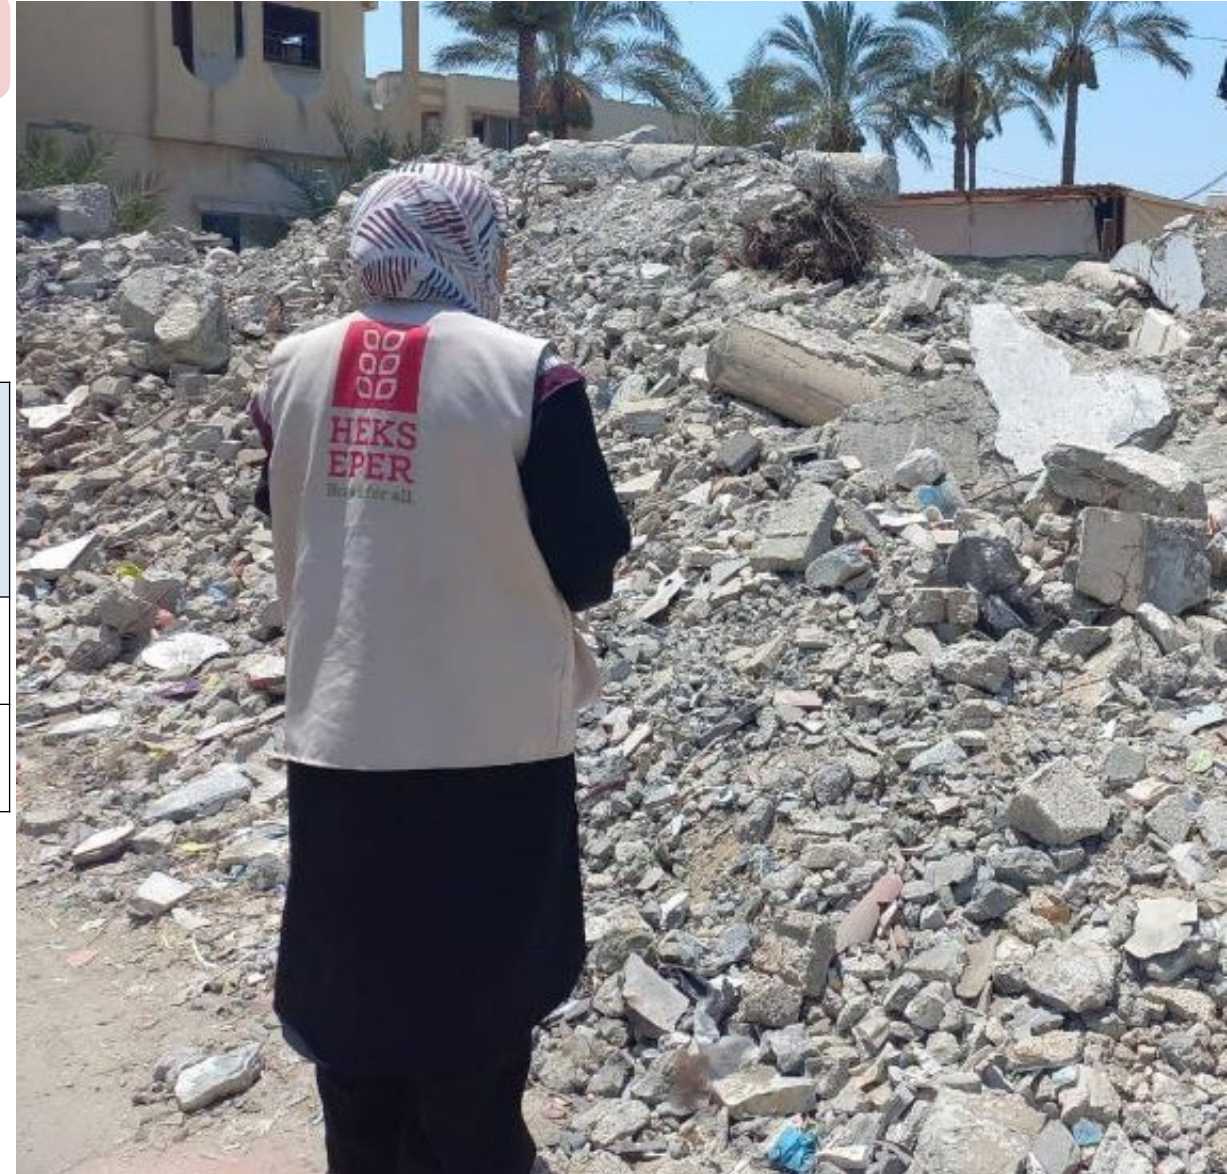
Extensive Damage

Destroyed	Severely damaged	Moderately damaged	Slightly damaged	Total
46,223	18,478	55,954	35,345	156,000
30%	12%	36%	22%	100%

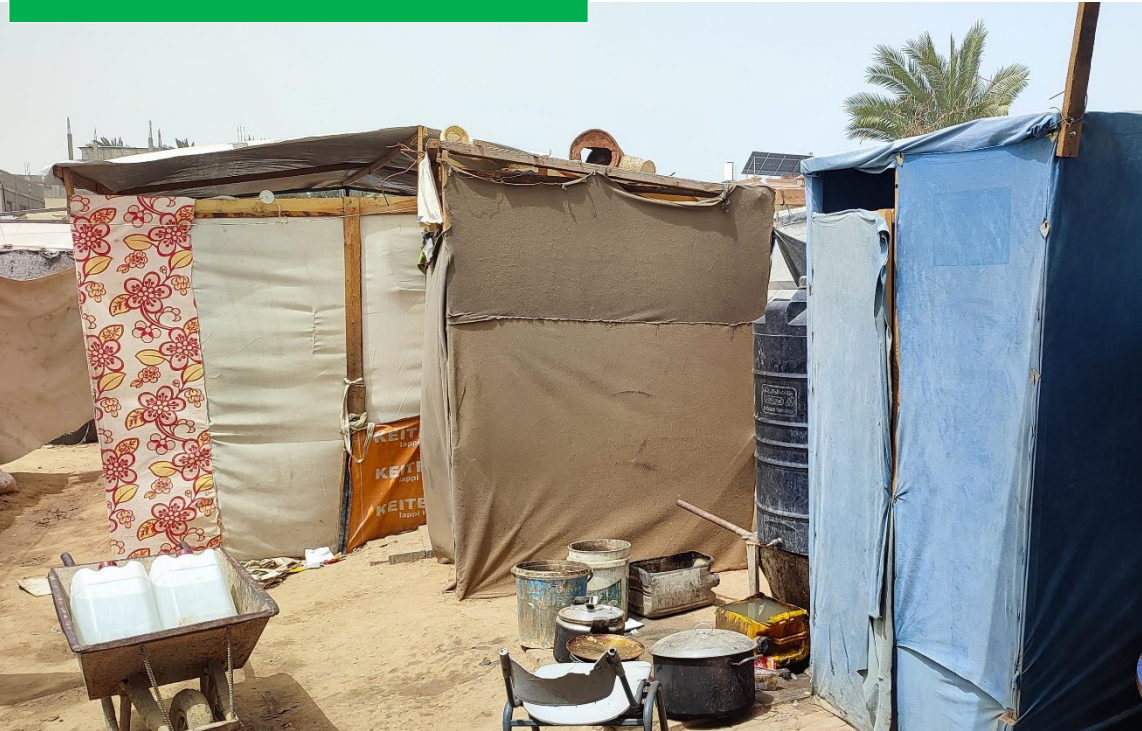
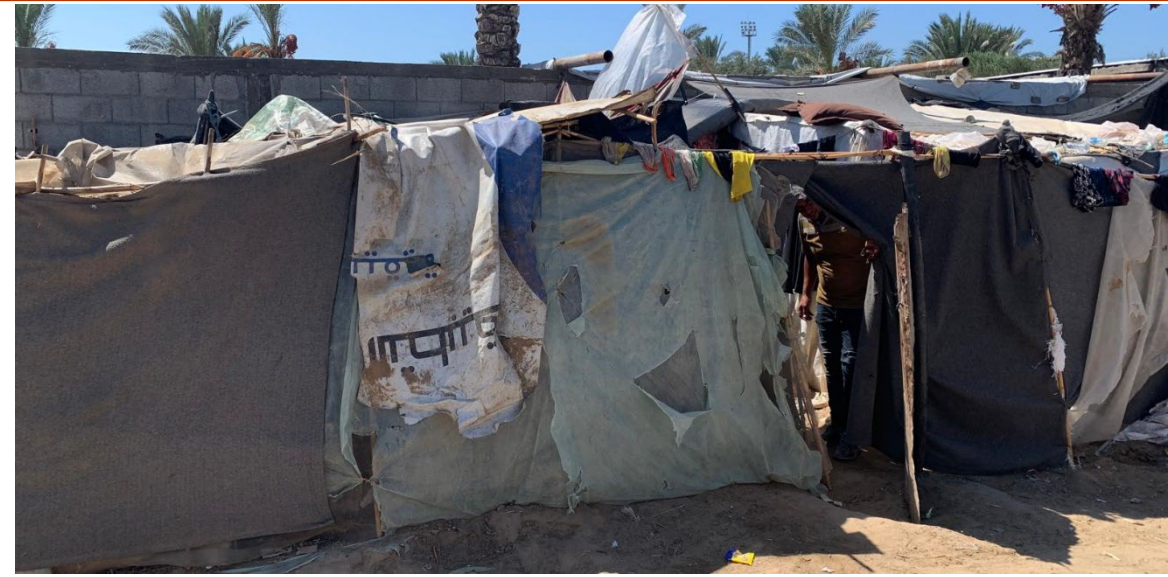
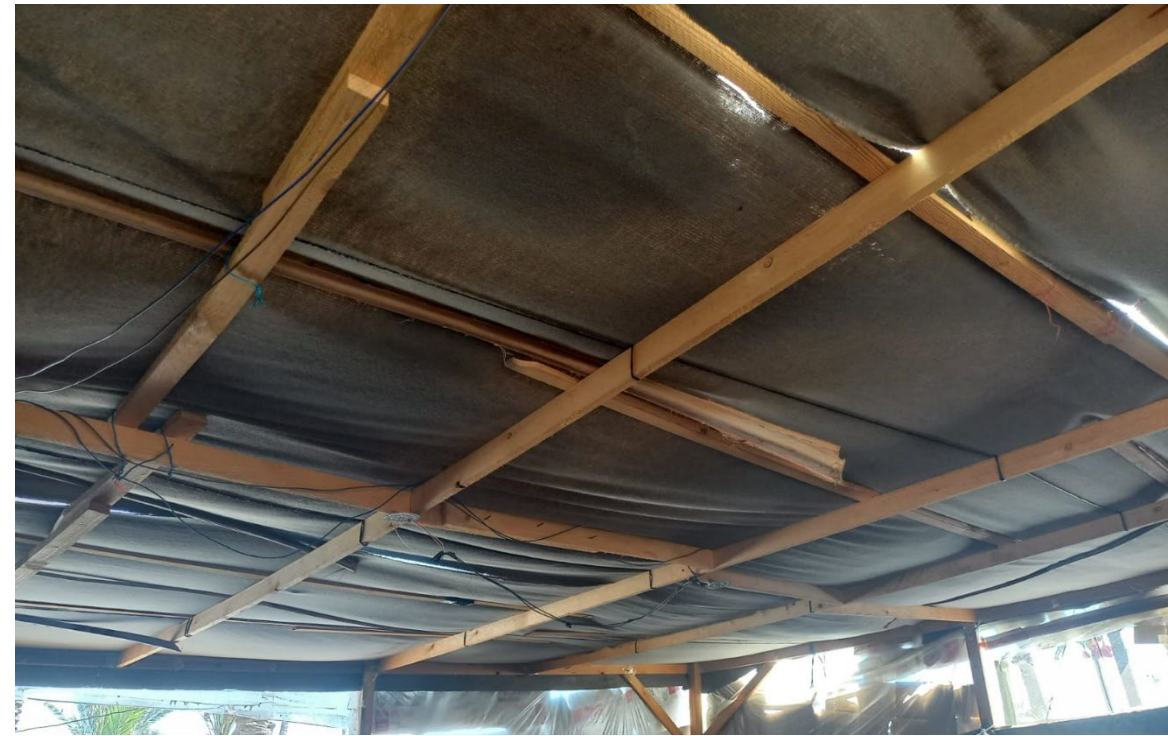
3.2 Structures of Makeshift Shelters

Due to the limited availability and high cost of tents, people are resorting to using materials like cloth, wood, blankets, and tarpaulin to construct makeshift shelters from whatever resources they can find.

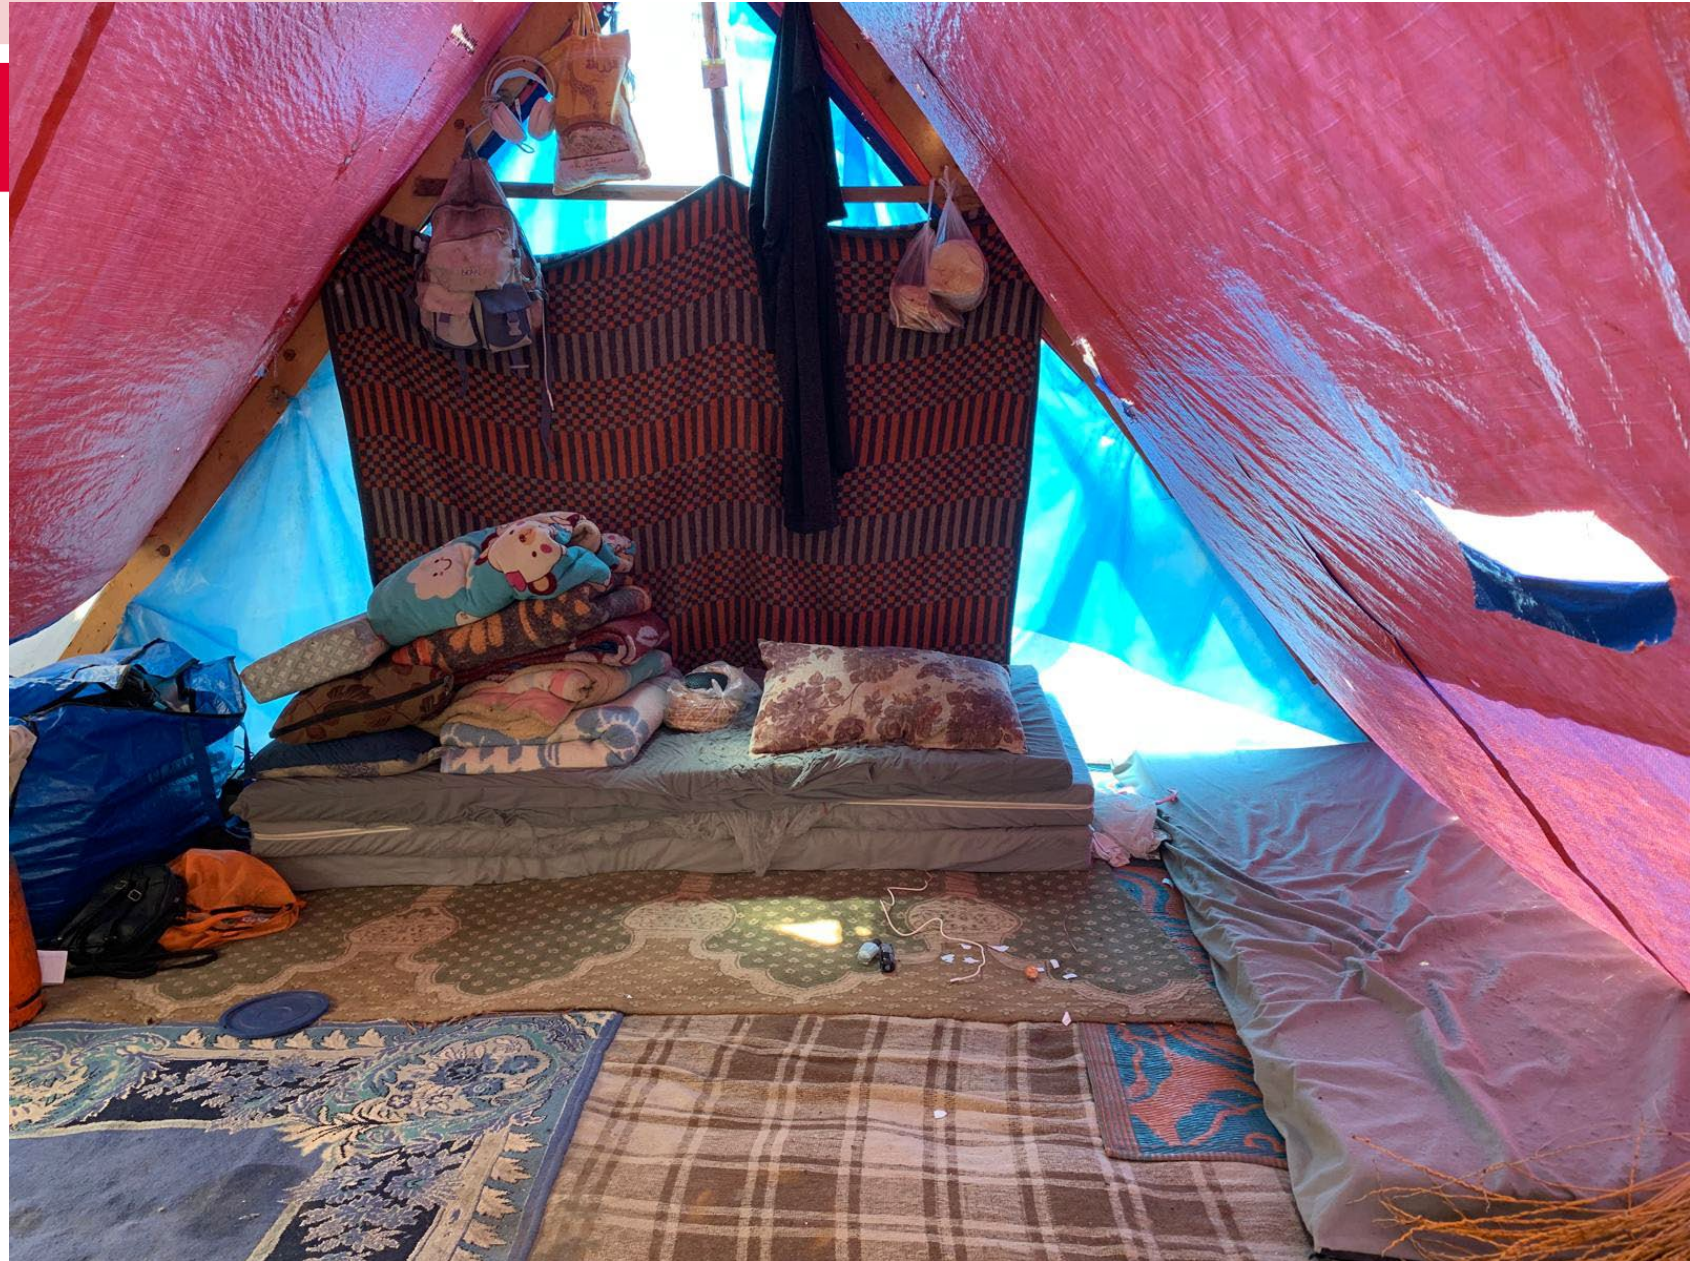
Ventilation

- **99% of assessed shelters have inadequate ventilation**
 - 48% partially adequate ventilation,
 - 51% highly inadequate ventilation

Natural Lighting:

- **98% of shelters have no natural lighting.**
 - 50% have no natural lighting
 - 48% have partial lighting

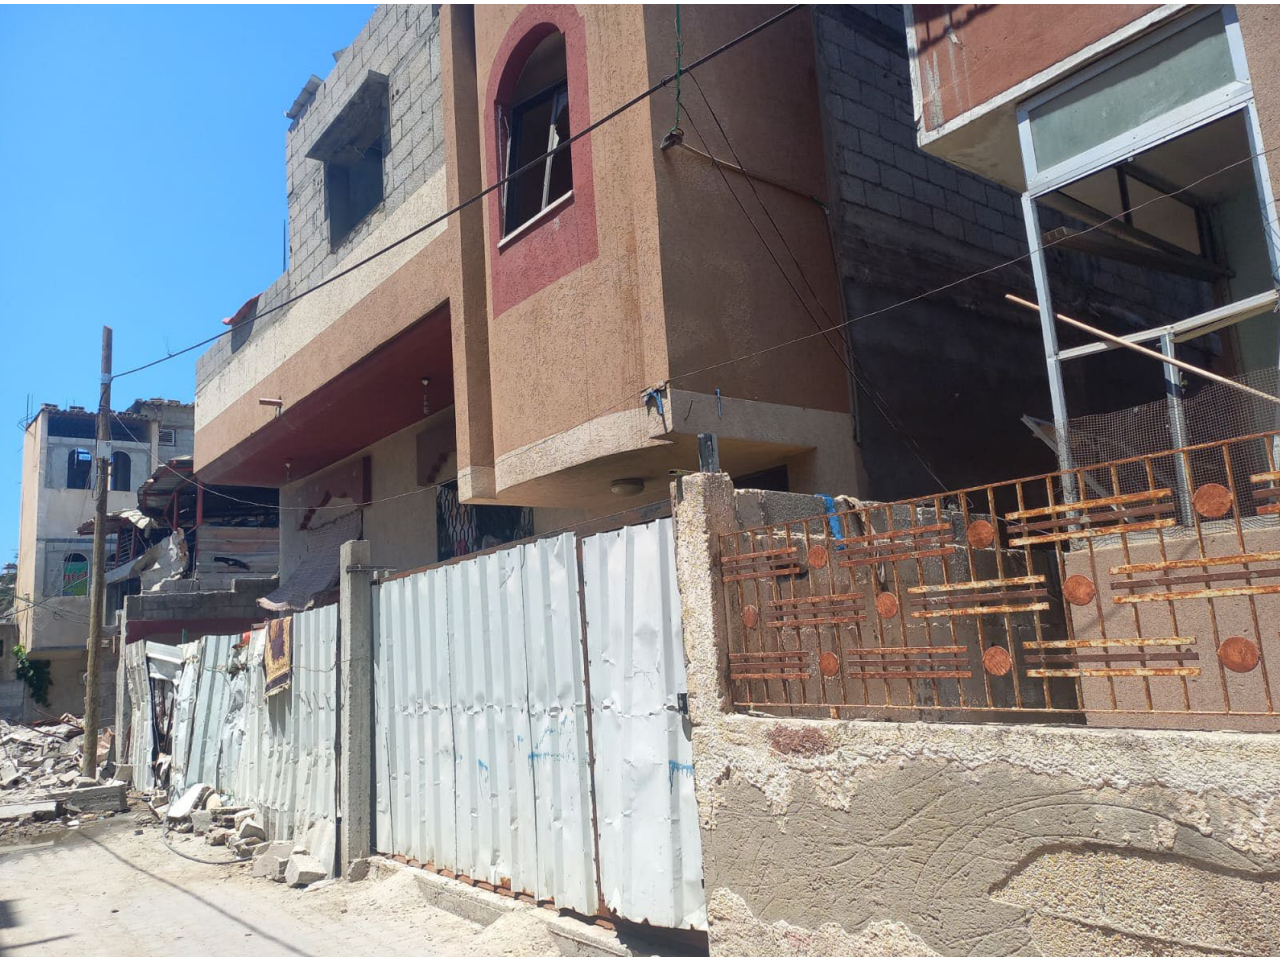
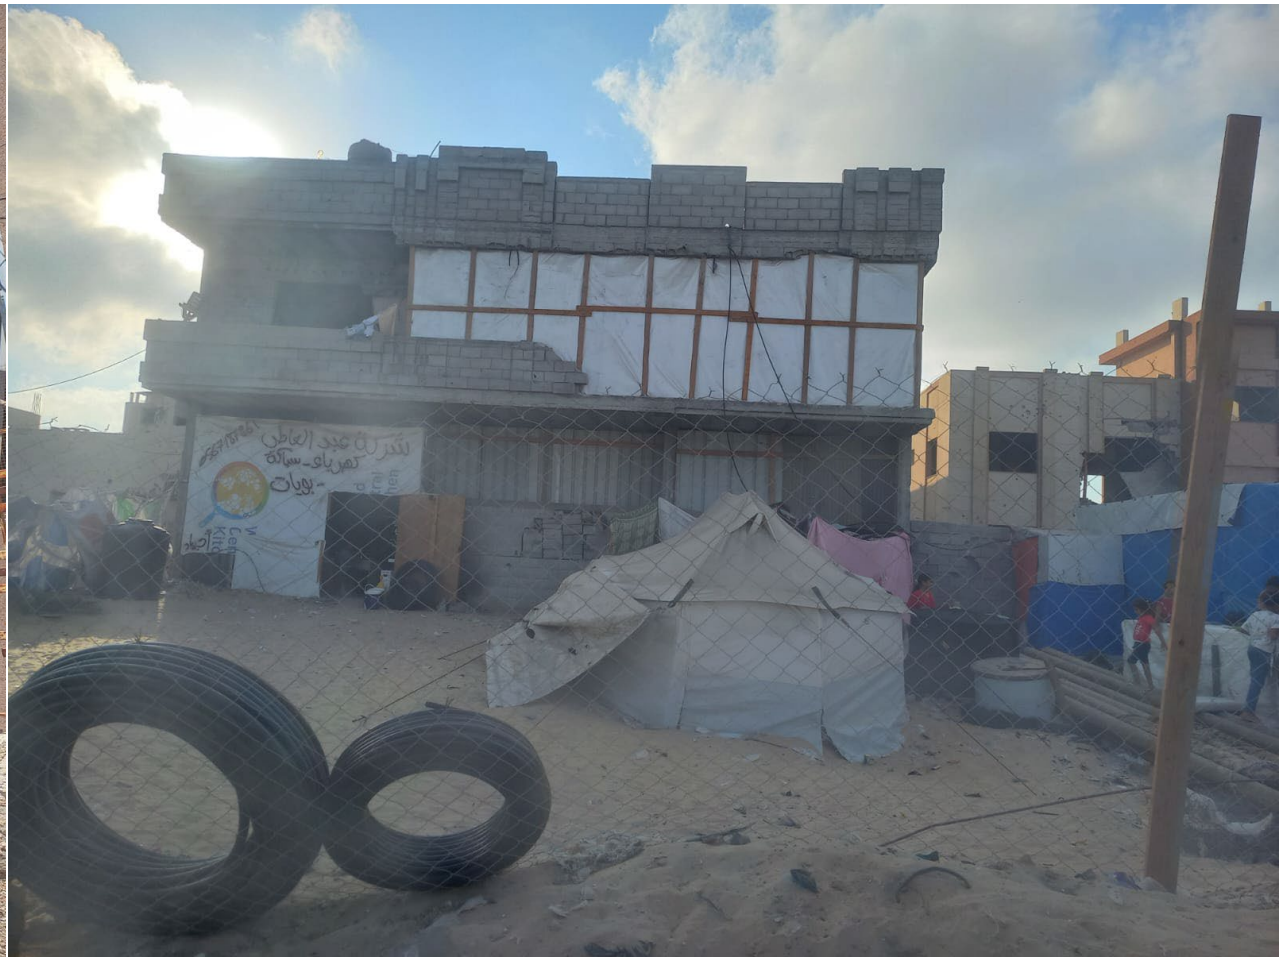
Some families repair their houses with limited resources such as cloth, blankets, old metal sheets, and tarpaulin to cover defective walls, windows, or door openings.

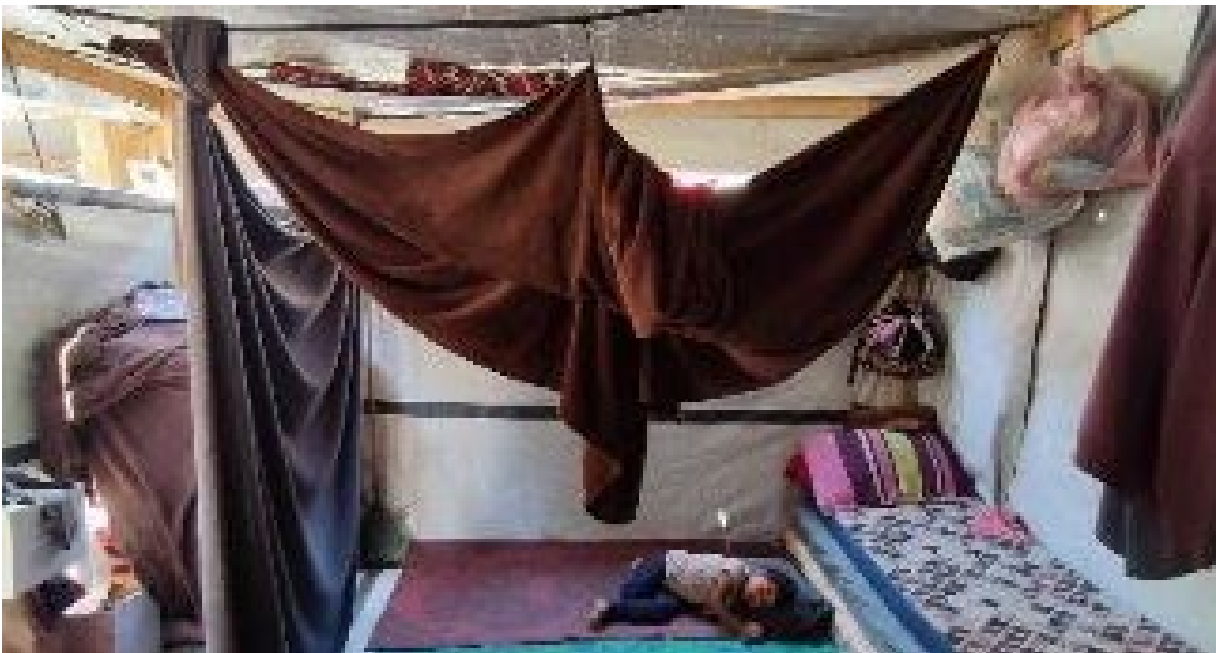
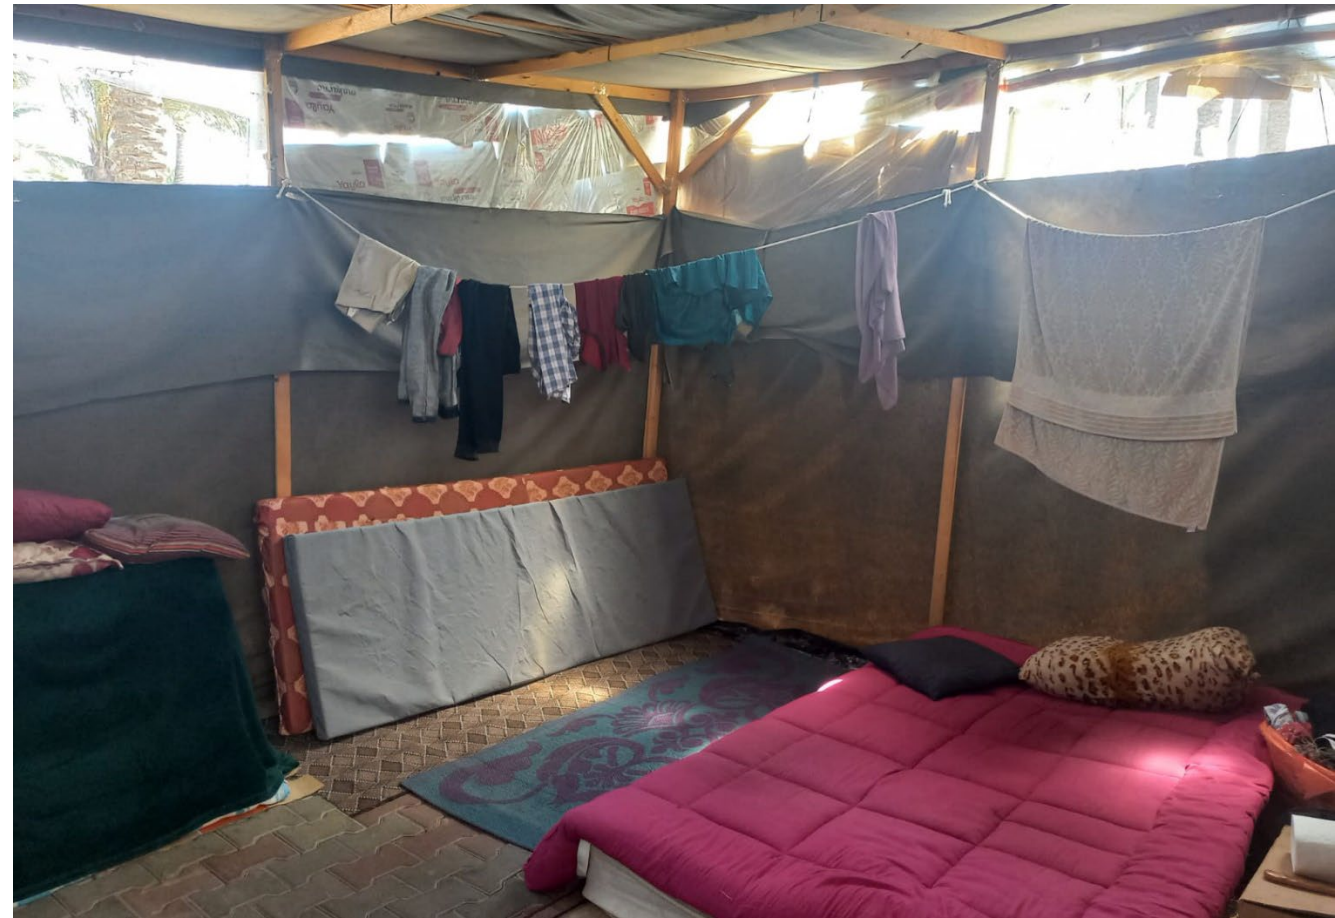
To improve privacy in overcrowded shelters, people use **available materials** like cloth, blankets, or tarpaulins to create dividers.

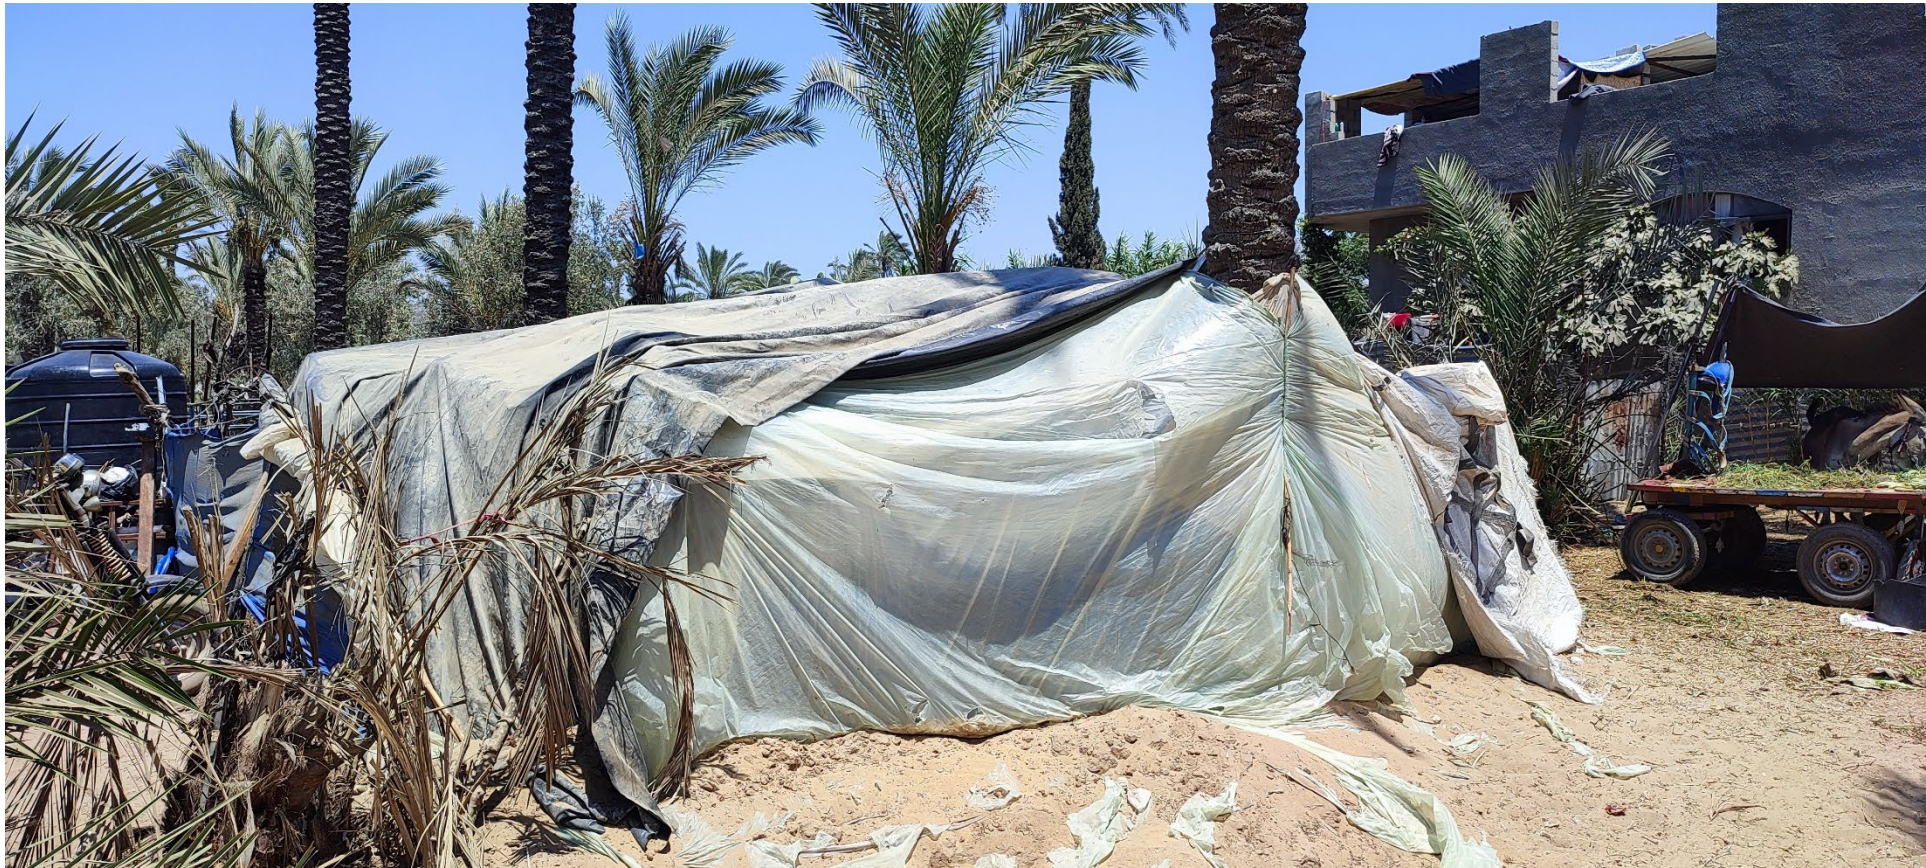
- Residents block openings for **privacy**, causing **darkness** inside shelter.
- Proper ventilation requires intake, exhaust channels, or gaps between plastic sheeting and structure.

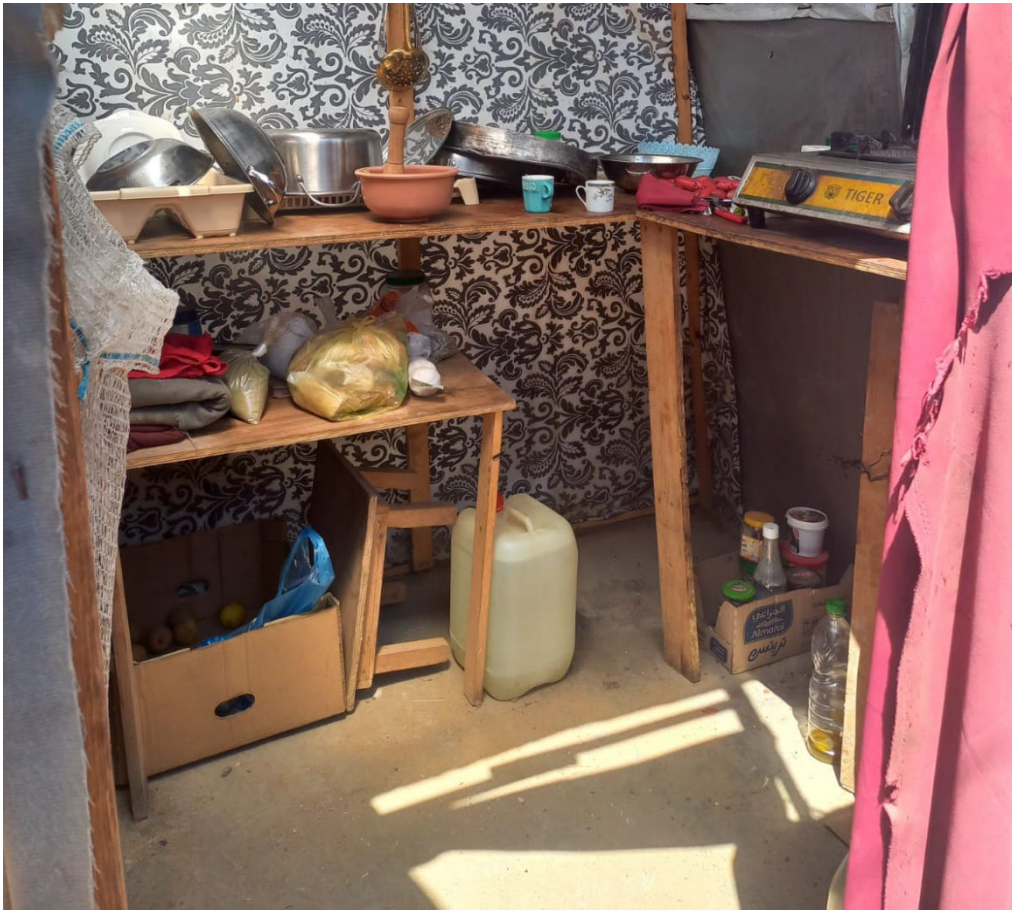
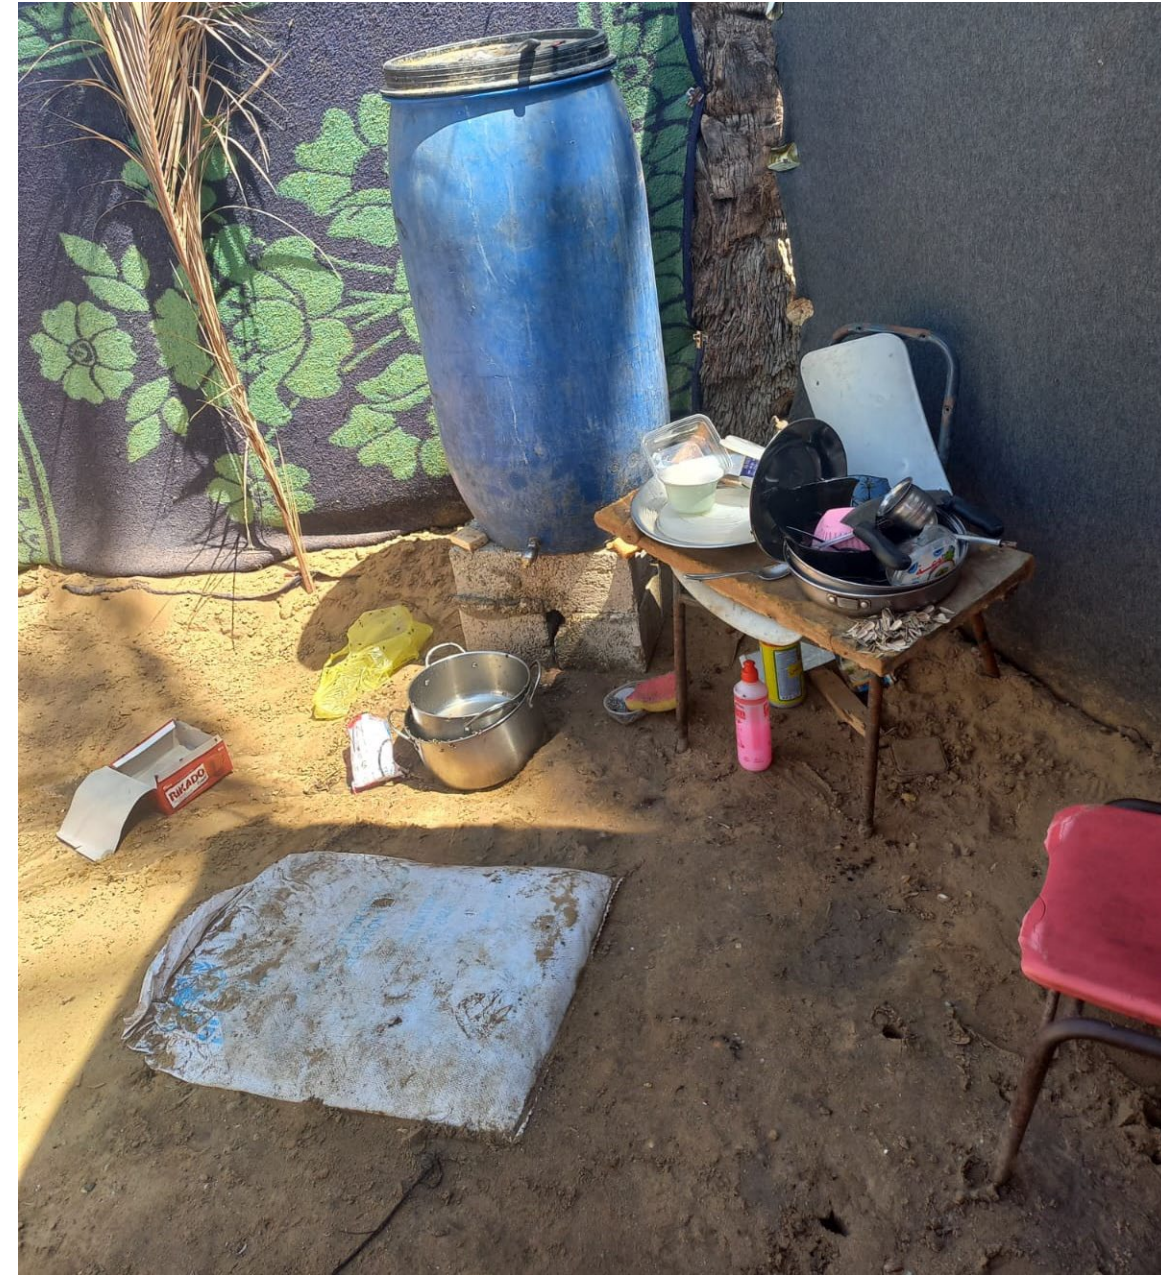
- Families create private **cooking corners** to prepare meals safely and hygienically
