Technical
Community of Practice

Striking the right balance:
Rapid vs. Detailed Damage Assessments
for Effective Shelter Programming

25 March 2025 - 11.00 to 12.30

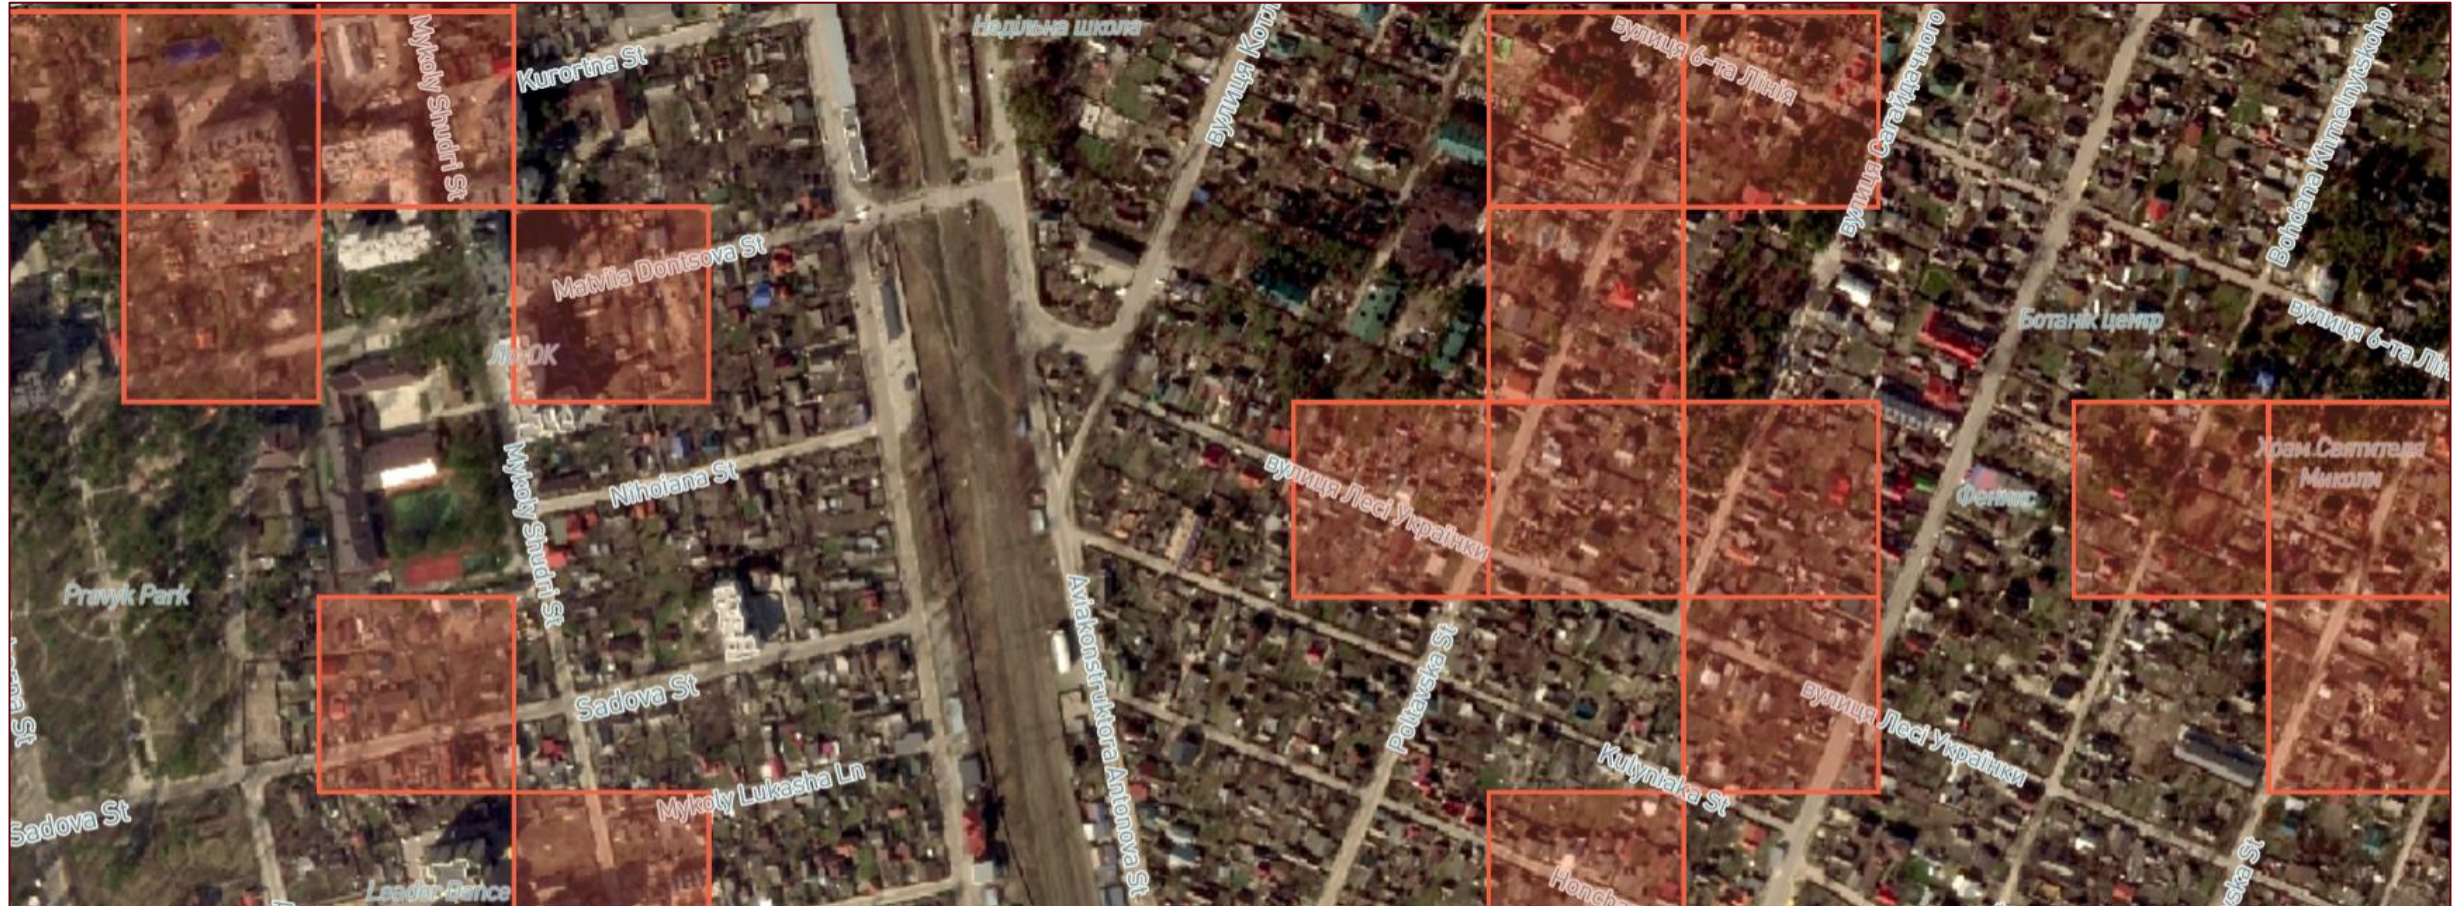
Google Maps - Irpin city in Kyivska Oblast, 2025

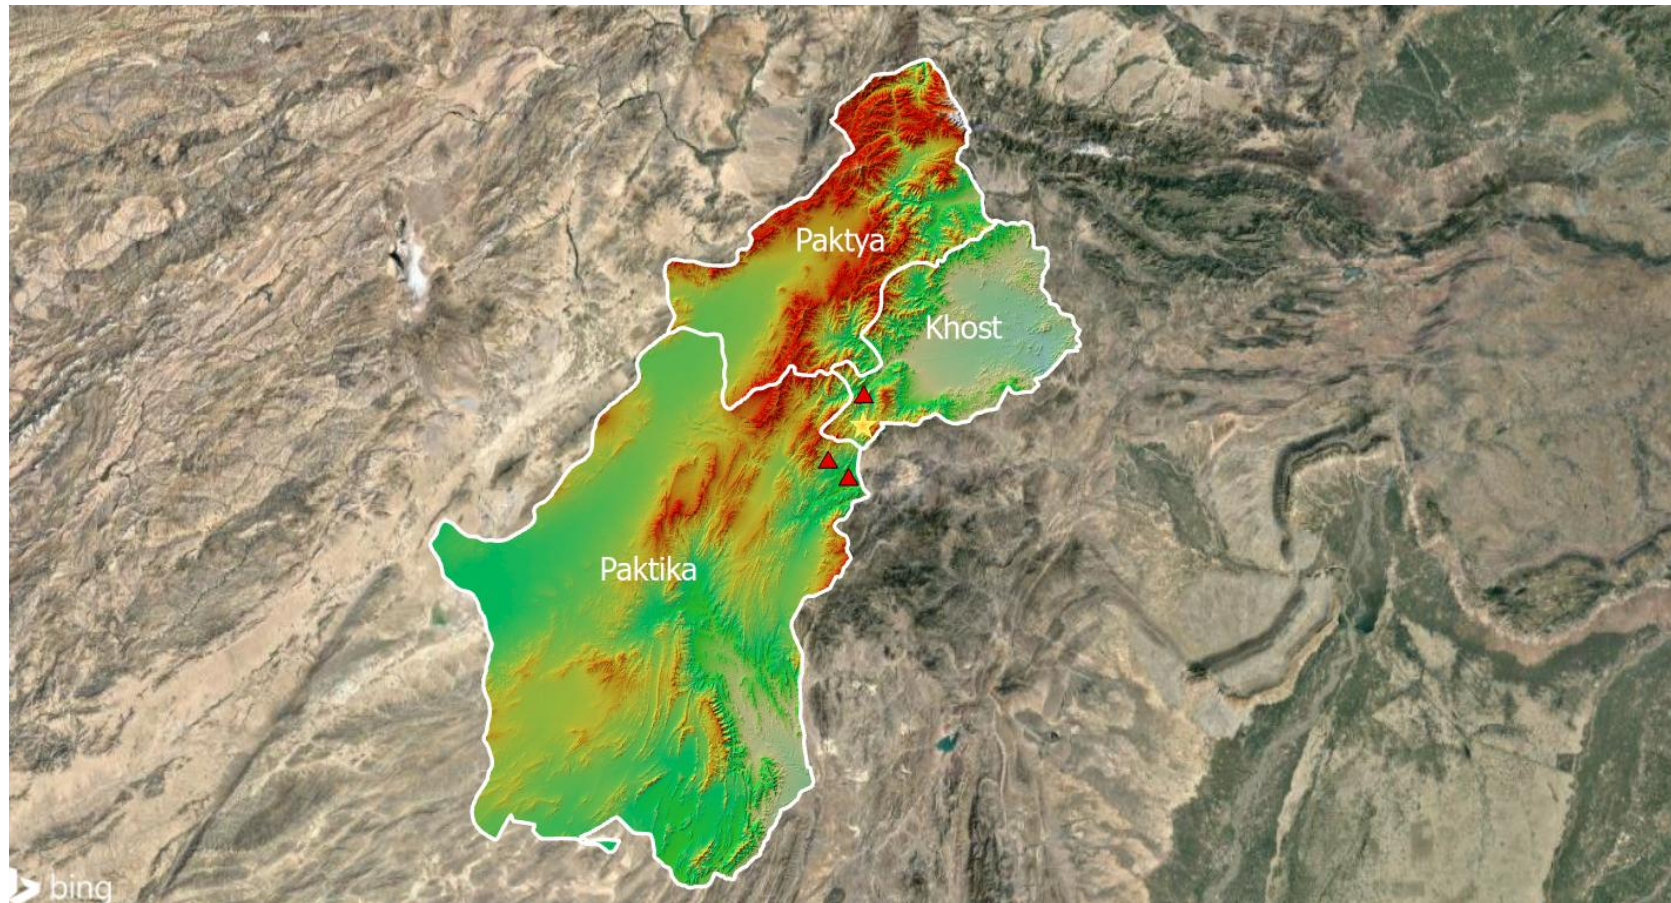
Remote/Sample Habitability Assessment Results

- Collapse(Red) 17%
- Repairable(Yellow) 51%
- Habitable(Green) 32%

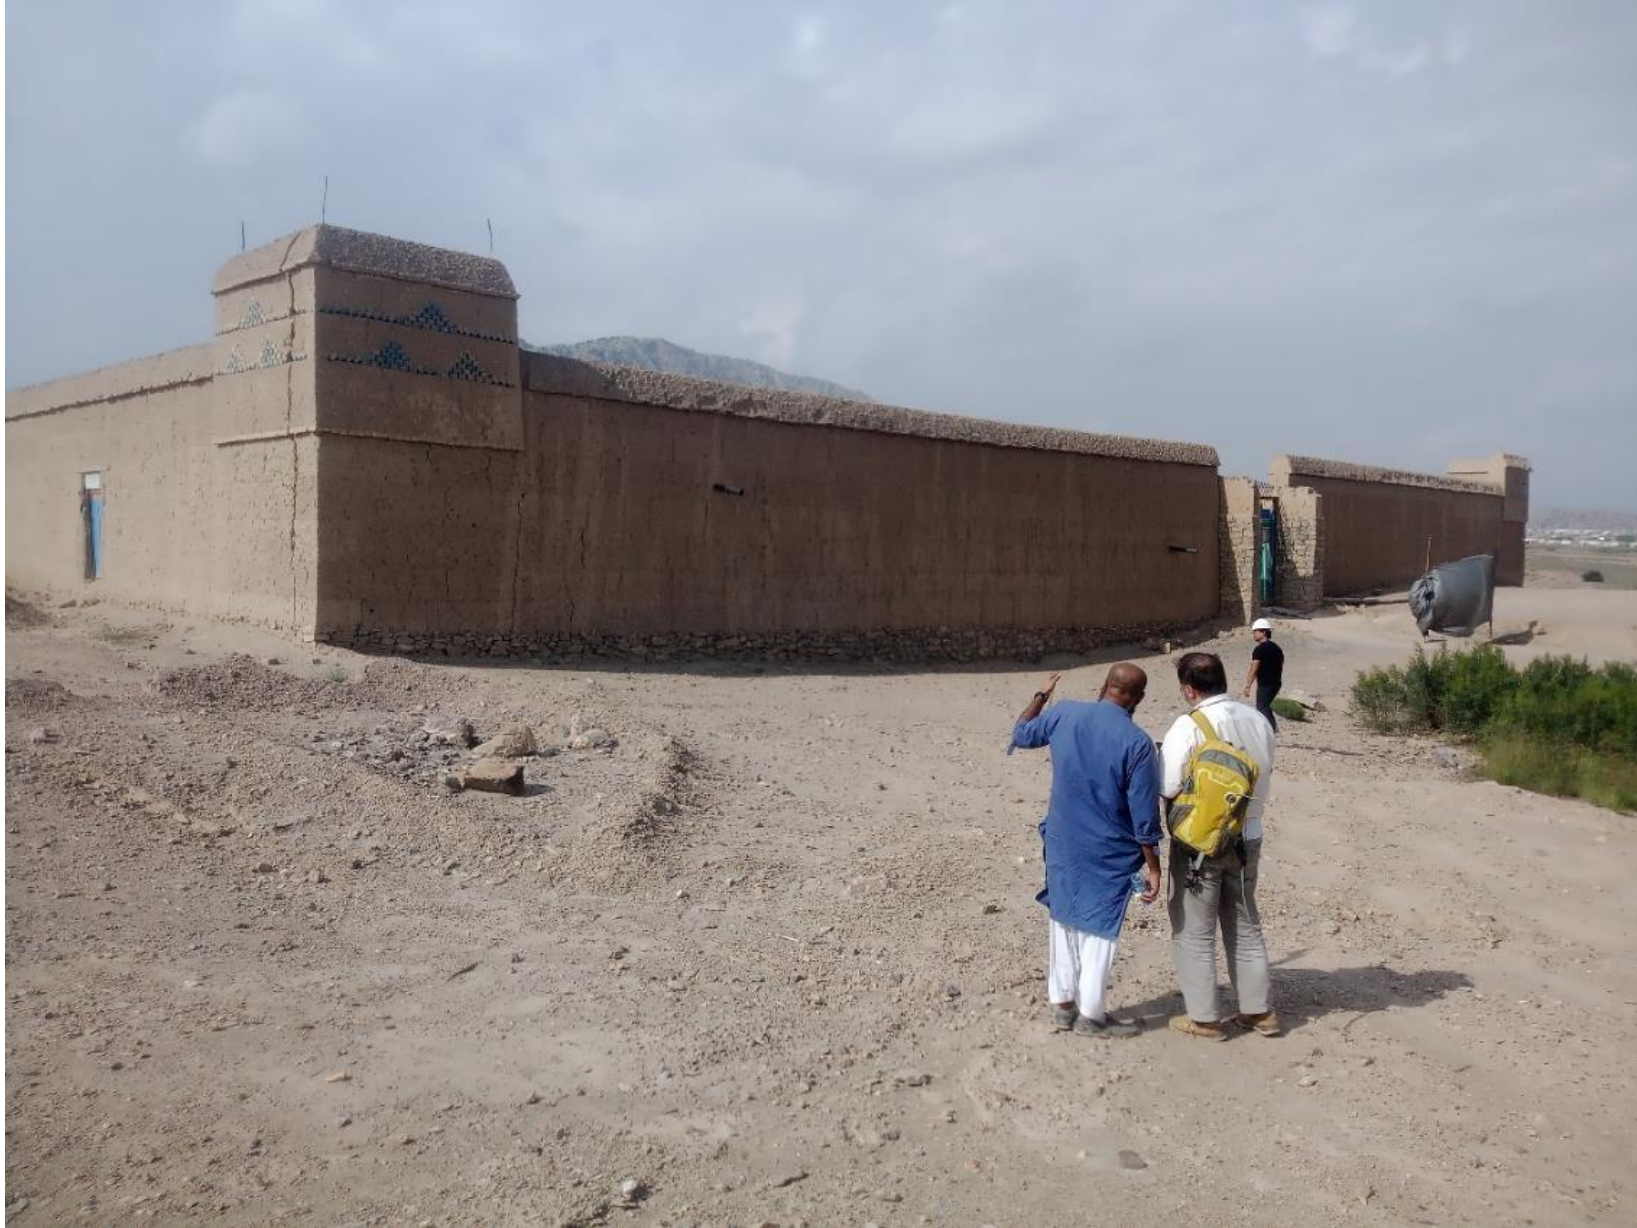
Vernacular clay construction

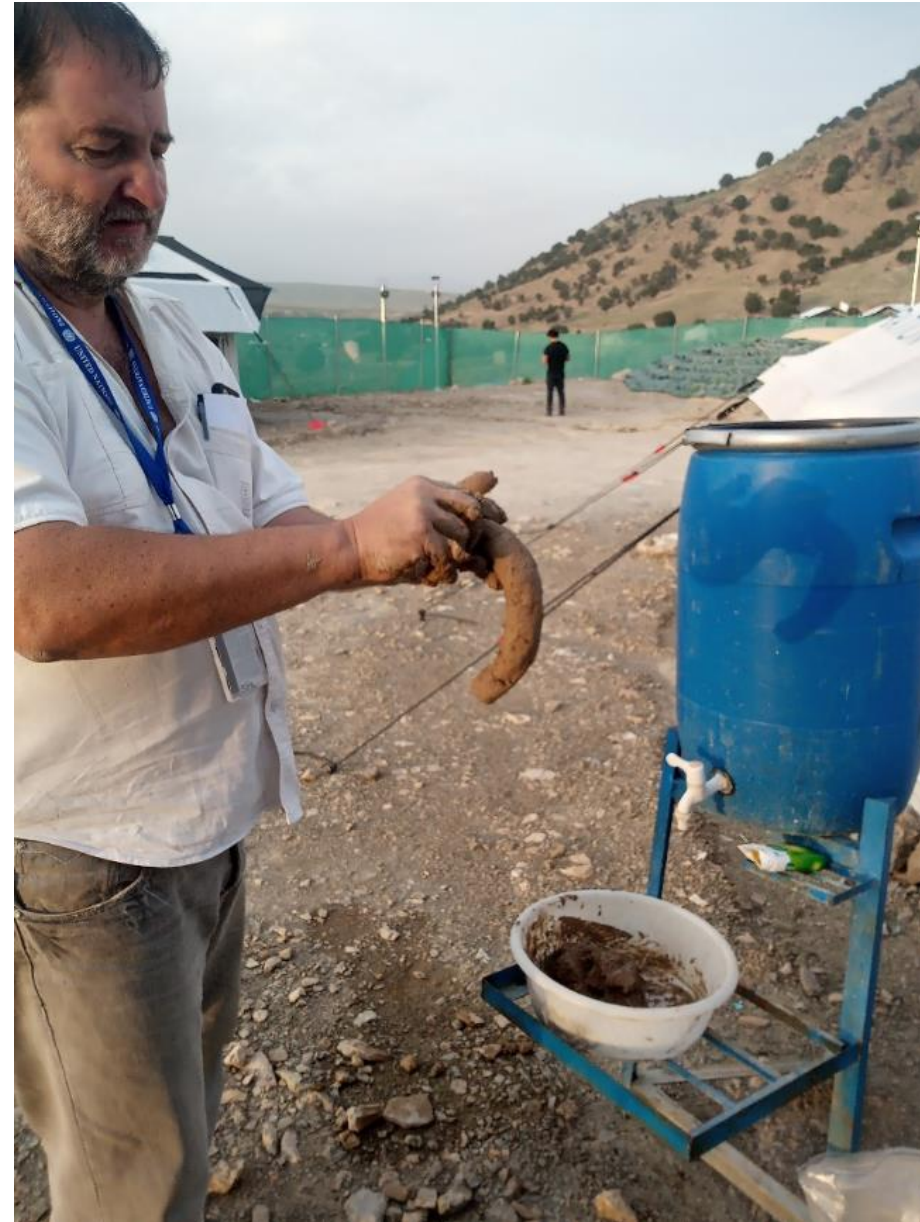
Vernacular construction

Cohesion Test (cigar test)

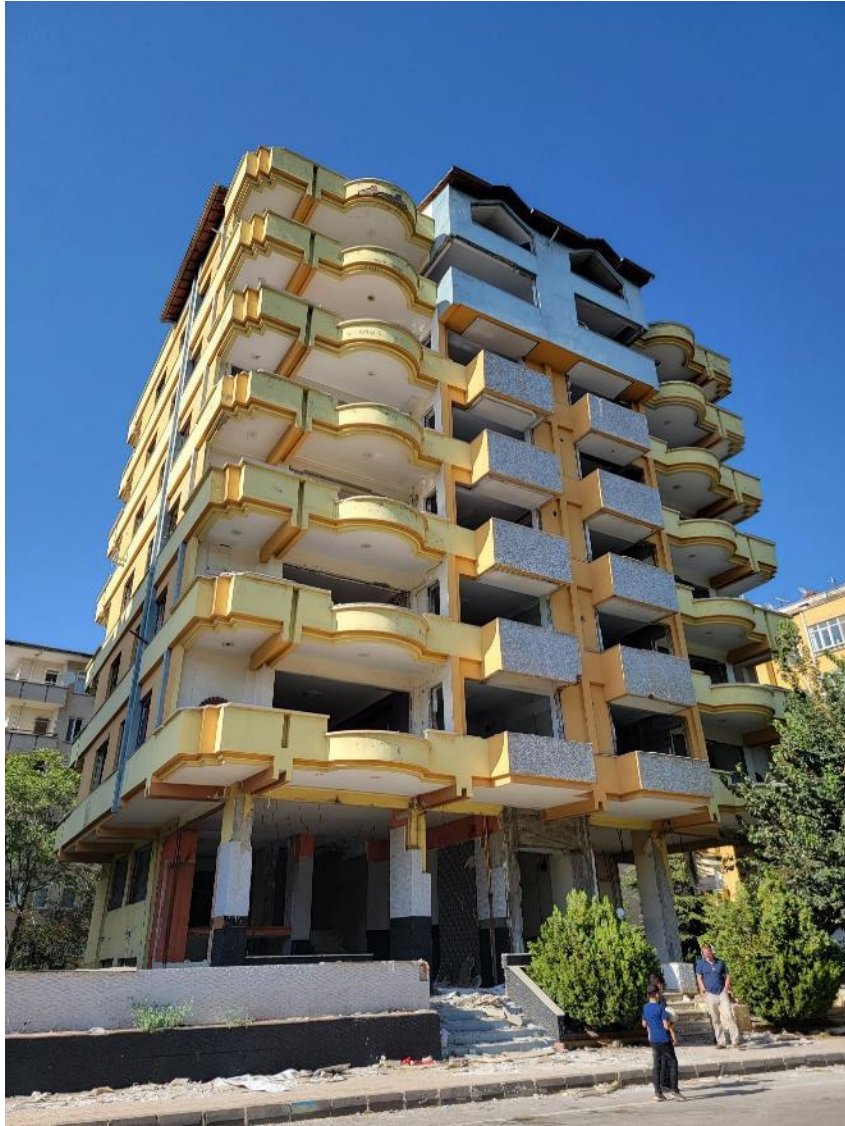
Building with **medium** damage

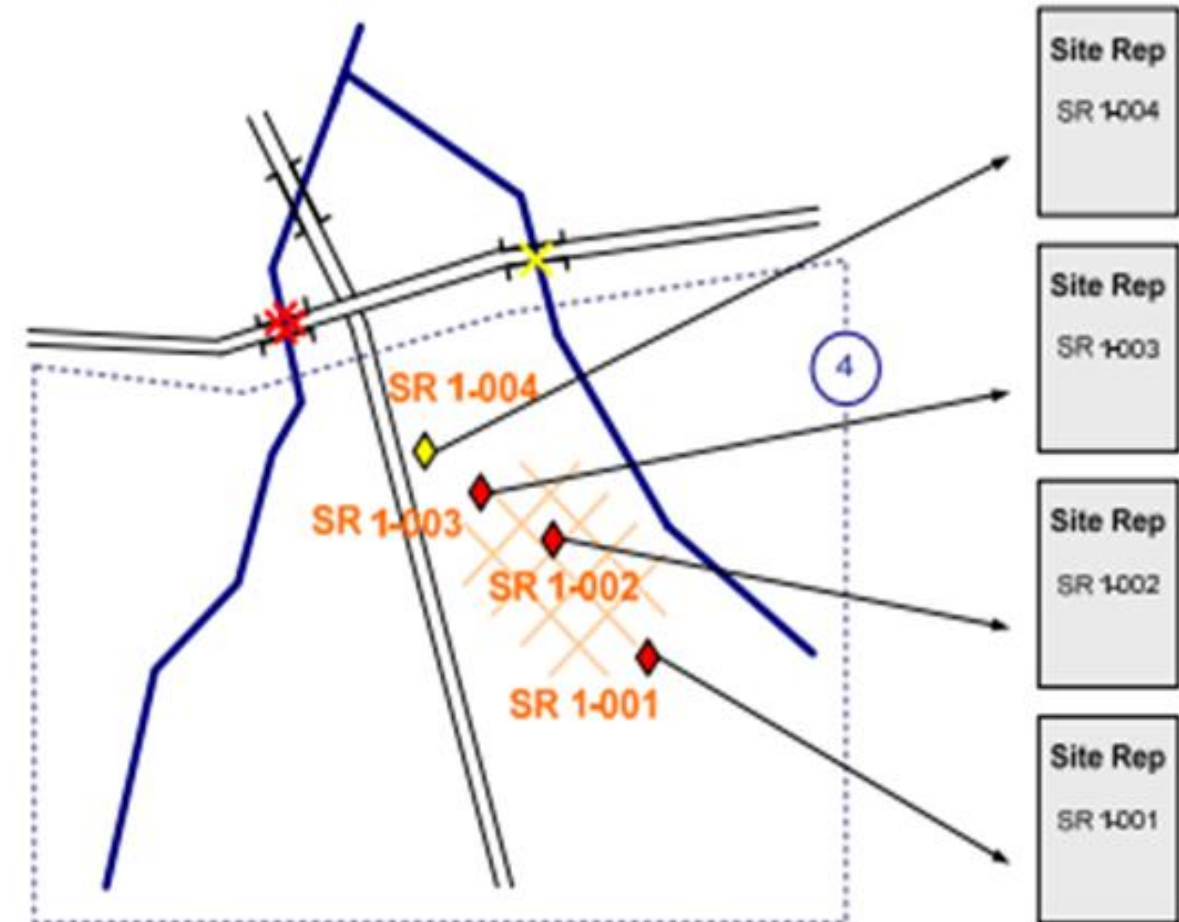
no damage	green	 
damaged/partially damaged	yellow	 
destroyed area	red

Evaluation of green, yellow and red

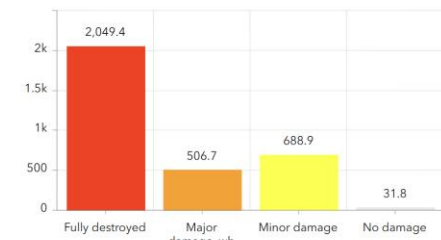
Number of damaged buildings estimated from HBDA data collection in Zindajan

UNDP data

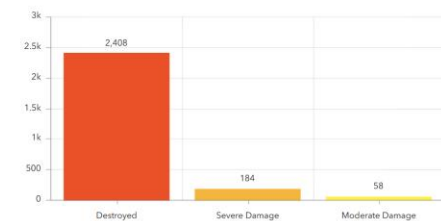
Number of damaged buildings in the Zindajan district (17 settlements only)

UNOSAT analysis
