**Evaluation of the 23rd July  
Flooding and Landslides on shelter conditions  
in Limbe**

**Shelter Cluster NWSW Cameroon**

Data Collection: August 2023

Analysis and Report: 7th September 2023

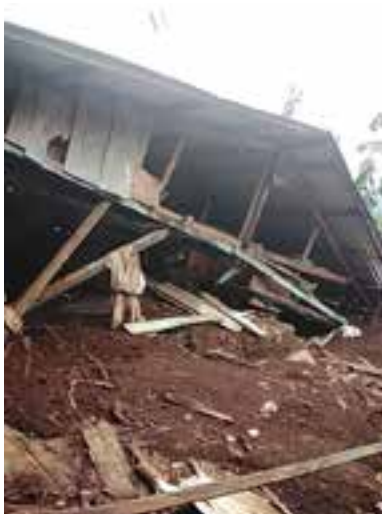
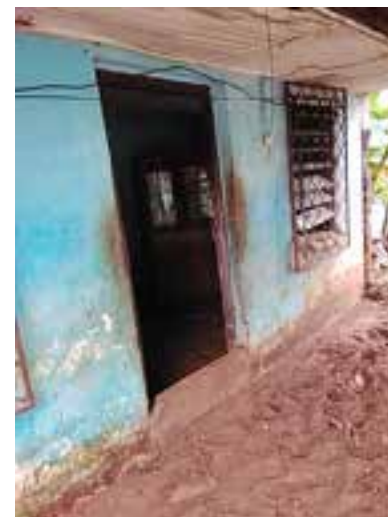
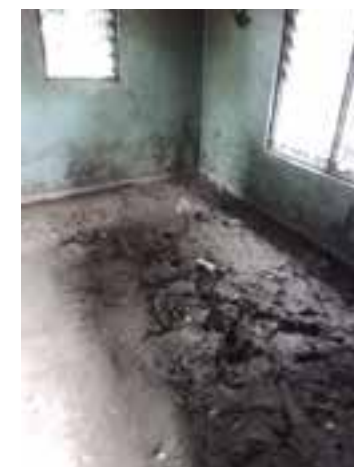
23 out of the 26 households interviewed had sustained damage to their shelters. 14 of the households said that the damage was caused directly by the flooding, and 9 claimed that the damage was caused by the landslides. 10 of the households are still living inside their damaged houses, while 13 are living nearby in another shelter. Households indicated the parts of their shelters that had been damaged, with wall damage being experienced in each of the households who had experienced damage. When describing the severity of the damages done to the walls, the households reported the following:

- 6 households reported moderate damage (some wall cladding damage from flood-borne debris or high velocity flood-water. Breakaway walls, staircases, carpets impact the structure of the building)
- 5 households reported total structural failure of their houses
- 5 households reported minor damages: breakaway walls, staircases, carpets etc. without damaging the structure of building; observable flood and mud marks on the wall
- 4 households reported severe damage: wash through of flood water removes cladding causing damages to the structure and other structures appended to the building
- 2 households reported partial collapse of their housing house shifted off foundation, structural damage exceeds 25% of the original shelter area
- 1 household reported very severe damage: failure of wall frame and structural damage not exceeding 25% of the shelter area

8 households reported that their windows were fully destroyed, leaving the shelter exposed to the elements, and 3 households reported that their windows had sustained minor damages. 7 households reported no longer being able to close their door as the damage to the door had compromised its functionality, while 3 households reported minor damages to the door, with 1 household reporting they could stick their hands through the door given the size of the damage caused. 4 households stated that their roof had been completely destroyed, 50% of households said that their roof was leaking when raining, 2 households stated that their roof is in a state of collapse, and 1 household reported minor holes in the roof.

3. Repairs cannot be done in areas that are not suitable for building such as less than 5 m from a roadway or a water way. Additionally, construction should not be done on a steep slopes that put the house at risk of collapse or further vulnerabilities from natural disasters. The mayor of Limbe also asked citizens to move from many of these areas, so prior to supporting households with donation of construction tools or materials or providing repair support, organizations should seek the advice of the government and ensure that the affected household has the proper ownership documents. Ensure that the population has messages and awareness of building back safer to avoid additional constructions in these areas.

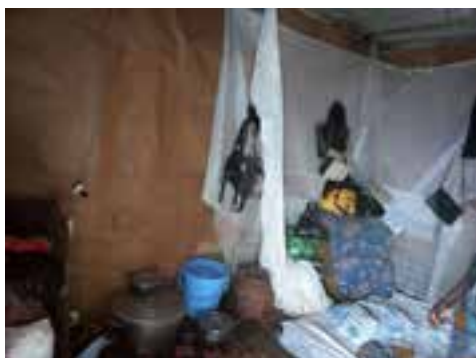
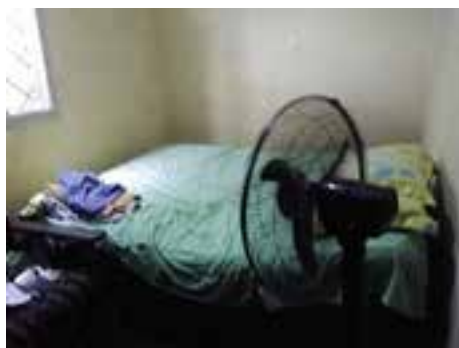
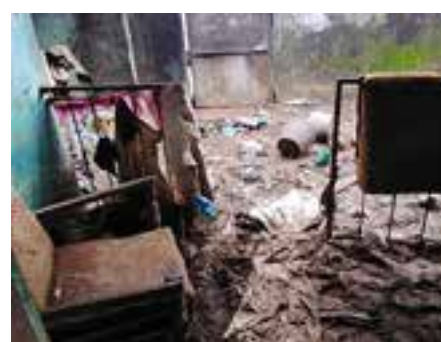
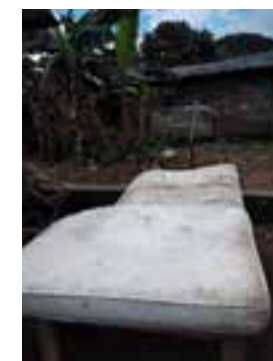
In addition to the basic items, bedding was found to be a significant need of the interviewed households. 16 of the households had beds as their primary sleeping source, 5 had just mattresses, and 5 had sleeping mats. When asked about the number of mattresses each household has, it is determined that each household has 1.65 mattresses per household which is only 3 mattresses for every 10 people interviewed, indicating that this would be a need for the community. Households were also asked about how many bedsheets that they have. This would work out to 2.2 bedsheets for each household or 4 bedsheets for every 10 people. By looking at the chart above, blankets and mosquito nets are also a critical need. The number of blankets available reflects that there are only 9 for every 100 people interviewed. Interviewers observed many of the beneficiaries' personal items were damaged or destroyed by the flooding and landslides.
