CARE International Indonesia

## Rapid Shelter assessment (Remote and Rural areas)

West Sumatra Earthquake of 30 Sept 2009

DRAFT Zero 15<sup>th</sup> Oct 2009

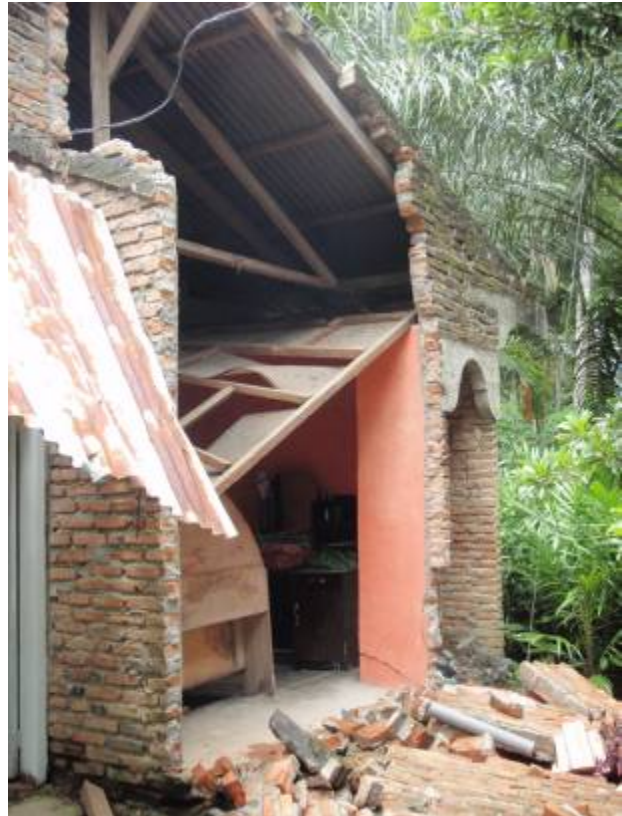
### ***Brick walls***

Brick wall construction is common in the region, however without reinforcement brick walls just crumbled and peeled away. This is a very hazardous construction technique as the wall collapse and roof cave in or the wall falls in on top of the people inside.

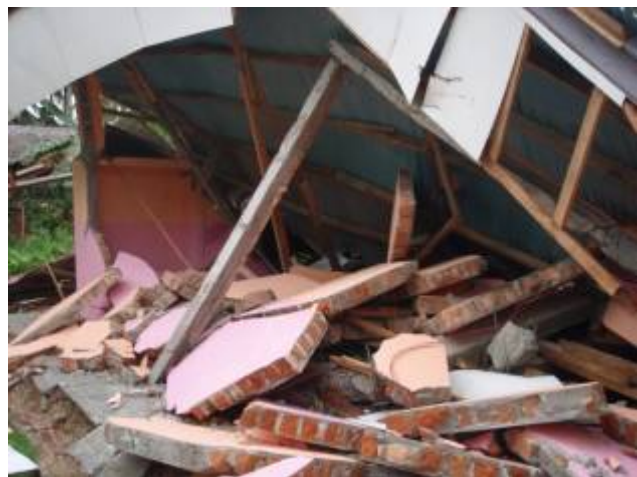
### ***Concrete column with brick infill***

Slender concrete columns failed. Brick infill walls peeled off the columns as there were no ties between column and wall.

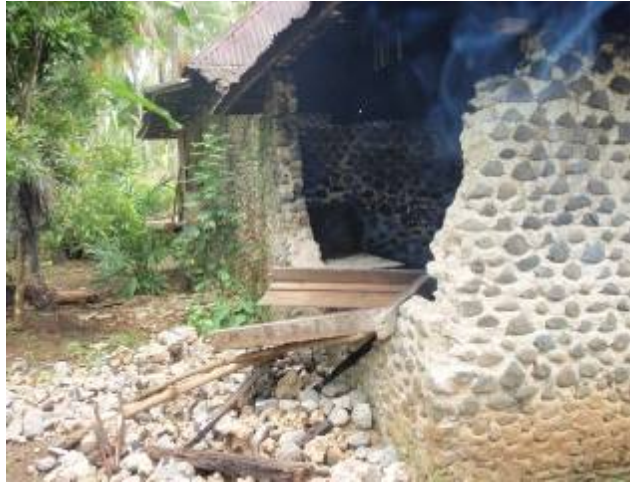
### ***Stone with clay and lime mortar***

In some areas the use of local stone with clay and lime mortar have been seen, however much of them have been damaged.

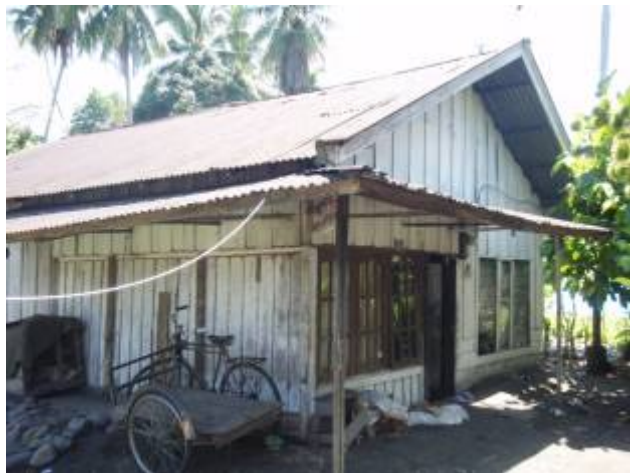
### ***Timber frame***

Timber frame houses are present in the area although brick building are more common as it is seen as “*permanent*”. In the same village, timber frame houses generally have seen less damage. This photo shows a undamaged timber house and next to this house a totally destroyed brick house.

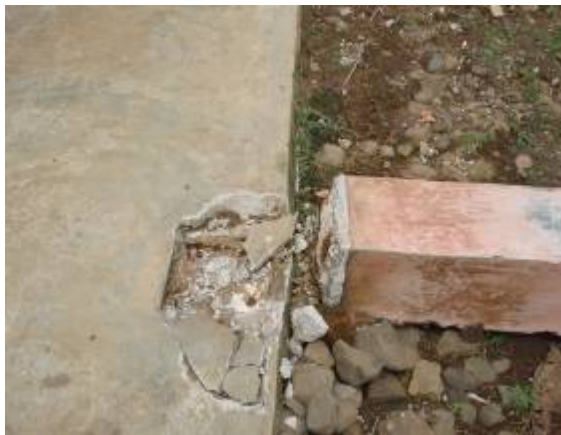
Lack of reinforcement connecting the column to the foundations.  
No ring beam (sloth)

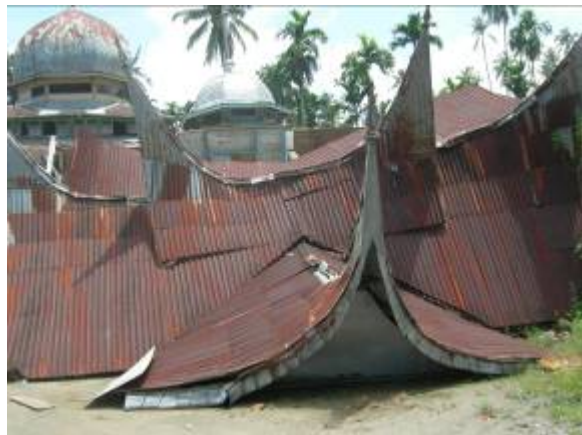
Traditional Padang roof structures are heavy and in this instance structural columns failed.

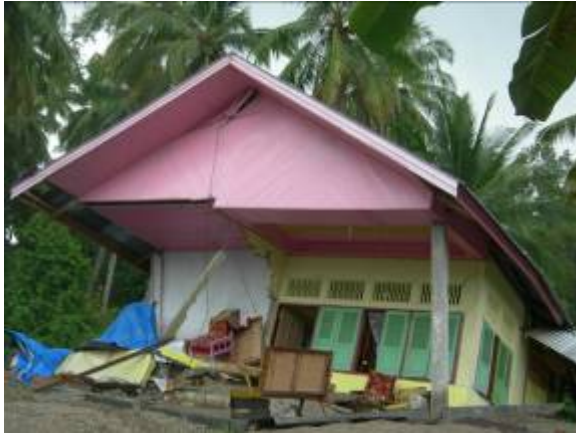
Land movement, causing sedimentation to the foundations, relocation and tenure issues may become important.

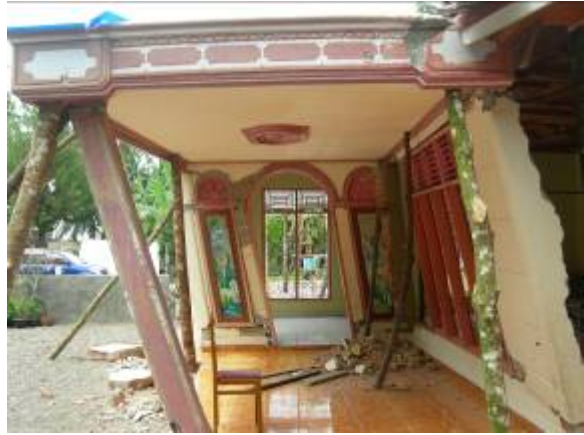
Lack of lateral bracing, dangerous structure.

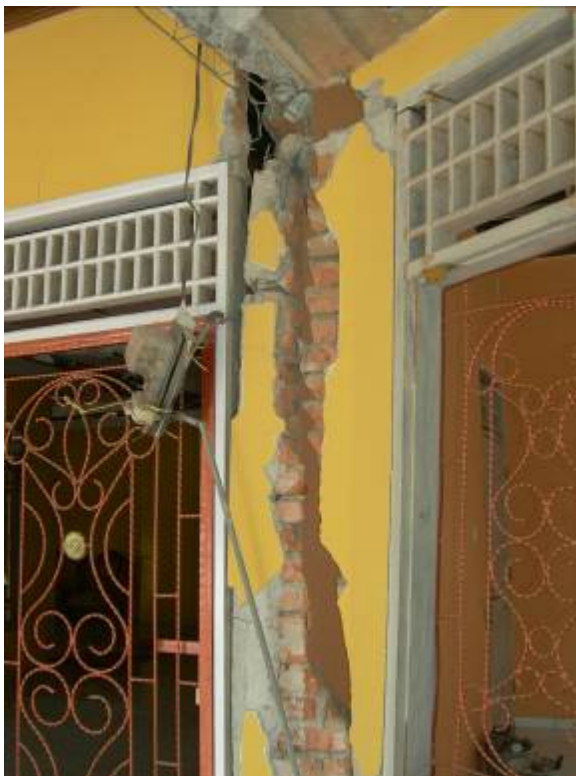
Size of structural columns too small and low quality of re-enforcement bars.

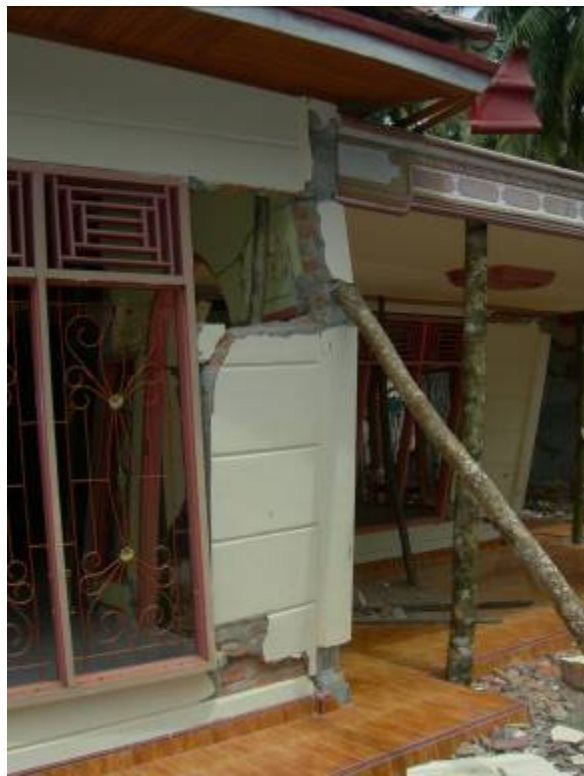
Dangerous structures left and owners put supports to avoid collapse.

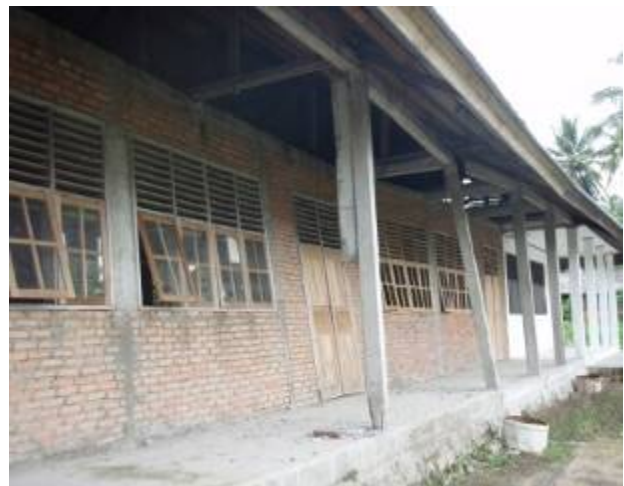
### ***Weak structural columns***

The low quality of the structural design can be clearly seen by the damage. Where there are no steel reinforcements at the beam to column connection the structure failed.

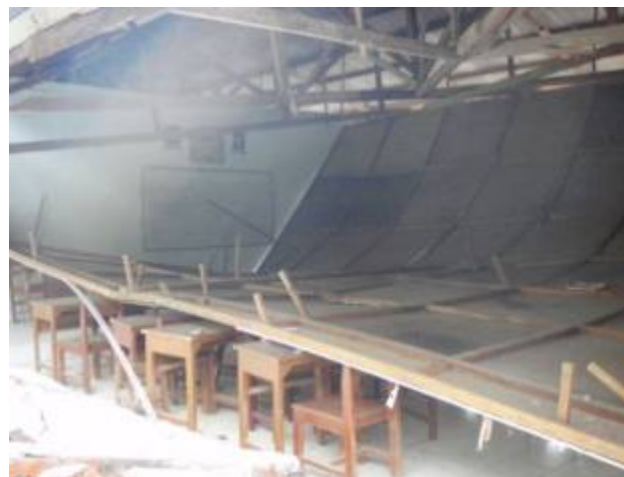
### ***Ceiling caved into class room***

This photo shows one of the external walls have collapsed and then the ceiling dropped.

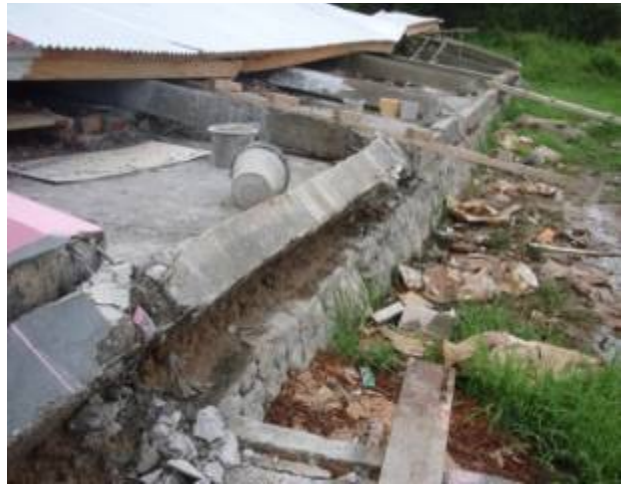
***No connection from the Ring beam to the foundations***

This detail shows the ring beam was not anchored to the foundations. Thus the building collapsed.

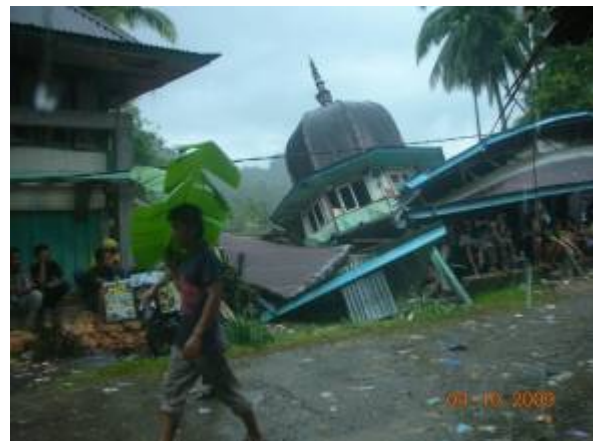
Some Religious buildings have collapsed also, destroying community space.

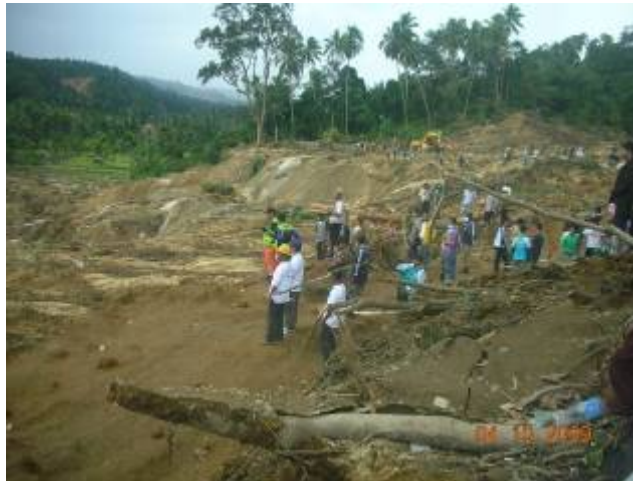
The area of Pariaman have experienced many landslides. This photo is from a village in Patamuar where three complete villages (300 households) were claimed by the landslide, only 4 survived.

- Weakened soil, higher risk of further landslides
- Risk of mud slides in heavy rain
- Loss of agricultural land
- Potential re-location and related tenure issues
