# **Bangladesh Flash Flood and Landslides**

## **Shelter Cluster Bangladesh**

### **Joint Field Mission Report on Flood Affected Communities**

30 July 2026

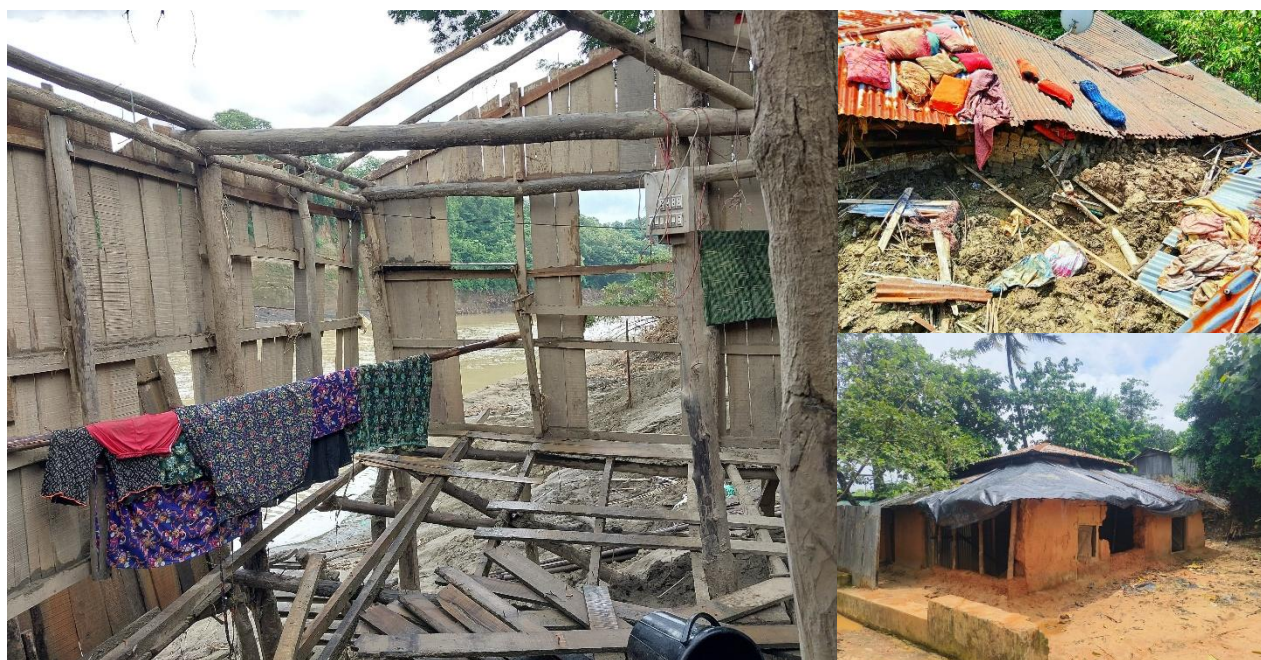
The combination of exceptionally high upstream river discharge and severe flooding generated powerful hydraulic forces that resulted in extensive destruction of residential structures. Houses located near riverbanks were disproportionately affected, with many partially or completely washed away due to prolonged inundation, and sustained exposure to fast-flowing floodwaters.

Traditional kancha houses, predominantly constructed from mud, bamboo, and other locally available materials, experienced the most severe impacts. These structures are common throughout the region due to their affordability and alignment with local construction practices. Prolonged flooding significantly weakened earthen foundations and walls, causing widespread structural failure. Many houses collapsed entirely, while others became severely damaged and unsafe for occupancy. Consequently, the majority of mud-built houses within the affected areas were either

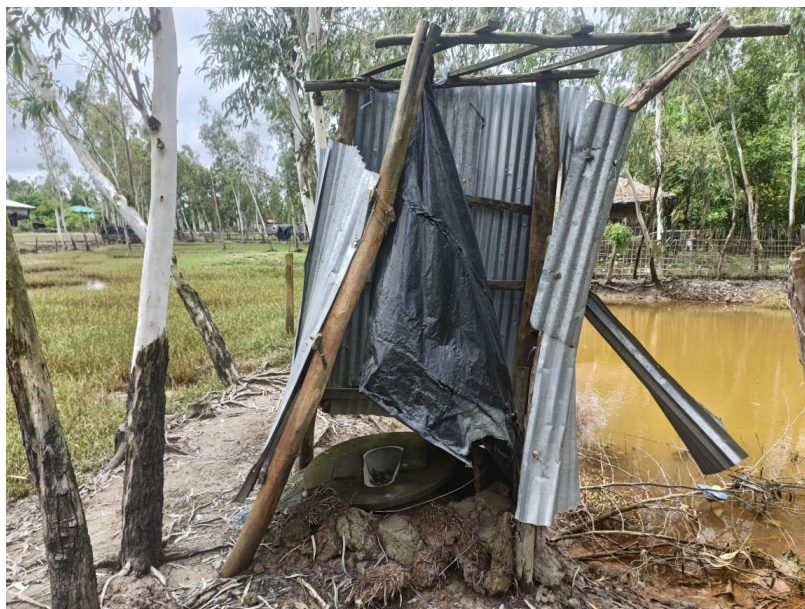
**Sanitation:** The July 2026 flash floods severely damaged sanitation facilities across rural and hilly areas of Chattogram, particularly in vulnerable communities affected by steep terrain, erosion, and weak infrastructure. Flooding submerged latrines, overflowed septic pits, and increased the risk of open defecation and faecal contamination of water sources. Immediate

interventions are needed to restore safe sanitation services, including repairing and desludging latrines, installing emergency facilities, and promoting hygiene practices to prevent waterborne diseases such as cholera and diarrhoea. In the longer term, flood-resilient sanitation infrastructure is essential to support recovery and reduce future disaster risks in the affected areas.
