Site Visit PoC UN House extension

2014/01/03

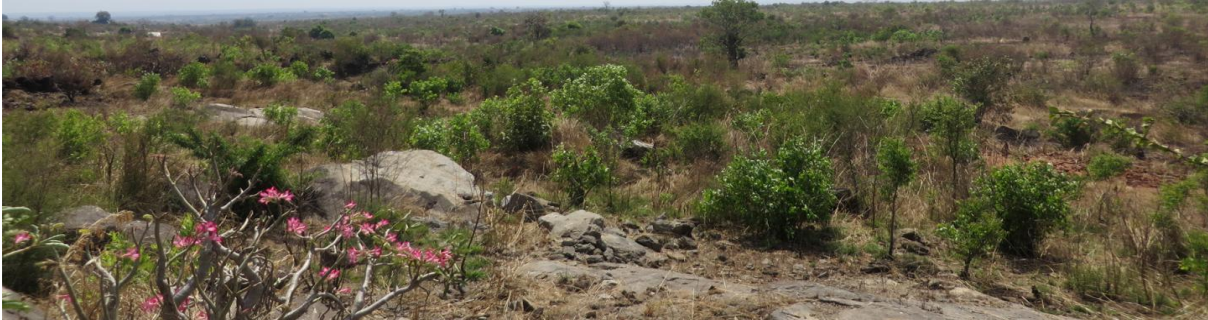
View south west across the site – showing a patch of bare rock in the foreground

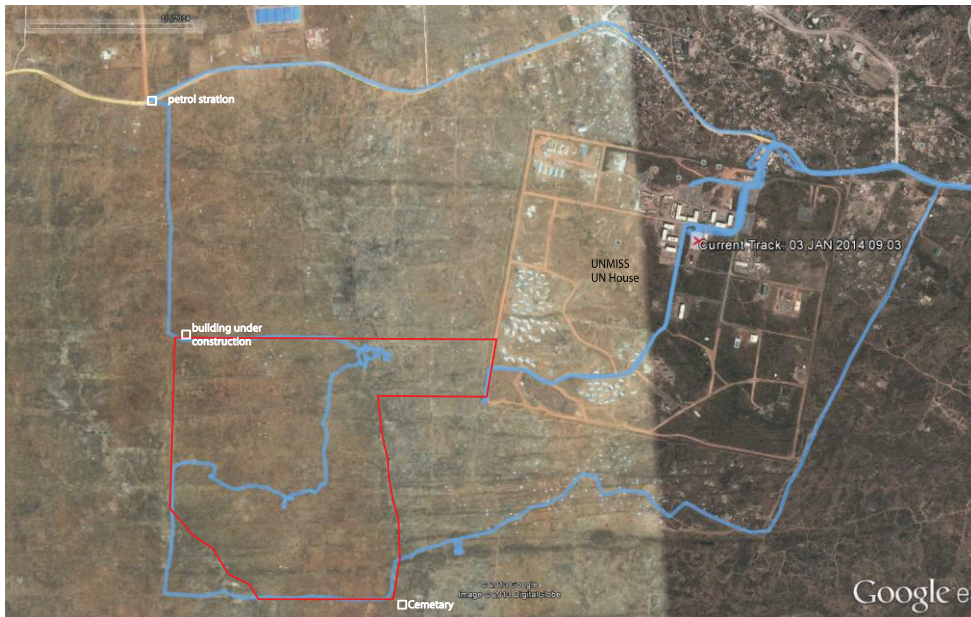
Overview of rapid site assessment (blue track shows path surveyed) with key landmarks

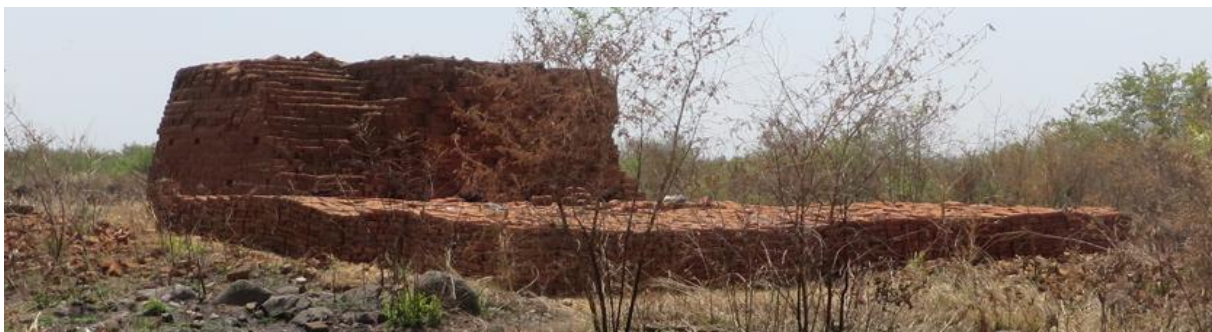
No houses were observed onsite, but the survey was incomplete, and subsequently shelters were observed in satellite images. This requires further verification. Signs of previous occupancy and two brick kilns were observed in the site next to water courses.

One of two small scale Brick kilns observed on the site.

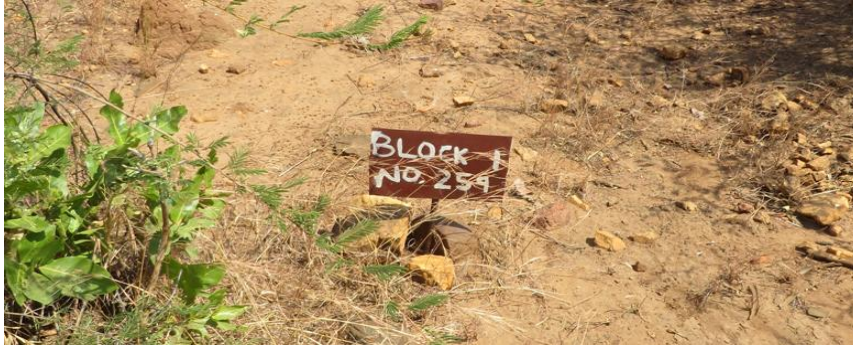
Example of a plot marker found on site. Note the rocky soil typical of many parts of the site

The site appears to be divided into plots with markers observed on site. Clarification is required in identifying ownership.

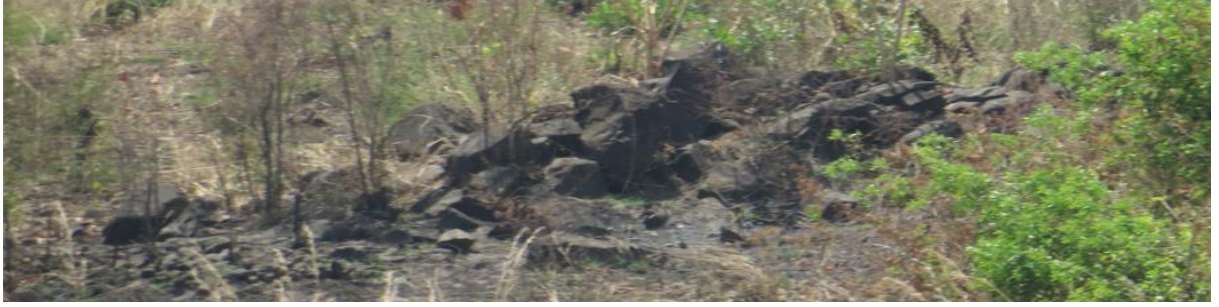
The site is primarily granite with varying degrees of fracturing and soil cover across the site. Some areas such as the corridor between the main site and the UNMISS base have large areas of exposed rock (estimate as 30% of this area is not usable.) To the east of the stream that splits this corridor from the main site, there are fewer areas of exposed rock, and the ground condition is variable. However, it is generally hard and rocky.

Example of a rocky part of the site where tent pitching will not be possible.

- A flexible approach will be required for site planning, to adapt to the specific local ground conditions. The existence of exposed rock will mean that at many locations across the site shelter will not be built.
- Site planning for family plots and other structures should follow drainage planning and layout.
- Sledgehammers (shared with tent erection teams) additional pegs should be procured/made. Pegs can potentially be made from larger diameter (12+mm) steel reinforcement bars should be procured to secure tents in case of peg bending / failure.
- Additional time and human resources will be required to place tents given the hard ground.

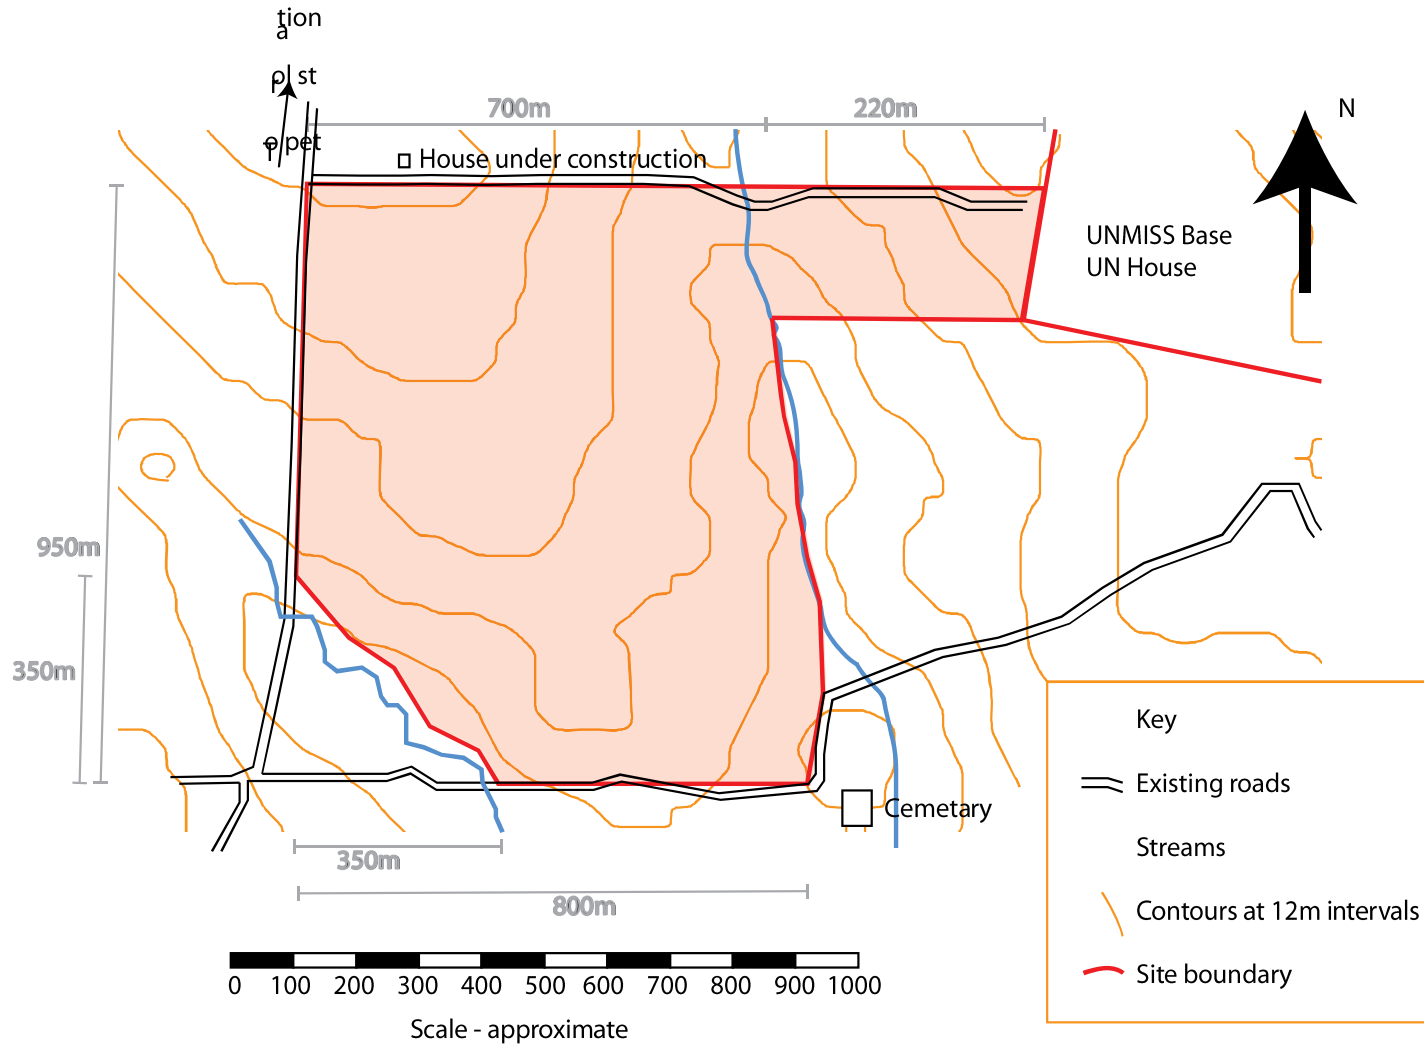
Approximate site sketch - Key physical features and topography.

Dimensions are subject to verification and should not be used for detailed planning purposes. Practically boundaries will need to be offset from existing roads.
