UKRAINE

HORENKA, KYIVSKA OBLAST

IMAGERY ANALYSIS: 31 March 2022 PUBLISHED: 11 April 2022 V1

UNOSAT Damage Assessment Overview Map

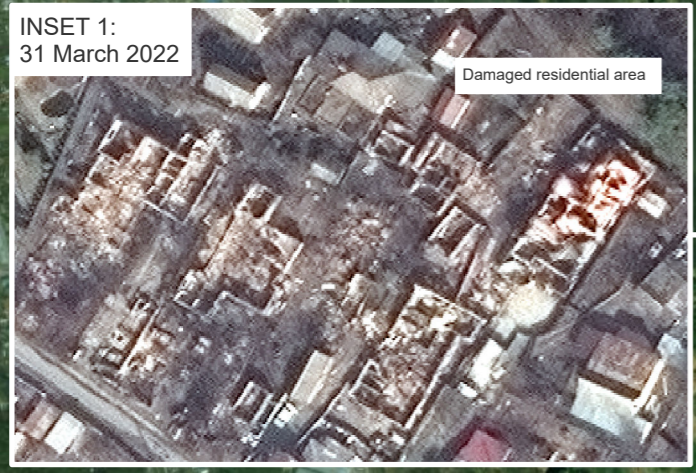
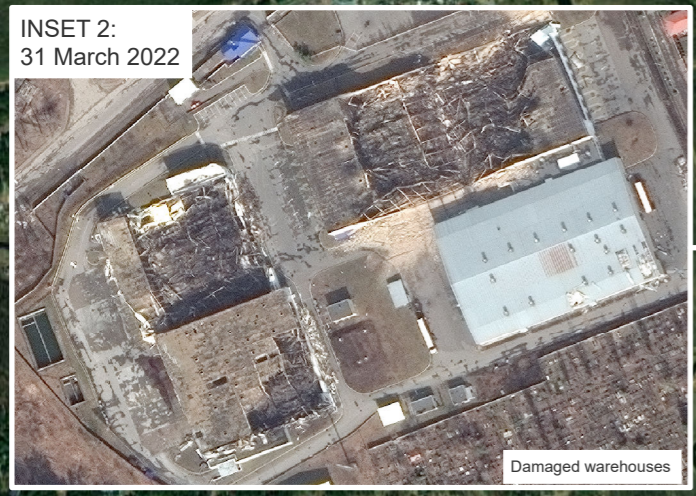
This map illustrates a satellite imagery-based Rapid Damage Building Assessment (RDBA) in the Horenka, Kyiv region, Ukraine. The RDBA divides the city into 500m x 500m cells, each of which is analyzed to determine whether or not there are damaged buildings inside the cell.

Based on imagery collected on 31 March 2022, analysts found that 51 cells out of 66 cells in Horenka sustained visible damage. This represents approximately 77% of the cells over the area.
