Malawi Floods and Rains Recovery Program

Learning from tradition

Learning from Tradition

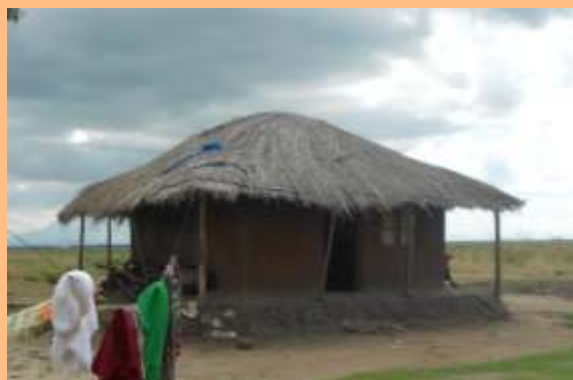
A traditional house that survived the floods. The raised platform protected the core structure from erosion; the hipped roof with large overhangs and veranda avoids having exposed gable ends and prevented driving rain from damaging the walls. The roof and walls had been maintained and in so doing provided additional protection. The design provides protection from the elements and has been developed over centuries.

Other than some minor repairs to the veranda wall, the house was in good condition and allowed the family to return to their homes once the floods had subsided.

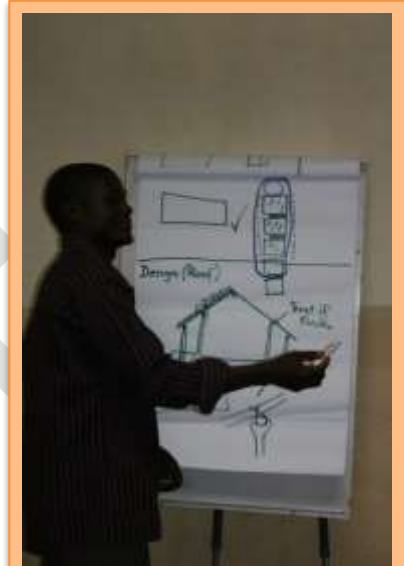
Local builder describing techniques for connected the roof structure to the wall.

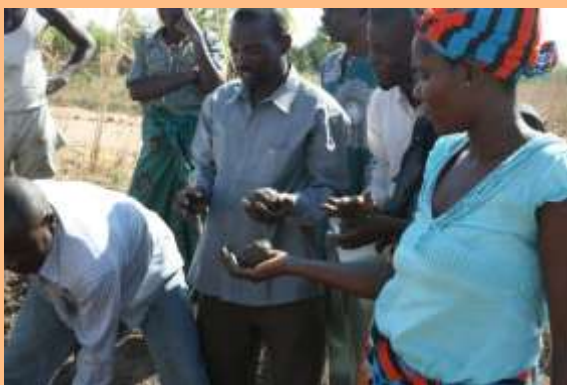
The strength and durability of earth bricks are determined by the ratio of sand and clay, the amount of water used, and care taken during moulding and drying.

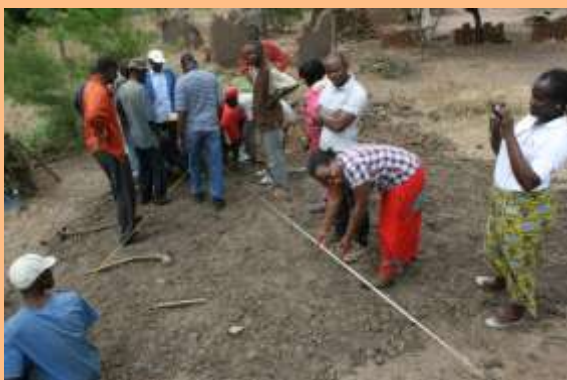
Setting out foundations using simple 3,4,5 triangulation formula to obtain a 90 degree corner as basis for the rest of the setting out.

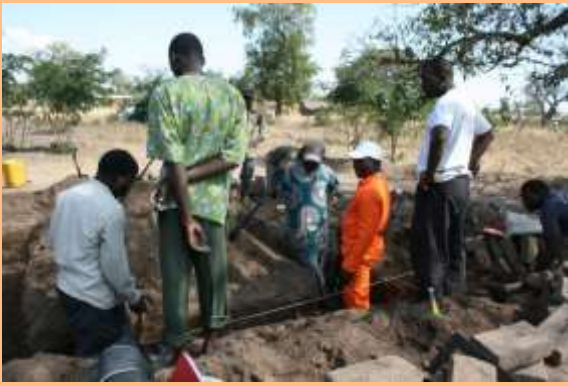
Foundations dug to a depth to ensure proper ground bearing and to avoid exposure due to erosion.

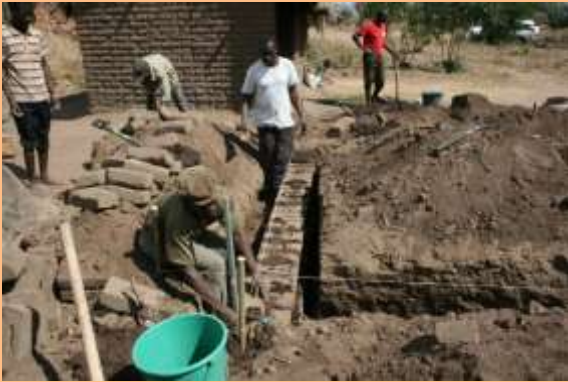
Foundation walls constructed to provide a substantial footing for the walls. Infill compacted to prevent subsidence.

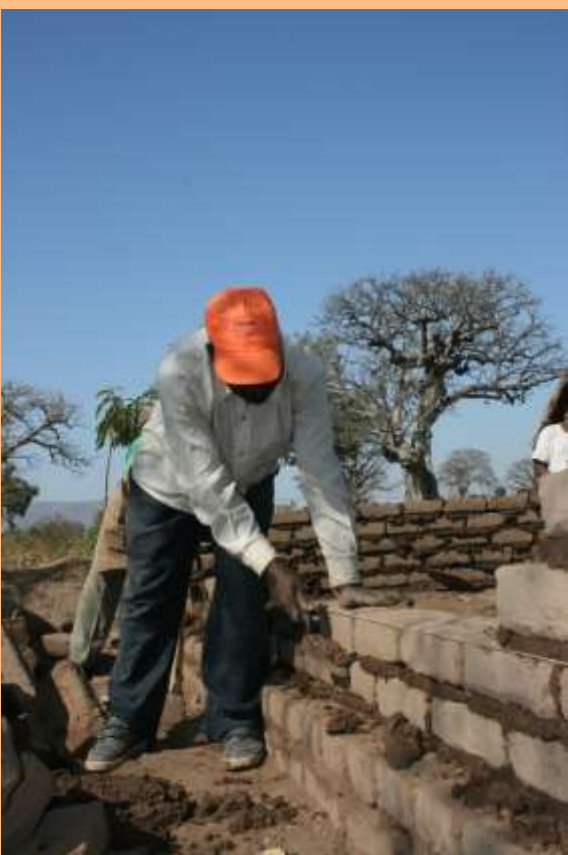
Brickwork constructed using mortar to the same standard as used for brick manufacture. Corners constructed using gauging rods to ensure regular mortar beds and so that the walls are level.

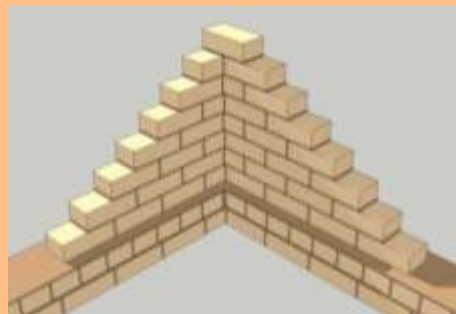
All mortar joints to be fully filled and the mortar compacted in the joints. Stretcher bond brickwork to have proper half bonds and corners constructed in steps.

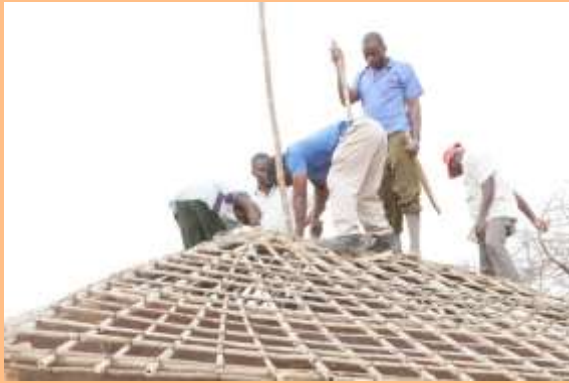
Rafters and battens fixed with tie wire. Wall plates fixed securely to posts and walls.

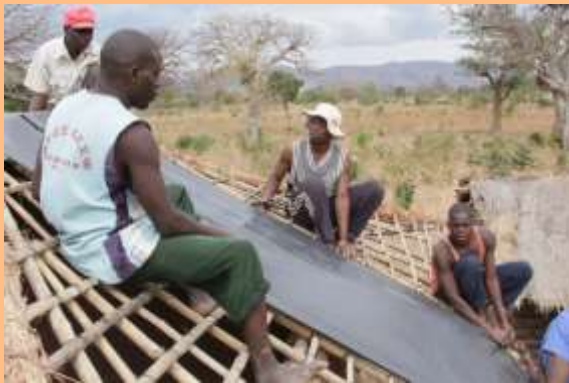
Plastic membrane fitted prior to thatch providing additional protection especially at times when there is a shortage of thatching material.

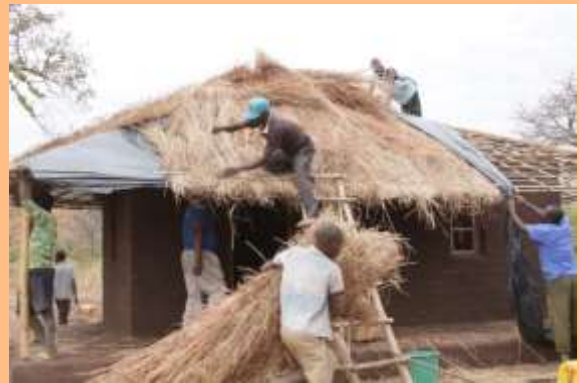
Thatch fitted over the membrane.

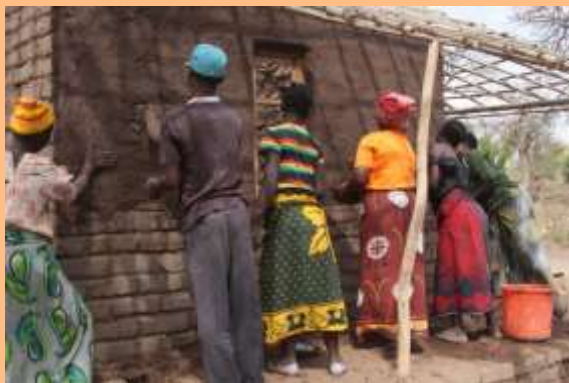
Walls are rendered using traditional techniques.

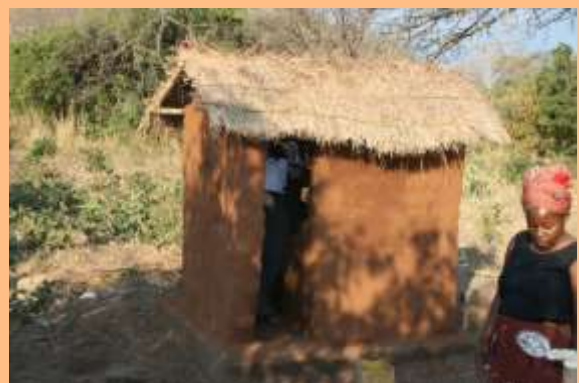
Latrine constructed by householder.

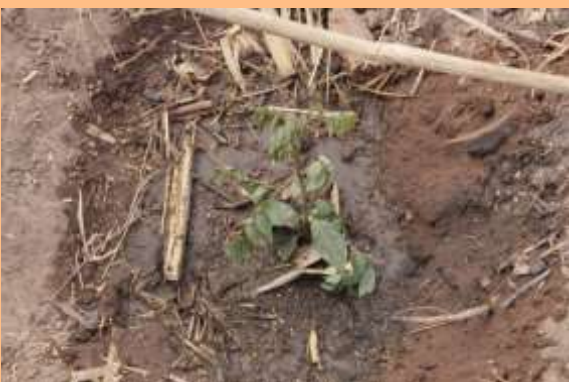
Trees planted around the house to provide shading, wind and rain protection, and a supply of wood for construction and fuel.

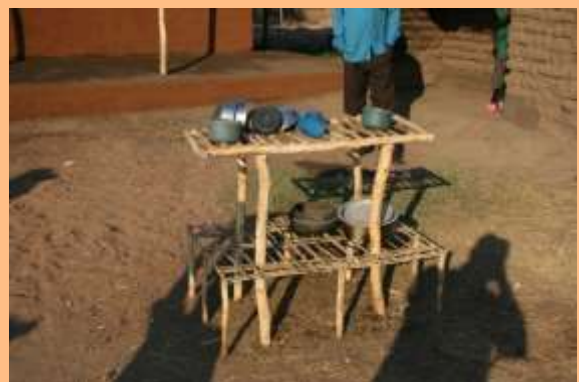
Small details such as wash stand and plate drying rack to encourage safer hygiene practices.

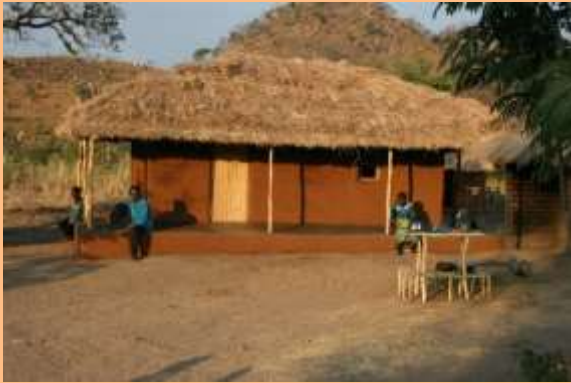
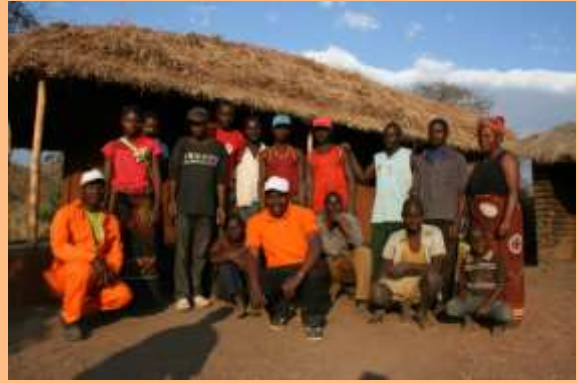
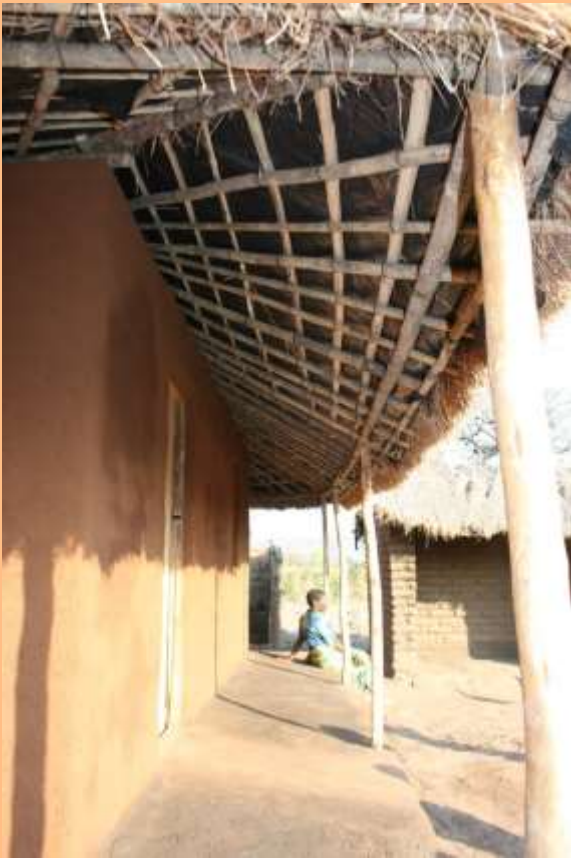
The finished product

- Families prepare latrines with temporary superstructures and clear sites prior to receiving construction materials
- The CADECOM team constructed the model home in less than 10 days.
- Floor area (not including veranda, and kitchen) 16.5 M2
- Total costs of materials approximately \$200
