## **Pretesting in Nsanje**

**Dyna Khonde & Madalitso Jere**

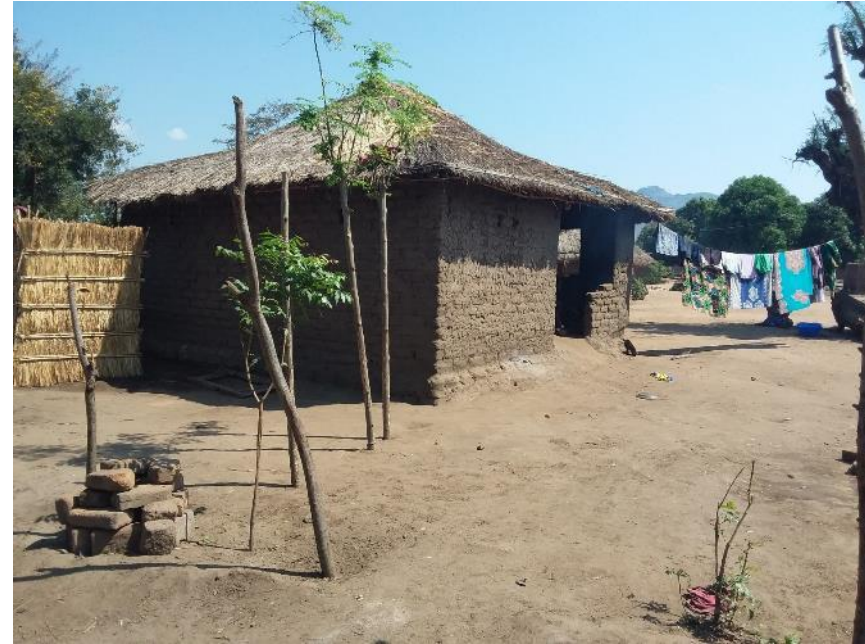
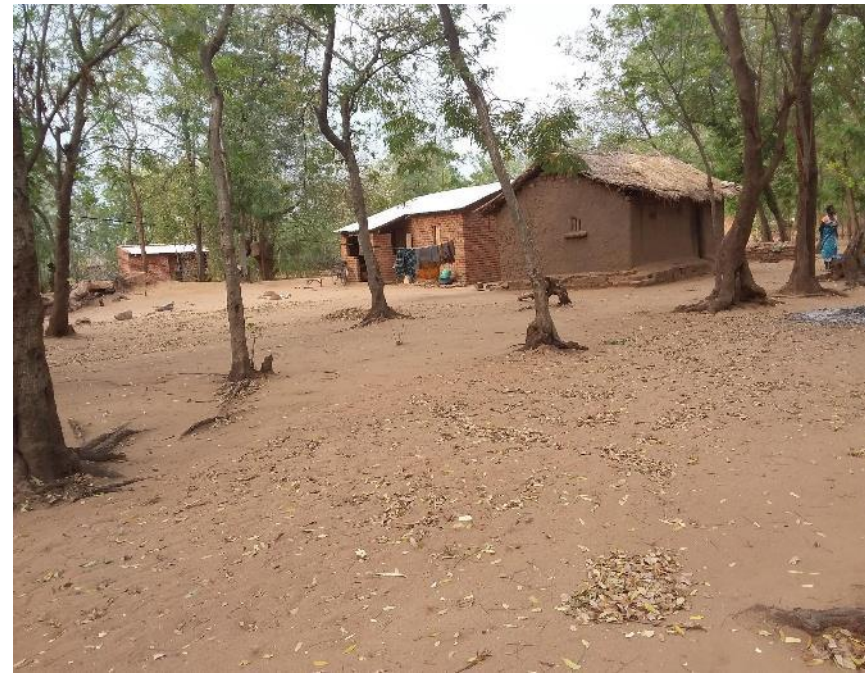
- Cheap local materials hence easy to maintain
- Mosquito-nets in windows to shield mosquitoes
- Plenty of trees around as wind breakers, shade and for cooling
- Masonry columns instead of timber poles post to avoid termites
- Narrow spacing on battens strengthening the roof
- Tied thatch grass with bamboos to avoid strong winds.
- Cladded with clay soil to add an extra protection layer to adobe soaking.

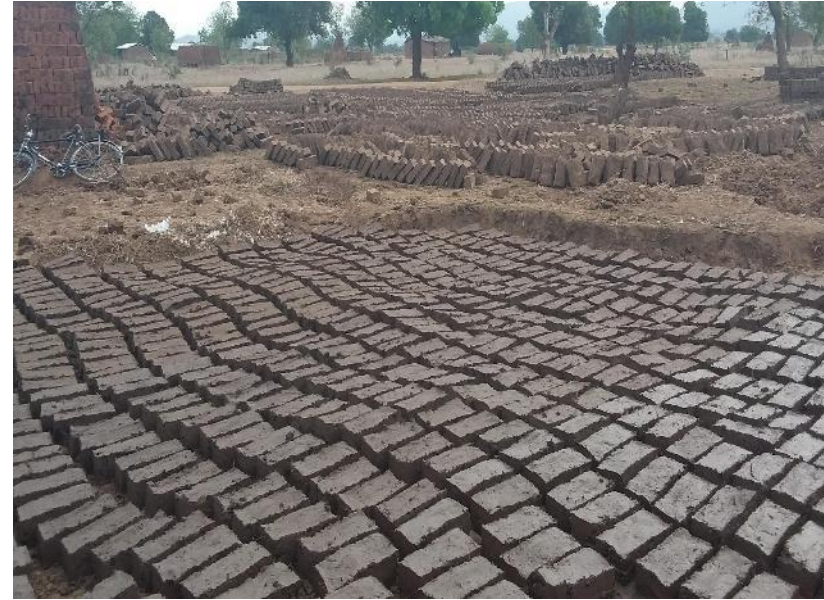
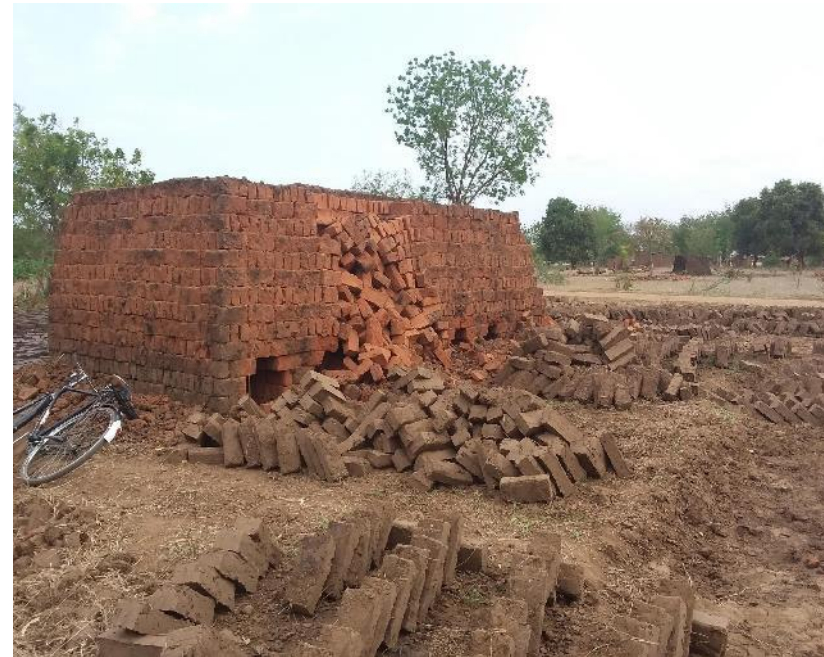
- Skill in molding strong earth bricks
- Most people prefer burnt bricks to construct their houses
- Use of burnt brick for construction
- Mud-mortar on both foundations and walls.
- Double-brick wall for foundation
- Elevated foundations to prevent the adobe soaking and running water.

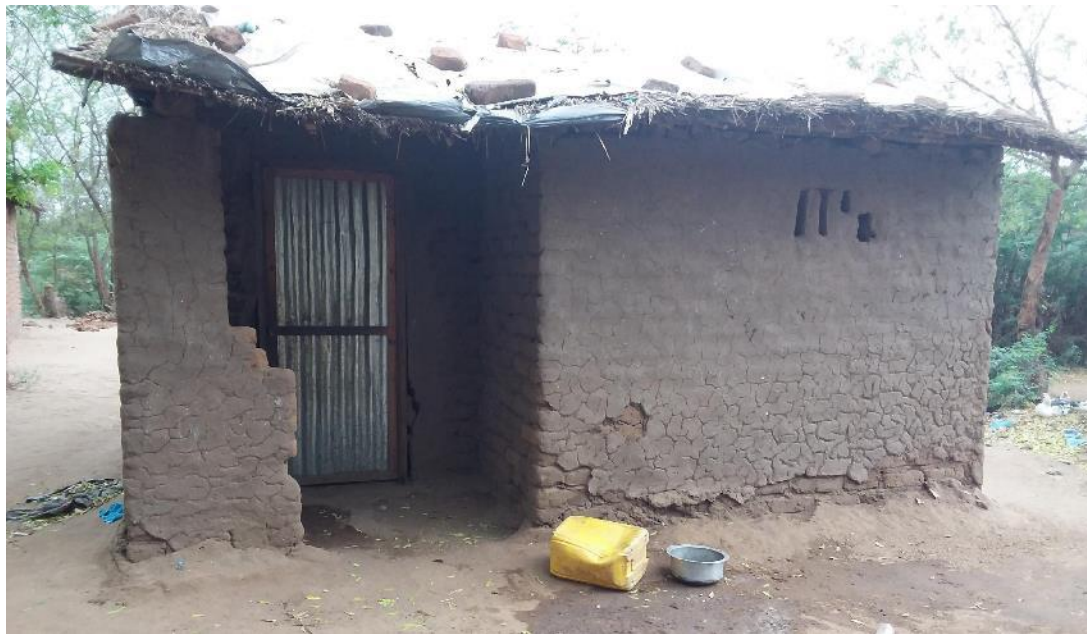
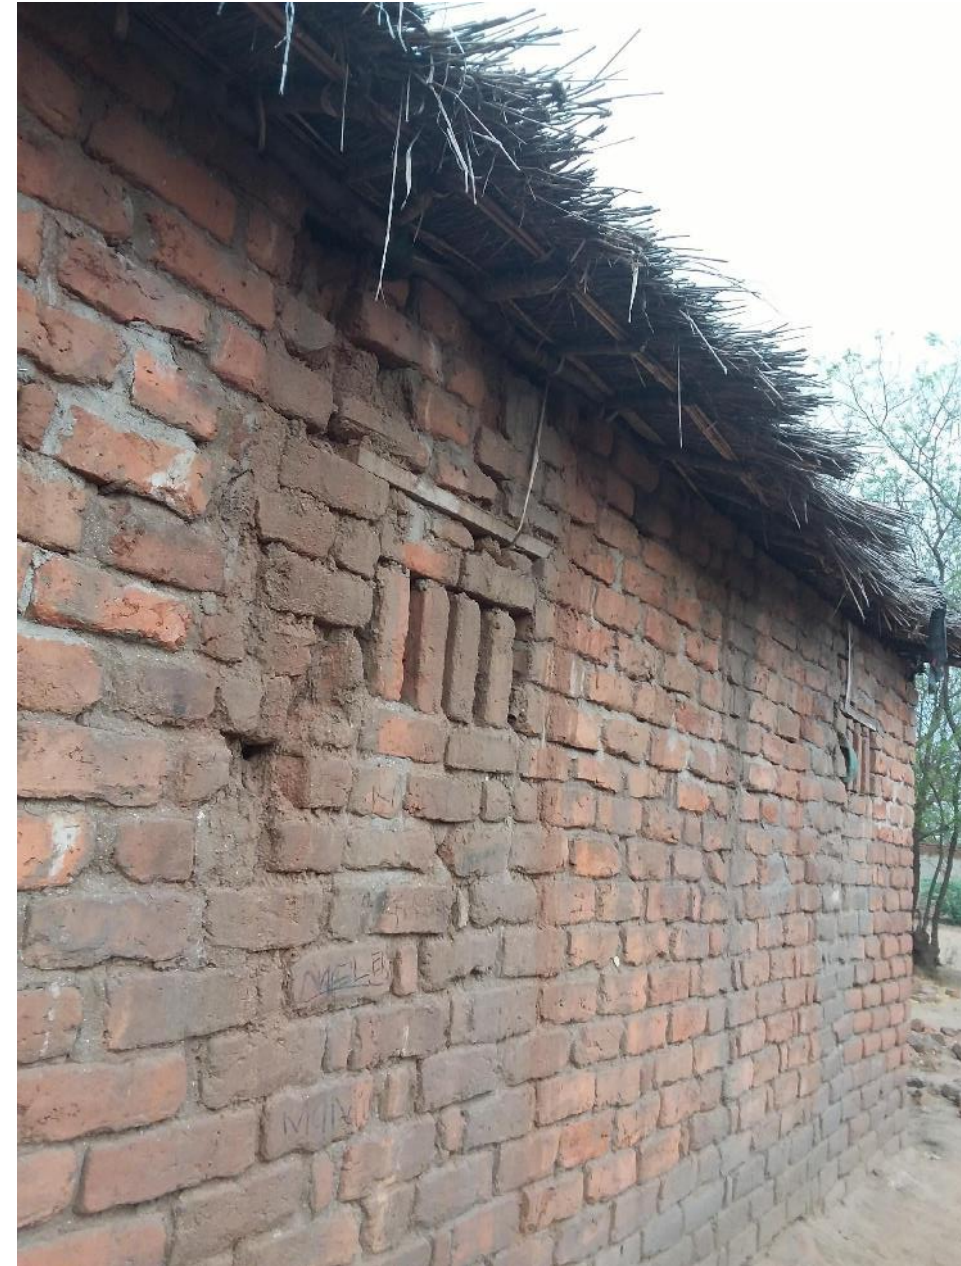
- Roofing not well thatched to protect from leaking and strong winds
- Exposed walls cannot stand heavy prolonged rainfall
- Most houses are built without foundations

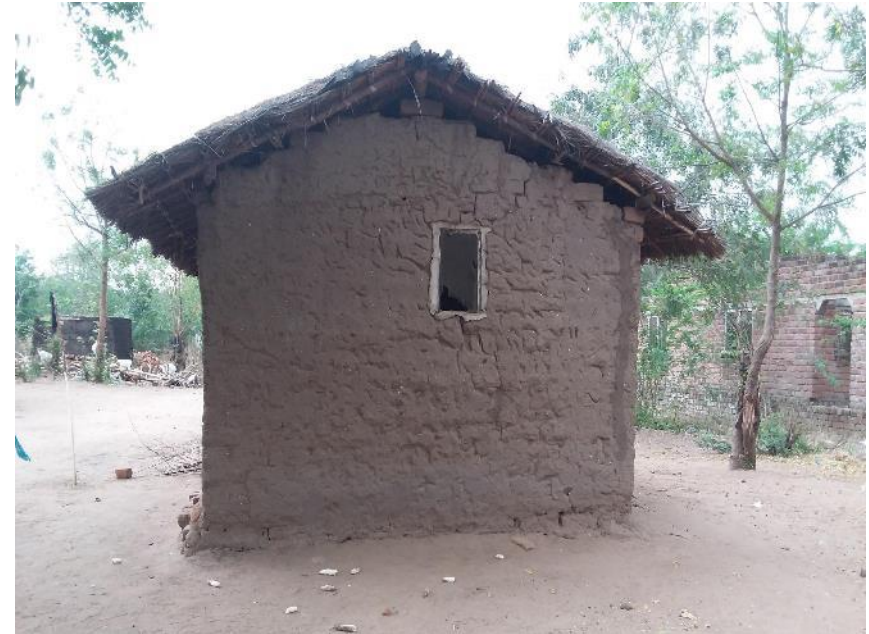
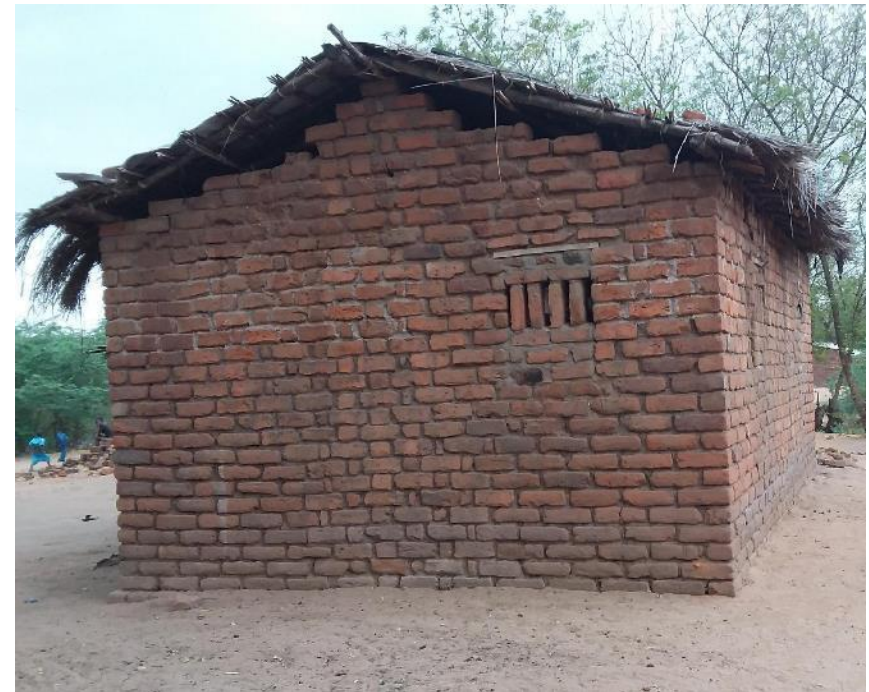
- Few houses with foundations they don't use Damp-Proof Membrane after foundations
- Most house has no plinth wall to protect foundation from soaking.
- No adequate windows for ventilation and lighting
- Lack of gauze wire on opening for mosquito protection being a malaria area

Most house walls are not cladded, and floors are not smeared

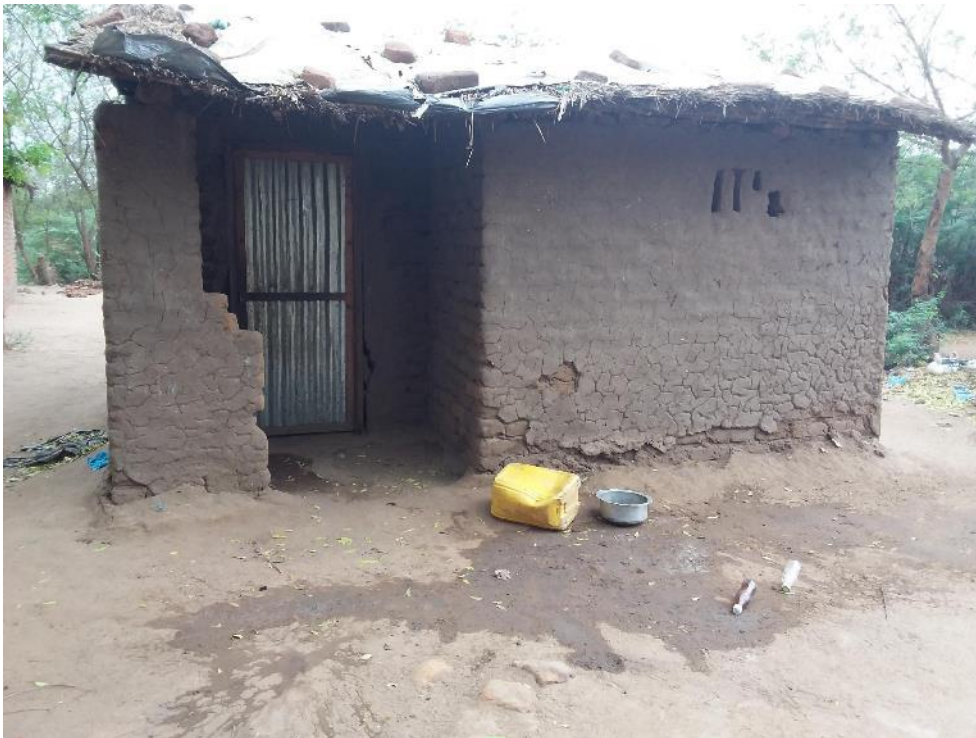
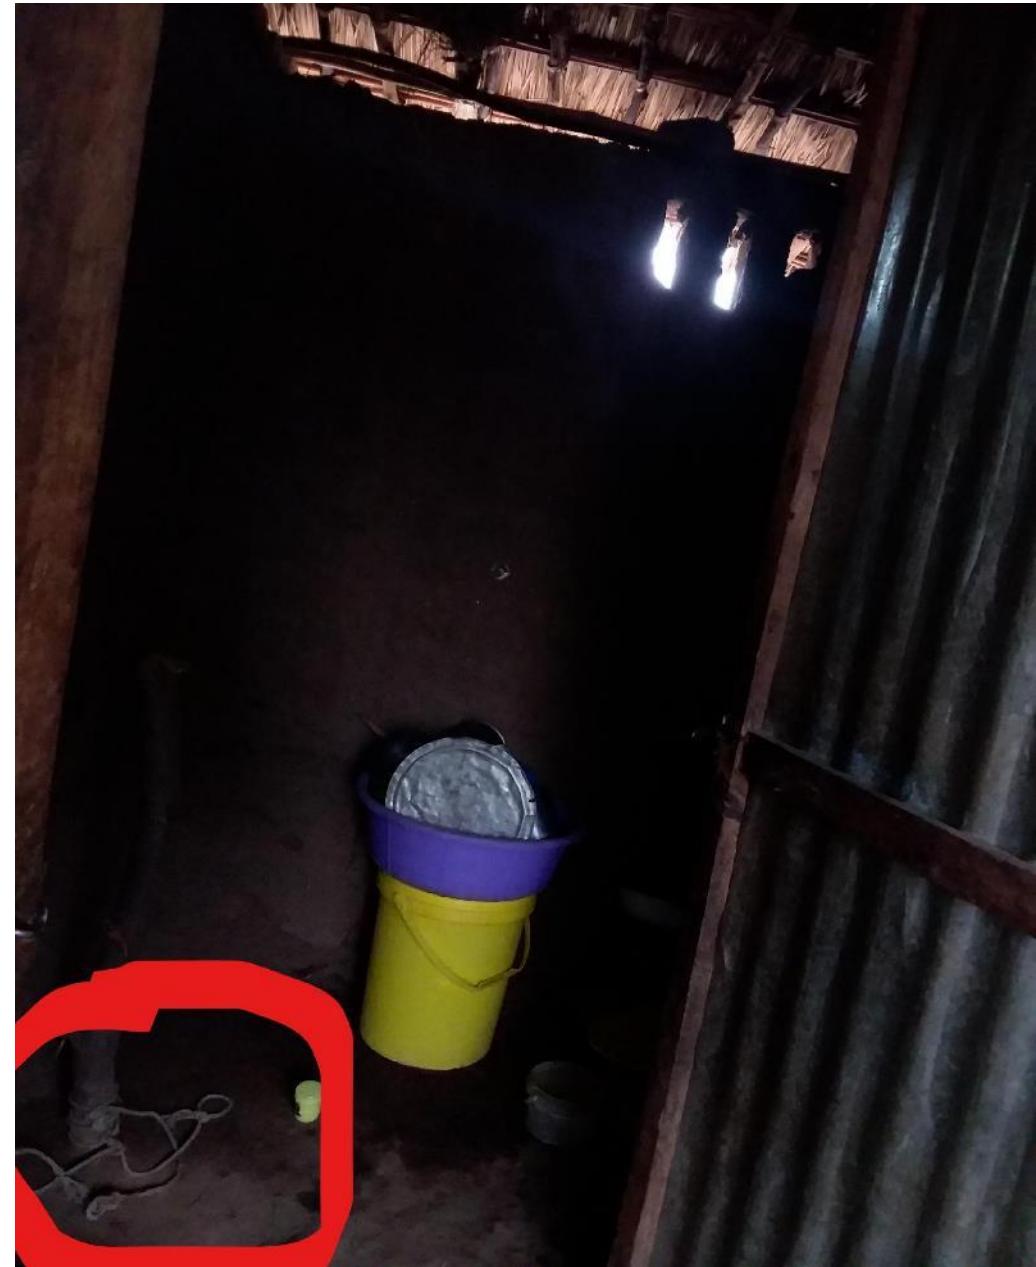
- health hazard as some household sleep with livestock in their houses due to security issues.

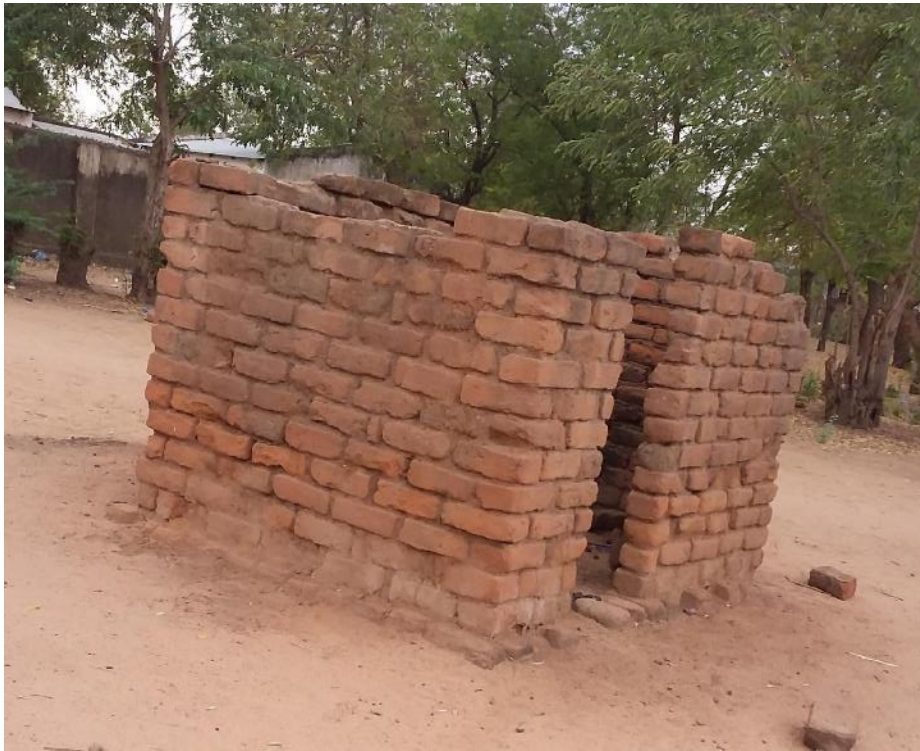
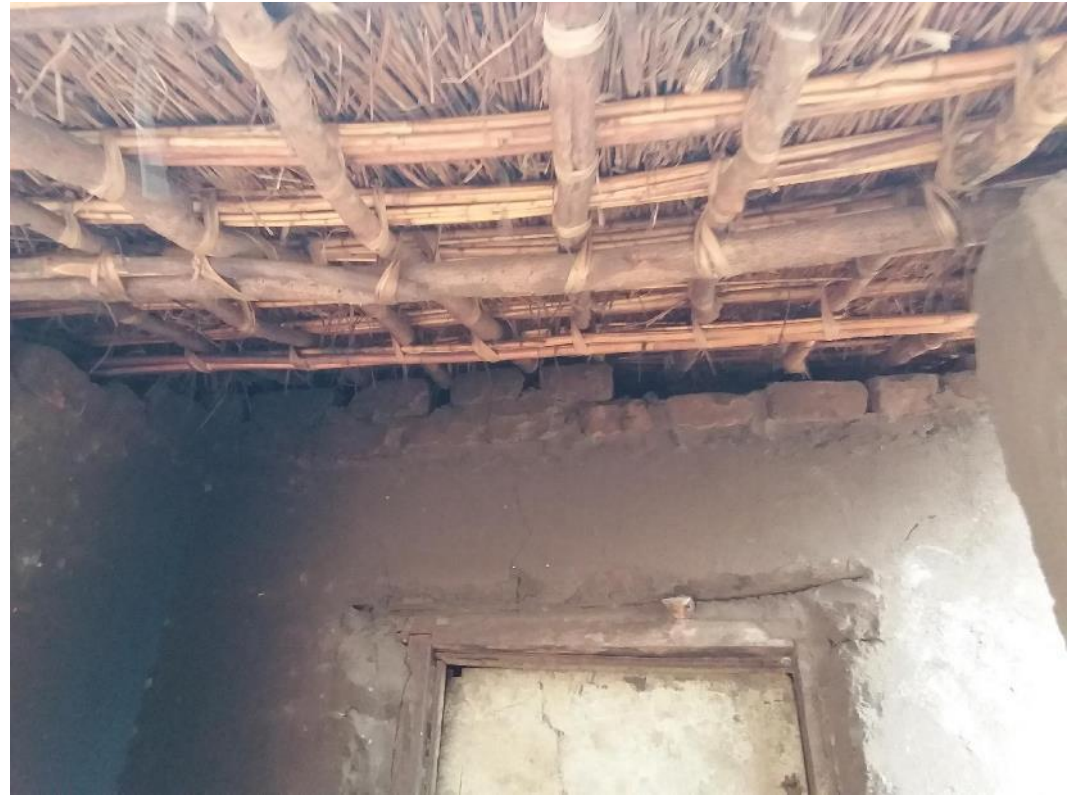
- Roof not tied to walls with tie wire/linear thread hence prone to winds

- Latrines have no roofing and thus not safe during rainy season
- Use of weak burnt bricks
