Assessment of Individual Transitional Housing constructed by the DRD in Thandwe Township

Transitional Shelter constructed by a Contractor

Draft Minimum Technical Standards for Transitional Shelter

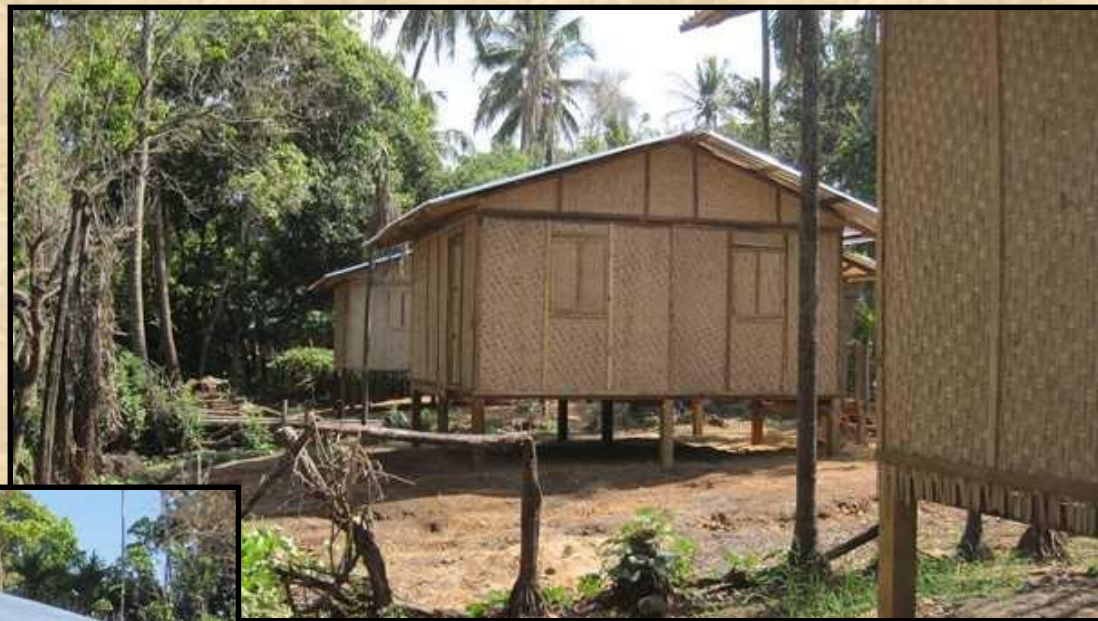
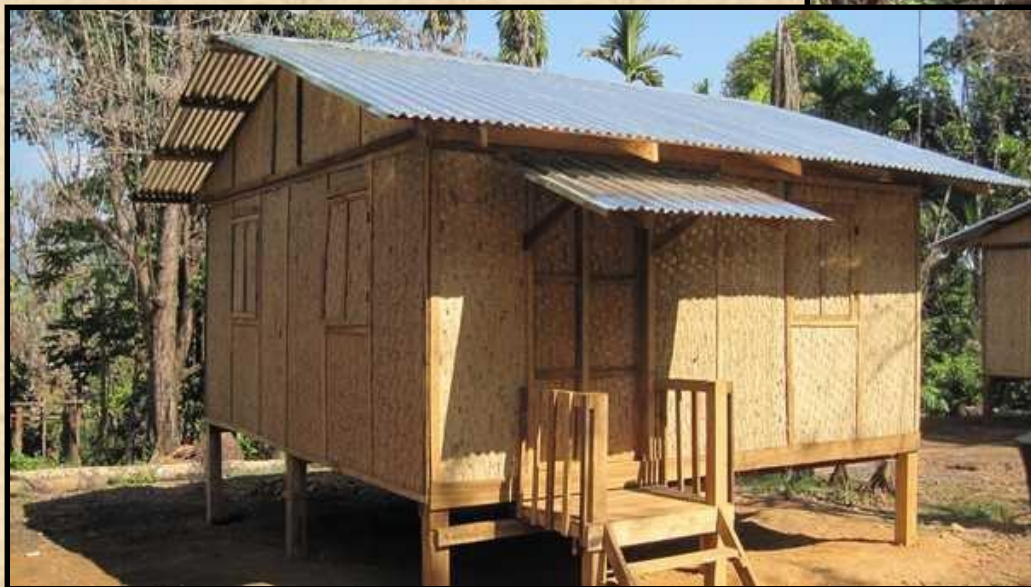
- Small Floor Area [16ft x 15ft]
- No Kitchen Area
- No Partition Walls
- No Area for Rice Storage

- Lower Quality Workmanship / Materials
- Single Design
- No Anti-Pest Treatment

- Preferred implementation strategy:
 - **Cash Grants** with supporting **Technical Assistance**
- **Private Building Contractors:**
 - *Reduce the sense of ownership*
 - *Increase the risks of sub-standard workmanship*
- BoQs must reflect '**real**' **market prices**
- **Local Carpenters** require capacity building prior to construction
- **Full-Time Engineers** required on-site throughout
[Technical Assistance & Monitor Workmanship]

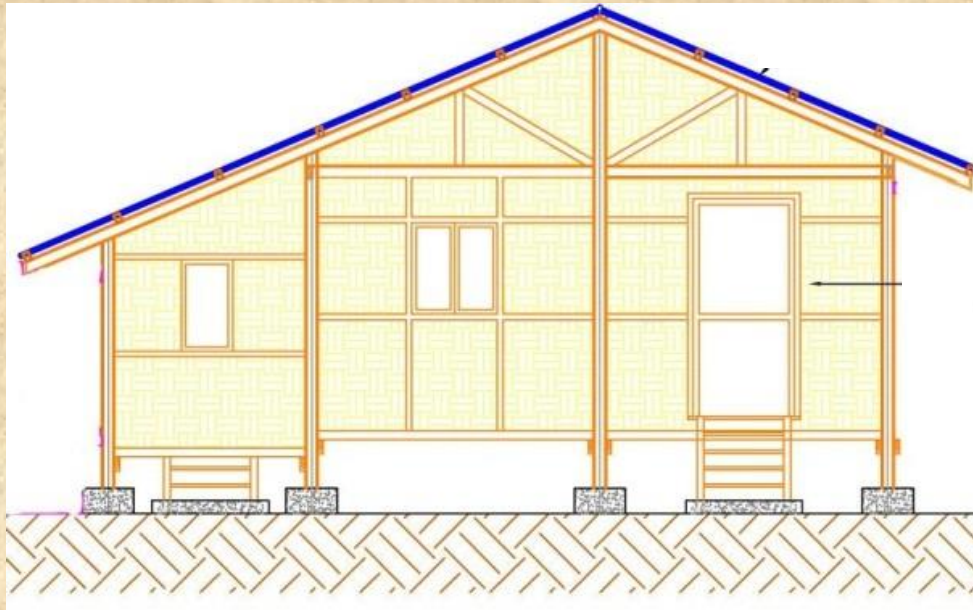
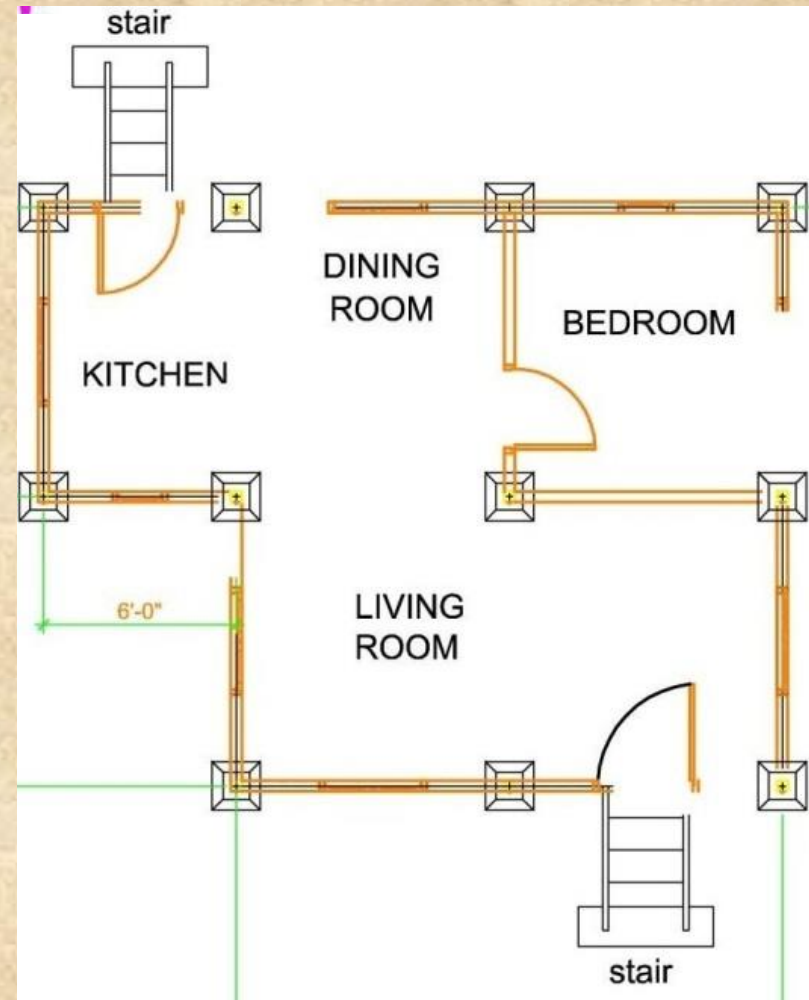
- Floor Area: (18ft x17ft) + Kitchen (9ft x 6ft)
- Concrete Footings
- 5 " x 5" Scantling Timber Columns
- Planked Floor
- Bamboo Mat Walling
- Thatched Roof
