## 1: Modified Ladder Beam

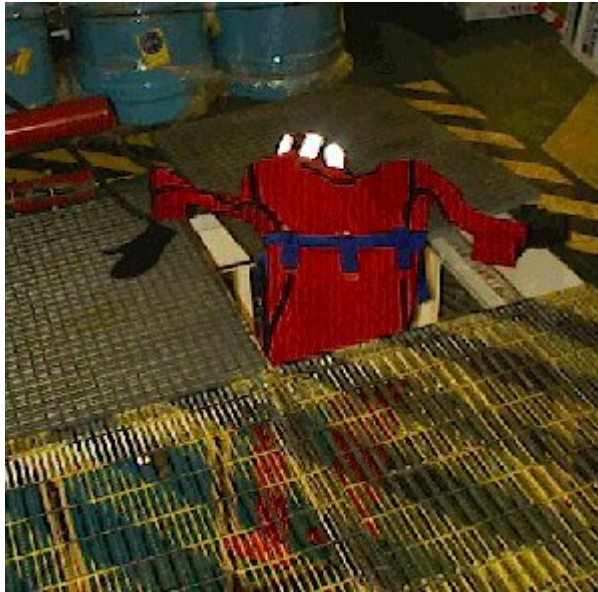
| Lessons Learnt: | 1. Grating section undersized and able to move horizontally enough to slip off beam. 2. Cargo handling operations on grating had loosened clamps fixing grating to beam. |

| Recommendations: | 1. Replace all undersized gratings. 2. All gratings to be bolted to support beams. 3. The grating maintenance routine will now include how clamps should be tested, e.g. lever to check if loose etc. 4. Consider highlighting of clamps with a coloured spray paint to help locate them. 5. |

Clamp type and design to be reviewed where clamp performance is questionable.
