## 171: Failure of Isolations

Summary: As residual fire water drained from joint, drop in pressure caused the fire pump to start

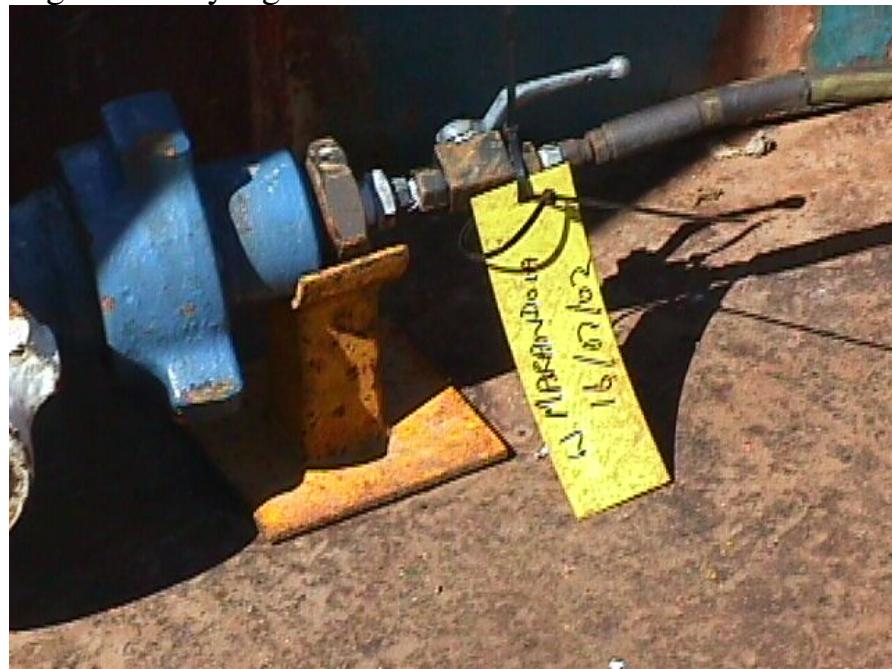
High visibility tag in use.

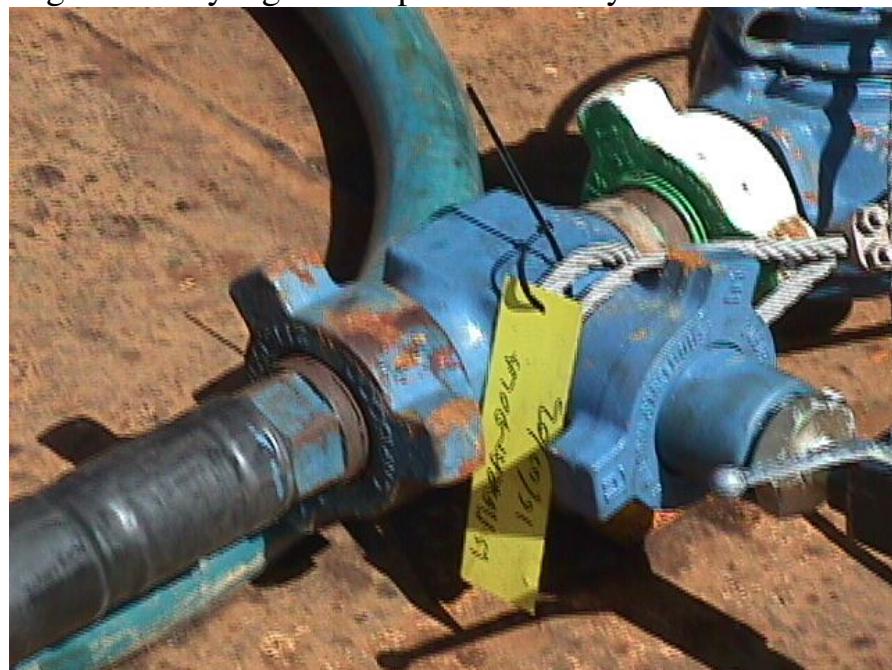
High visibility tag on a T-piece assembly

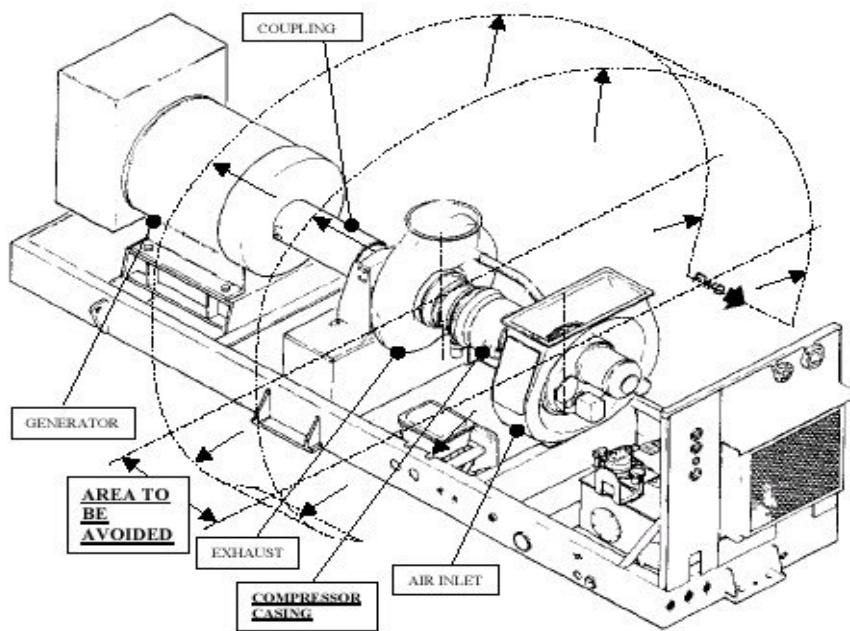
Figure 1. Typical Saturn® 10 Generator Set

Recommendations: Solar recommends that in order to avoid possible injury to personnel, users are cautioned to advise all personnel to avoid the area adjacent to the compressor section during an engine start and while the engine is in operation. See figure 1 for the locations of the engine area to be avoided. Users are also advised to ensure that all maintenance checks are performed on all package systems including control system and safety shutdowns, vibration monitoring, fuel, and fire systems and ensure that all are operating properly as set forth in your Operation and Maintenance Manuals.

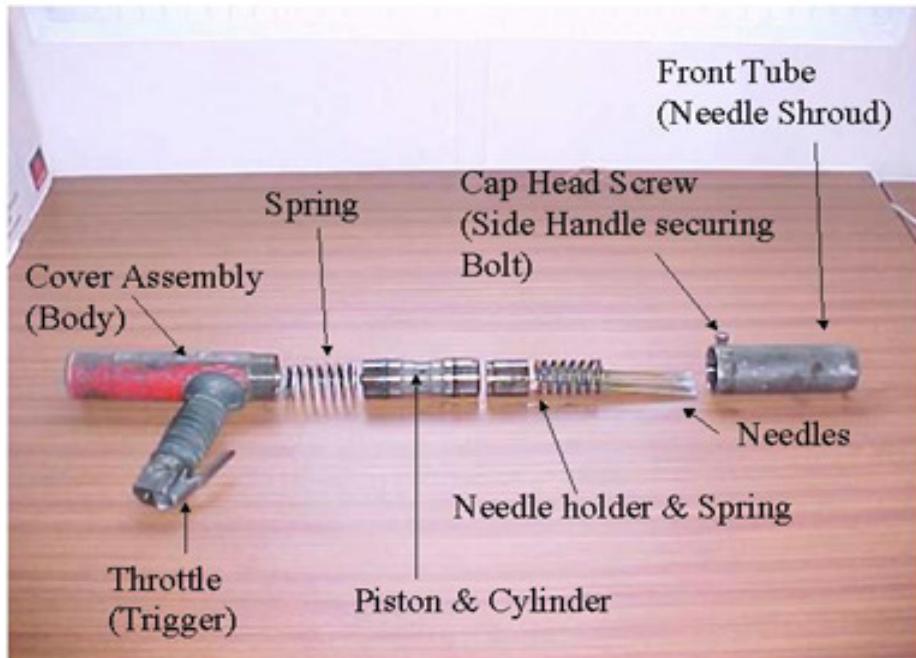
### Needle Gun Overview

Summary:	During operation, the needle shroud on a needle gun became detached allowing the piston and cylinder to fly out.
Incident consequences (potential or actual):	<i>No details available.</i>
Cause of accident or incident:	<i>No details available.</i>
Activity Location:	*Any Location Type
Activity Type:	*Any Activity Type
Description:	While being operated the needle shroud on a needle gun became detached allowing the piston and cylinder to fly out, with the potential to cause injury. The follow-up investigation concluded that the presence of water in the air supply and the repeated, rapid operation of the trigger mechanism to remove it had caused the retaining screw on the needle shroud to work loose and the shroud to unscrew
Specific Equipment:	<i>No details available.</i>
Lessons Learnt:	<ol style="list-style-type: none"><li>1. The rapid operation of the trigger to remove water from the line was a common practice but not covered by procedures or manufacturers recommendation.</li><li>2. An on/off isolation valve was not located in the air hose near the tool as recommended by the tool manufacturer.</li><li>3. The quality of the air required to operate the needle gun had not been communicated to the compressor supplier and thus the unit was not provided with a means of removing moisture.</li><li>4. Operators should be aware of the requirement to</li></ol>

- Recommendations:
1. Ensure that the specification of the equipment for air supply are compatible with the requirements of the needle gun (or other air tool) manufacturer.
  2. Ensure that all operators of needle guns (or other air tools) are aware of the procedures to follow in the event of water being present in the air supply, e.g. using suitably located drain points.

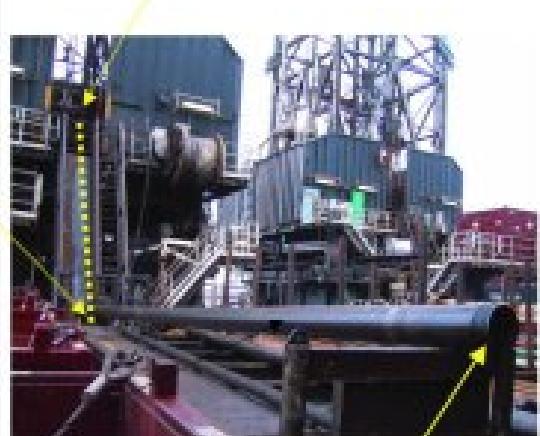
As casing moves away from crane boom the pin end rises and clears the end of the catwalk striking an upright stanchion 2.5m up.

Casing Joint  
10m long  
weight 900 kg

Recommendations: 1. The risks associated with the operation to pull and lay down casing should be reviewed in light of this incident and any associated procedures and work guidelines should be revised accordingly. 2. Any lifting operation to transfer loads between the drill floor and the pipe-deck should be under the control of a responsible person who should ensure that the work is planned, work guidelines are communicated to all personnel and the work is executed safely. 3. The competence of all Crane Operators should be verified. 4. An engineering review should be carried out to determine if alternative means of mechanical handling could be used; eg the addition of a catwalk tugger would eliminate the need to use the platform crane in this operation.
