### 301: HP Grease Gun Cartridge Holder Failure

Summary: Correct procedure for changing the grease cartridge in the high pressure grease guns.

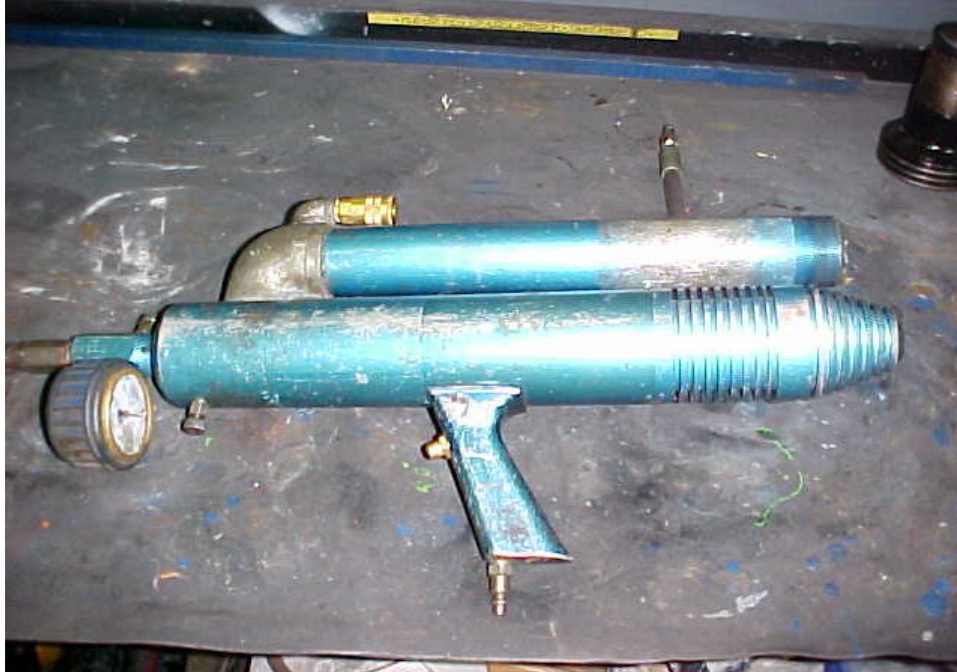
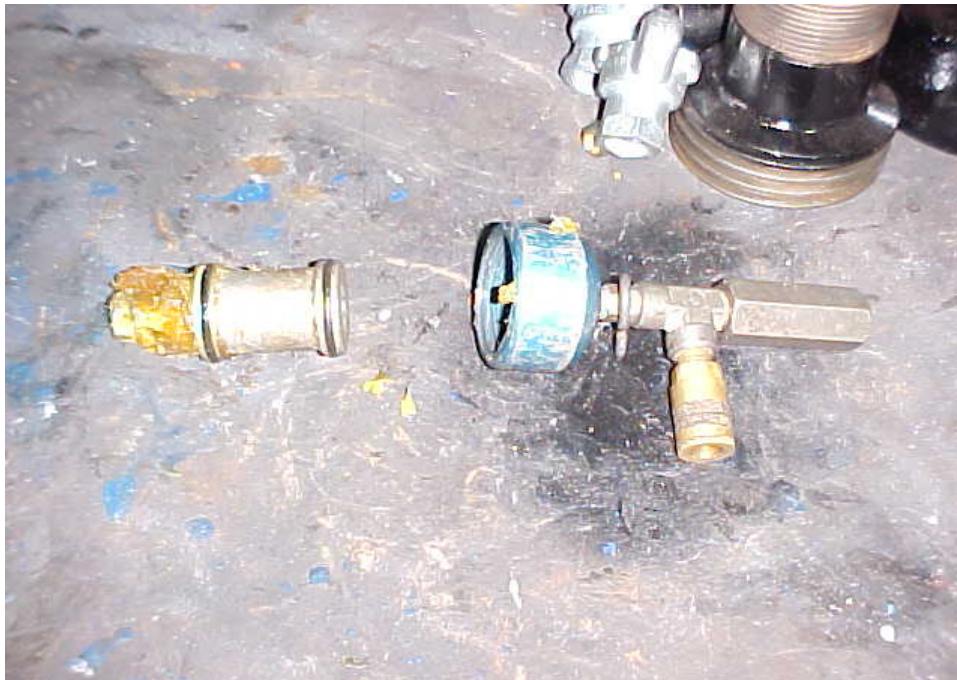
Description: Two new trainees were changing a grease cartridge in a high-pressure grease gun (used to grease treating equipment). The air had been bled off and the air pressure used to force the piston to the "out" position so that the new cartridge could be fitted. The end of the gun has to be screwed off to allow the cartridge to be positioned; the air pressure had been trapped between the piston and the end cap. The last few threads were not able to hold the cap & it blew off under pressure and hit the near by wall. Had there been any person in its way it could have caused a nasty incident, it also went out with a loud bang on ejection.

Lessons Learnt: Inadequate procedures and training.

Recommendations: Correct procedures for replenishing the grease gun were sought from FMC, an authorised user list drawn up & all persons on the list made aware and given a copy of the changing procedures.

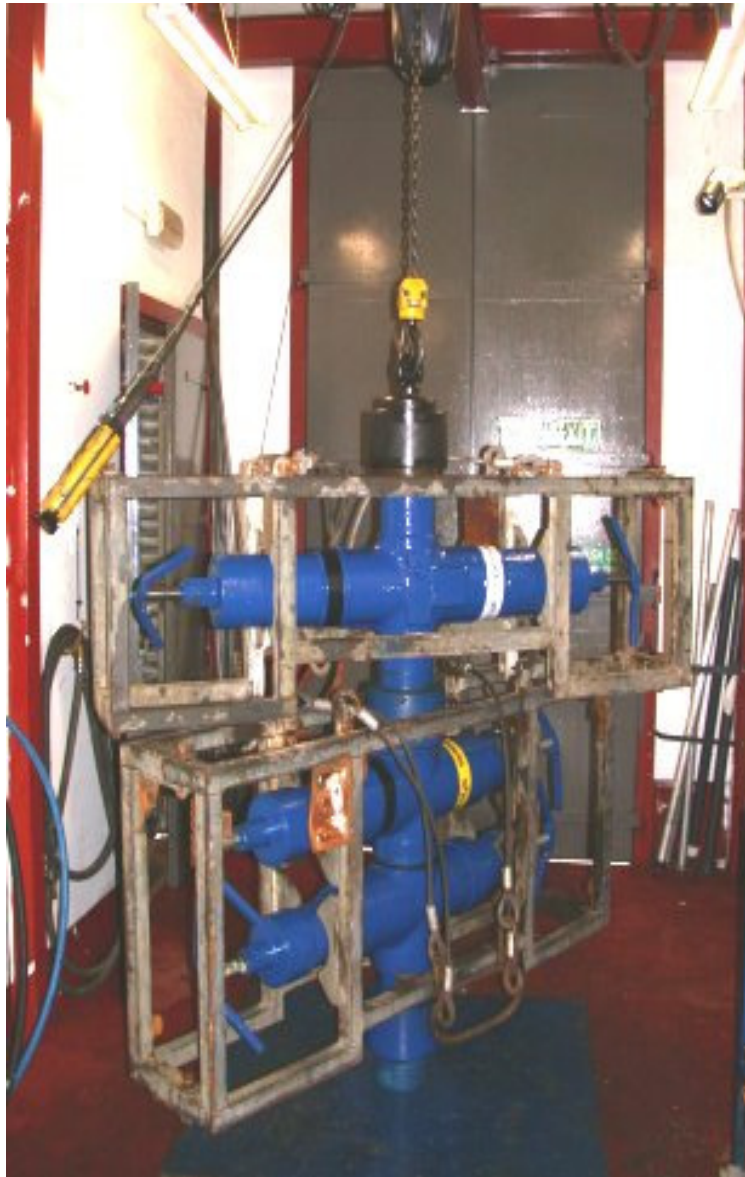
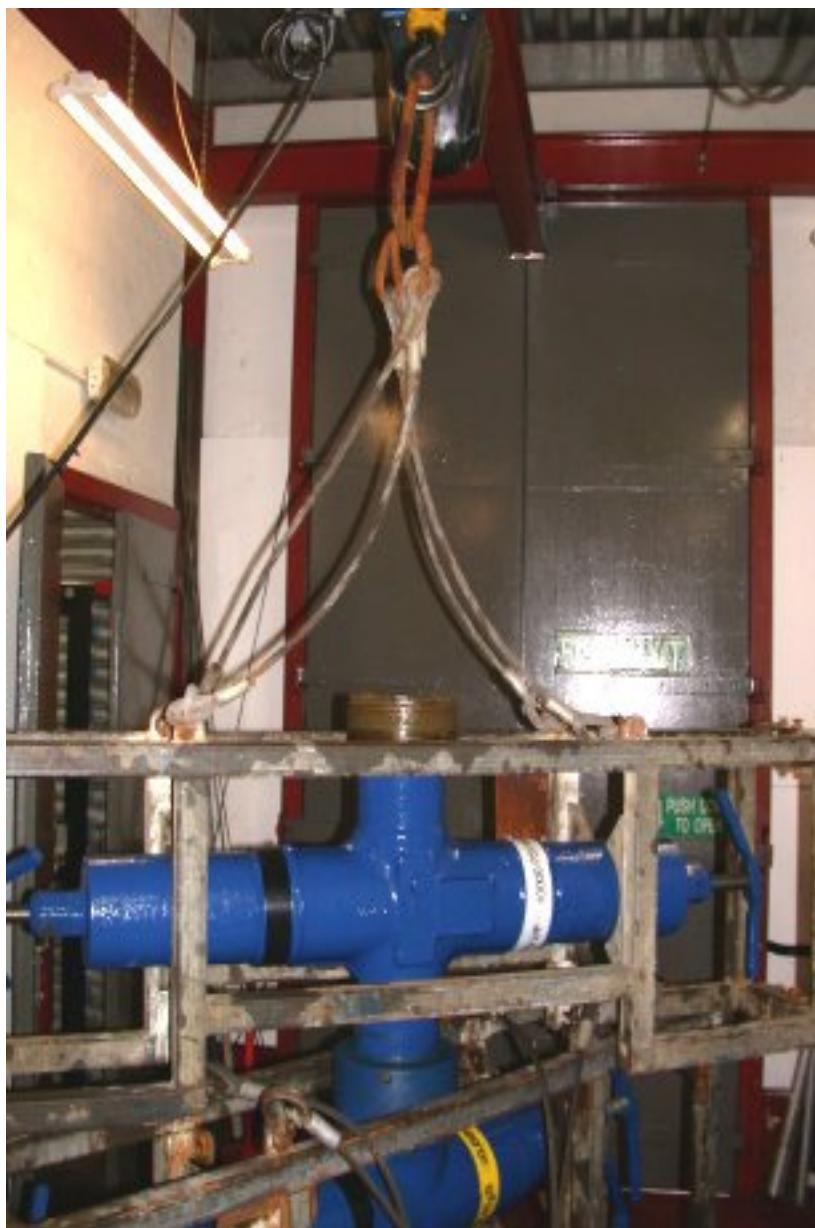
Summary:	Correct safe procedure for lifting made up Wireline BOP's.
Incident consequences (potential or actual):	<i>No details available.</i>
Cause of accident or incident:	<i>No details available.</i>
Activity Location:	Fixed Installation
Activity Type:	Production operations
Description:	Correct safet procedure for lifting made up wireline BOP's. Personnel are making up 2 BOP's and lifting them with the upper BOP cage sling assembly. This assembly is then being used above its rated SWL. When 2 BOP's are lifted already made up the correct method for lifting them is to use the 3 ton certified blank lifting cap. This may require the use of a certified shackle since the hook may not fit the ring bolt in the cap. The wrong and right methods for lifting 2 BOPS are shown below.
Specific Equipment:	<i>No details available.</i>
Lessons Learnt:	BOP'S have a cage installed around them rigged and certified for lifting the BOP on which the cage is installed.

Task Description:	<i>No details available.</i>
Recommendations:	All personnel involved in WHE operations
Contact Details:	Gordon Richmond Support Supervisor - Wireline Tel: (01224) 728000

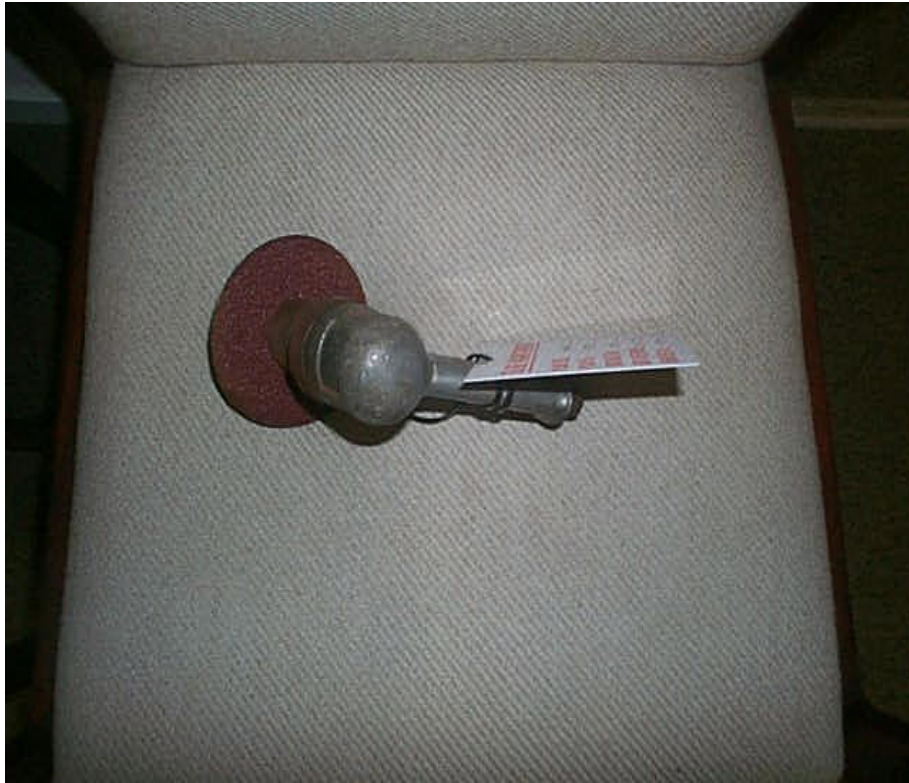
Summary: During maintenance/ testing of a 4" air operated sander recently the fitter received an abrasion to the index finger of his left hand. Investigation into the incident revealed that one of the root causes of the injury was that a 4" P24 abrasive disc had been used as a backing disc with the abrasive surface towards the rear of the machine.

backing discs, using this incident as an example. Conduct random checks of next three months to ensure this bad practice has been eradicated.

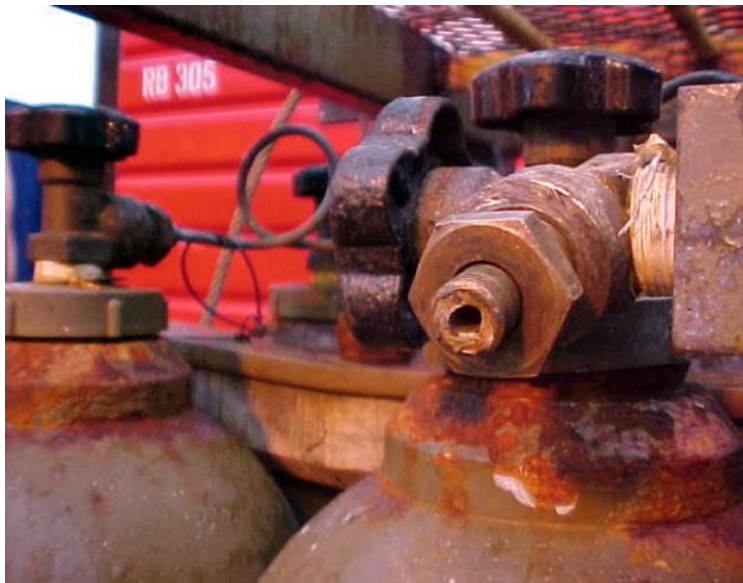
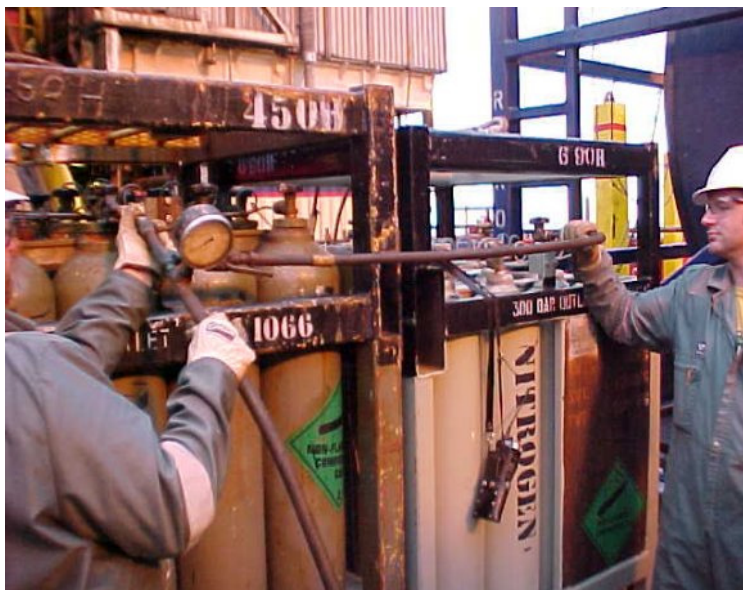
Summary: Fracture of Fittings on Nitrogen Quads During CT Reel Purging Operations

Recommendations: Inform staff of incident and highlight potential areas of risk in similar operations.

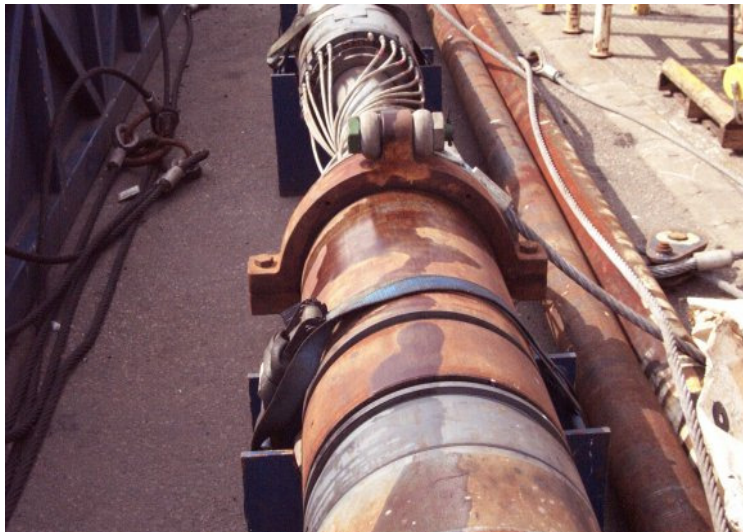
Summary: Finger Broken & Crushed While Preparing Sentree 7 Lifting Clamp

Recommendations: To raise awareness that Sentries 7 Lifting clamp alignment pins must be fitted. To raise awareness that all potential hazards must be identified and correct control measures taken.

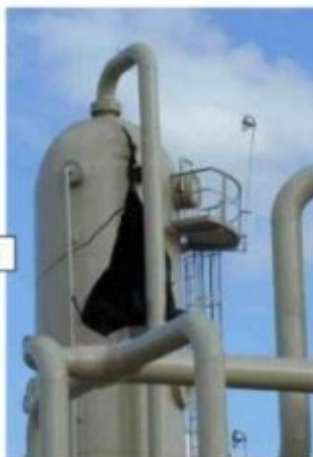
The root cause of the incident is not fully known but there was some thought that hydro-testing with "very cold" water was a contributing factor.

Fortunately no injuries occurred.
