Thermowell Safety Alert for Step Change

Janice A

Temperature measurements in compressor

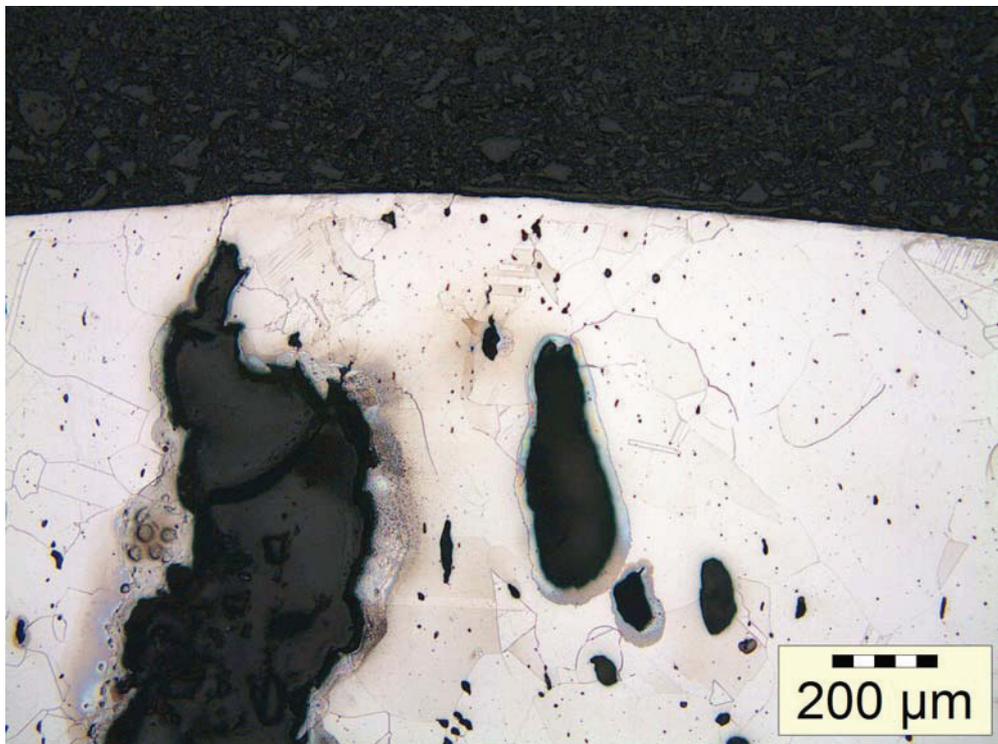
Picture 4

The thermowell was found to have small through-wall cracks through which the hydrocarbons leaked. Further and more detailed testing indicated the presence of relatively large shrinkage cavities in the body of the fitting, (pictures 2 and 3). The presence of these cavities, along with vibration in the plant from the gas compressors, caused the cracking. These cavities should not be present and were caused as a result of faulty manufacturing process.

Small cracks developed from the shrinkage cavities to the metal surface as a result of vibration.

1. Operators may wish to check the certification on thermowells they may have purchased to establish if any of them come from this same batch number. If any do, they may wish to plan to change them out.
2. The manufacturer did carry out all the tests identified on the order, but none of these would have found this defect type. Therefore, Operators may wish to consider specifying additional inspections at the supply stage for thermowells on high pressure hydrocarbon service to check for sub-surface defects.
