## Overfill of Helifuel Tank and Subsequent Ignition

# SAFETY ALERT

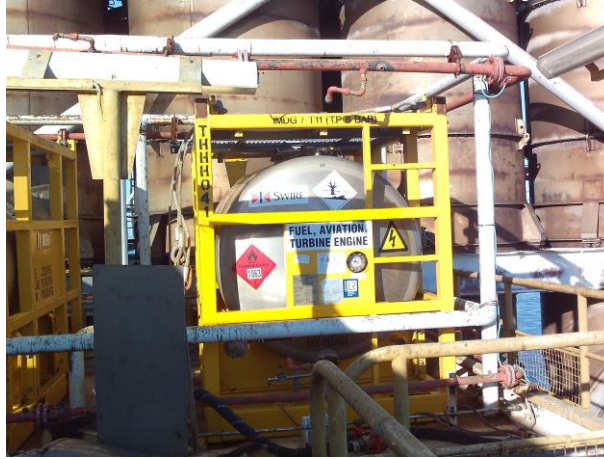
During the non-routine transfer of aviation fuel from one tank to another, an overfill of the tank occurred resulting in the release of approximately 0.57kg of aviation fuel through an open vent line on the recipient fuel tank. The released aviation fluid was projected onto nearby turbine exhaust pipework and subsequently ignited for a short period of time before self-extinguishing. Transfer operations were immediately suspended and the power turbine was shutdown.

The direct cause of the incident was determined to be an inaccurate level gauge which lead to the tank being filled beyond capacity.

The transfer of fuel between tanks was a non-routine operation - normally the platform crane would be used to replace helifuel pods. However, the crane was unavailable.

No detailed risk assessment or procedure had been completed for the task.

- Ensure the level indication is functional and subject to routine maintenance.
- Ensure non-routine transfer operations are subjected to sufficient risk assessment and develop a detailed temporary transfer procedure.
- When transferring between tanks, do not use two tanks of the same volumetric capacity, use a smaller supply tank.
