High personal H2S monitor reading during priming of gas compressor lube oil pump

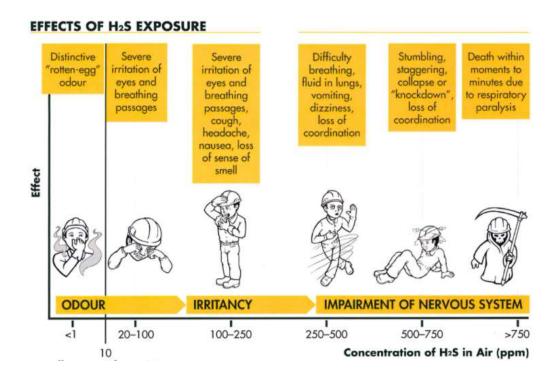
Prior to starting the gas compressor, the lube oil pump required to be primed by bleeding the pump via a vent valve. As the Operator was completing this task, he noticed a smell of gas from the vent followed by his H_2S monitor alarming. He immediately closed the vent, moved away from the area and informed the control room. The H_2S monitor was inspected and found to have a reading of 65ppm.

The investigation into this incident found a general theme of lack of awareness or adequate consideration of the hazard posed by increasing concentrations of H_2S within fuel gas. The MOC process, which was followed to implement the improvement i.e. to vent gas from the Compressor lube oil pump seals, did not sufficiently consider the

location of the vent point relative to the position of the Operator when opening the vent valve. The procedure which was updated to include this step when starting up the gas compressor did not include a warning of the H_2S hazard. There was also a perception amongst the offshore operations team that because this was a controlled, short-duration release of gas, there was no significant health hazard. Additionally, it was the opinion of the investigation team that the hazard posed by the gradual increase in H_2S concentrations within fuel gas over the last 1-2 years was not recognised (hazard creep) and that there was not adequate communication of this from the onshore asset team.

- Consider location of vent points relative to the position of operators when opening vent valves
- Ensure adequate general awareness of H2S hazards and specific to site
- Ensure Task Risk Assessments capture all hazards present and the controls
- Carry out a Dynamic Risk Assessment / 20 second scan at site prior to commencing work
