Near Miss – Casing stud failure on water injection pump

SAFETY ALERT

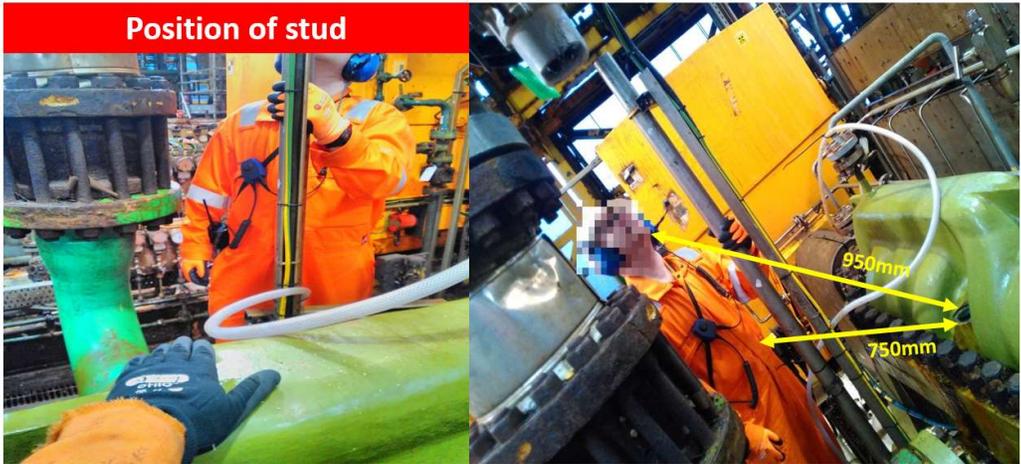
This was a high potential, near miss incident, related to an API 610 BB3 style of pump, specifically a 6x8x12.5" MSD 7 stg. The fastener was a 1.75" UN stud (BS 4882 GR B7). It was not designed to see or withstand sea water corrosion. However, the pump casing

was. The pumpset was reliable and was being operated within all recommended operating parameters. It was pumping de-aerated sea water. The pump materials were standard for a sea water injection pumpset. There was no condition monitoring data in alarm. The pump had been in service for an excessive period with only minor routine maintenance having been conducted. The fastener failed due to erosion and corrosion.

Cleaned area of erosion leak path to the fastener from last stage impeller (approx. 120barg), these channels are small approx. 0.75mm wide by 0.25mm deep, however this is enough to allow the sea water to get to the fastener. Hydraulic vortex erosion under this 120 barg is the estimated failure mode, this has also damaged/destroyed the gasket at this point

5. Are there any planned maintenance routines in place to inspect or schedule pump overhaul?
6. As part of pump overhaul, consider coating the two long casing fasteners to minimise corrosion/erosion effects if the pumped fluid does get to them, HVOF tungsten carbide suggested. This relates to fasteners 14 and 34 in this alert, the ones closest to the shaft and the last stage impeller. Only the area of the stud closest to the casing join requires additional protection.

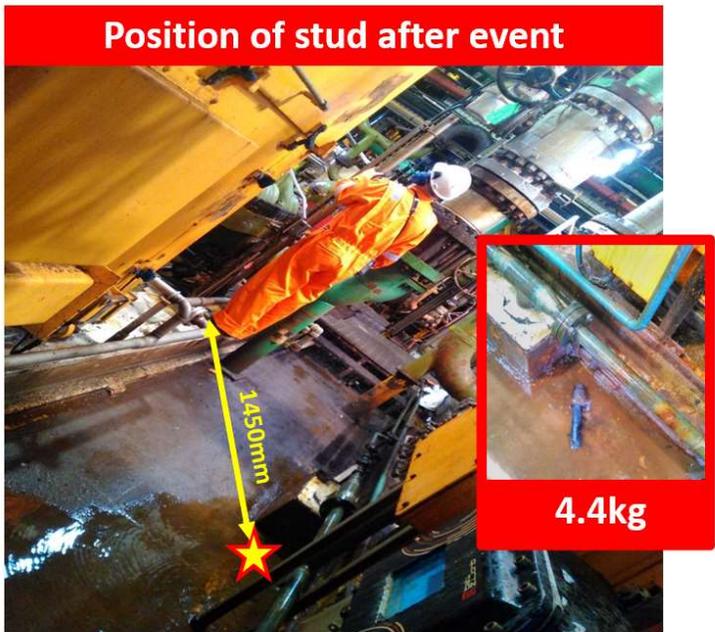
This is the failed fastener, cleaned, showing evidence of corrosion and erosion damage.

Orange arrow shows corrosion
