CONNECTING DATA TO DECISIONS

Linking Total Transformer Monitoring & Actionable Information
to Drive Business Value for Utilities

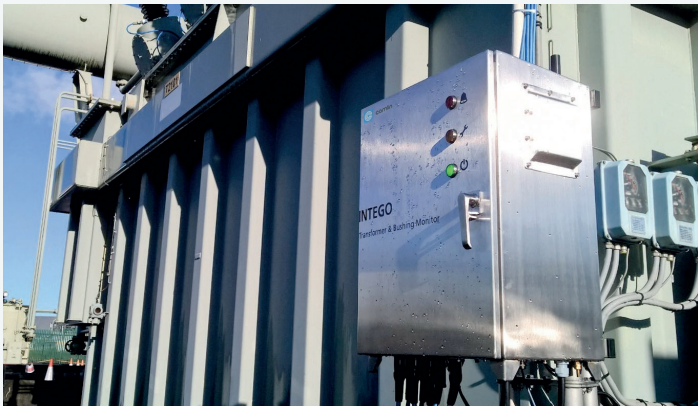
However, it was noticed that while the increase of capacitance in bushing A was quite small, both bushings B and C were showing a decrease of capacitance. This led to the assumption that the test setup was different when readings were taken. In order to take this into consideration, the relative difference between capacitance A and B was analysed over time. It was then possible to spot that this difference was quite constant in 2012 and 2014 (below 2 pF), while it was significantly high in 2015, exceeding 12 pF (roughly equal to 2.7% of capacitance increase).

Figure 1. Capacitance increase in bushing A1 and high energy event recorded at the same time.

It was then found that at the precise moment of the bushing capacitance increase, a high energy event (partial discharge activity with significantly high magnitude, generally equal or higher than 20 V peak-peak [6]) was recorded in the same phase (from same sensor) by the online monitoring system. In this case, the recorded event had just 8 pulses per second and it happened just once. The fact that this event was recorded in conjunction with the capacitance increase was an important detail that prompted an additional offline test: oil sampling from the bushing and Dissolved Gas Analysis (DGA). Table 2 reports the results of the DGA analysis for bushings A and C. It can be clearly seen that the amount of acetylene in bushing A is well above the tolerance values, being 76 ppm; while level of acetylene in bushing C was zero, as expected.

Following the results shown in Table 2, South Korean Transmission Company promptly planned and executed the bushing replacement within a few months, thus saving the bushing from a potentially catastrophic incident. It must be noted that both the capacitance change and the repetition rate of the high energy event were quite small in terms of absolute magnitude. But being able to detect both these phenomena online and see that they occurred in the same moment provided crucial information enabling South Korean Transmission Company to take a very successful action.

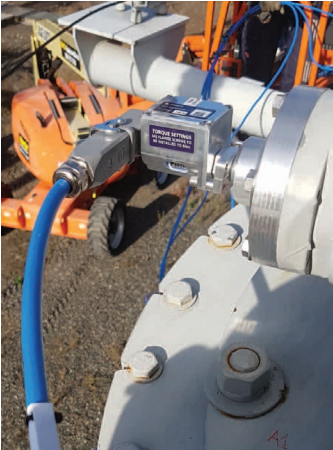
Figure 2. Bushing tap adaptor for partial discharge and bushing monitoring

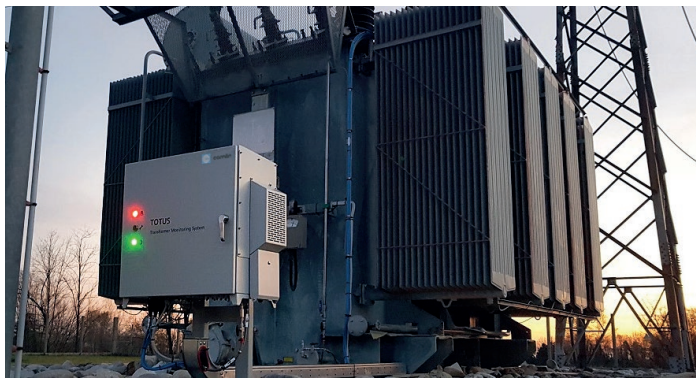
Figure 1. Online holistic monitoring system installed in 25 MVA GSU

Since the new gas pattern was not actually showing “hot metal” gases and considering that the H₂ increase was significant and coincidentally occurring right after the maintenance, the generation company suspected that the defect was somehow related to the latest maintenance. The utility equipped the transformer with a comprehensive transformer monitoring system that included a five-gas monitor and modules for monitoring moisture, partial discharges, and bushings, as well as analytics capabilities and temperature readings.
