CONNECTING DATA TO DECISIONS

Linking Total Transformer Monitoring & Actionable Information
to Drive Business Value for Utilities

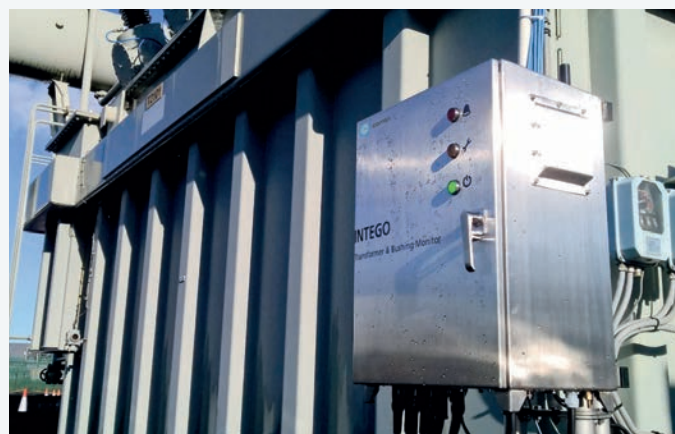
345 kV NGK Bushing OFFLINE Capacitance C1 (pF)				
	2012	2014	2015	Increase since 2012
Bushing A	435	429	438	0.60%
Bushing B	433	430	426	-1.60%
Bushing A-B	+2 pF	-1 pF	+12 pF	2.7%

However, it was noticed that while the increase of capacitance in bushing A was quite small, both bushings B and C were showing a decrease of capacitance. This led to the assumption that the test setup was different when readings were taken. In order to take this into consideration, the relative difference between capacitance A and B was analysed over time. It was then possible to spot that this difference was quite constant in 2012 and 2014 (below 2 pF), while it was significantly high in 2015, exceeding 12 pF (roughly equal to 2.7% of capacitance increase).

This offline test was not conclusive but led to further investigation of the online data.

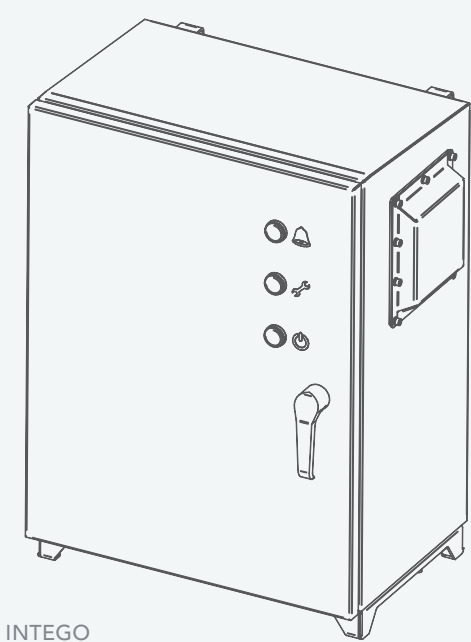
Following the results shown in Table 2, South Korean Transmission Company promptly planned and executed the bushing replacement within a few months, thus saving the bushing from a potentially catastrophic incident. It must be noted that both the capacitance change and the repetition rate of the high energy event were quite small in terms of absolute magnitude. But being able to detect both these phenomena online and see that they occurred in the same moment provided crucial information enabling South Korean Transmission Company to take a very successful action.

South Korean Transmission Company was able to take a very successful action thanks to the correlation of online data showing small variations of capacitance and partial discharges.

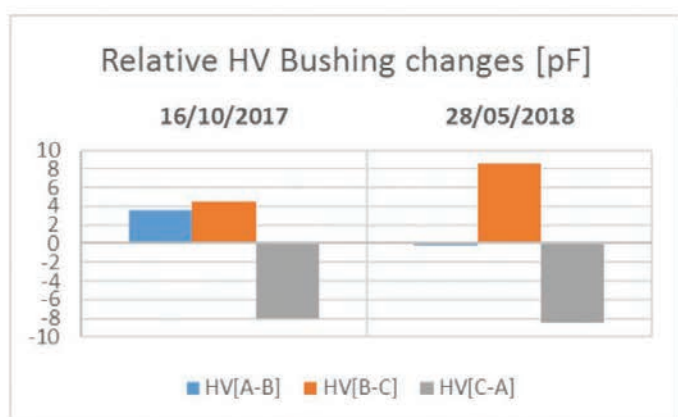
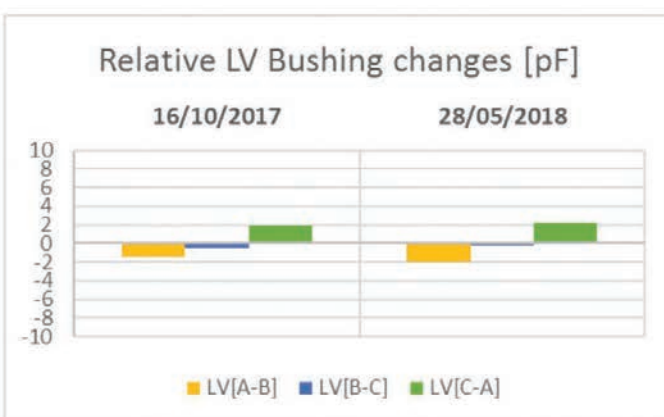
For the above reasons, Camlin evaluated the relative deviation between the phases and the results compared between the two measurement sessions:
