Case Study 1  
South Korean Transmission Company

# SOUTH KOREAN TRANSMISSION COMPANY REPLACES BUSHINGS DUE TO ONLINE MONITORING

South Korean Transmission Company successfully replaces 345 kV bushing.

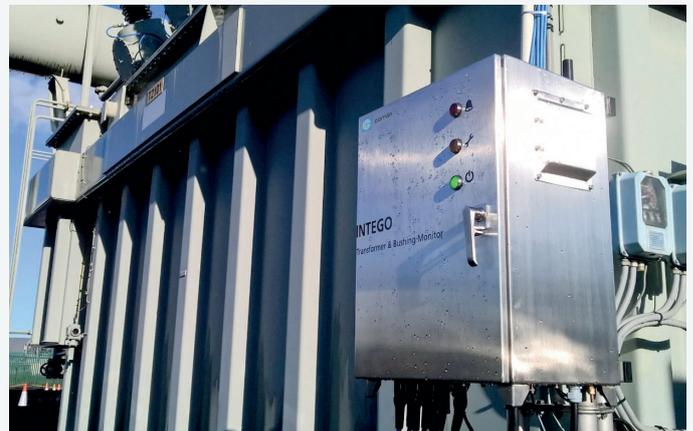
On February 2015, a sudden step increase of the capacitance (C1) in bushing A was detected by the monitoring system, estimating a capacitance change in the order of 1.7% which corresponds to a rough increase of 7 pF. Such a small change could have been caused by a partial short circuit between two layers in the condenser core, considering >60 control layers for 345 kV bushings. South Korean Transmission Company planned an offline test to confirm the online readings, but the results proved difficult to interpret. Indeed, the absolute value of bushing A capacitance had not changed significantly from the previous measurements, as shown in Table 1.

However, it was noticed that while the increase of capacitance in bushing A was quite small, both bushings B and C were showing a decrease of capacitance. This led to the assumption that the test setup was different when readings were taken. In order to take this into consideration, the relative difference between capacitance A and B was analysed over time. It was then possible to spot that this difference was quite constant in 2012 and 2014 (below 2 pF), while it was significantly high in 2015, exceeding 12 pF (roughly equal to 2.7% of capacitance increase).

This offline test was not conclusive but led to further investigation of the online data.

Following the results shown in Table 2, South Korean Transmission Company promptly planned and executed the bushing replacement within a few months, thus saving the bushing from a potentially catastrophic incident. It must be noted that both the capacitance change and the repetition rate of the high energy event were quite small in terms of absolute magnitude. But being able to detect both these phenomena online and see that they occurred in the same moment provided crucial information enabling South Korean Transmission Company to take a very successful action.
