Title: Static water penetration testing of the Barracuda brick slip system

Report No: N950-22-18406

**Title:** Static water penetration testing of the Barracuda brick slip system

**Customer:** James & Taylor Ltd,  
Sixty-Two, Barwell Business Park,  
Leatherhead Road, Chessington, Surrey KT9 2NY.

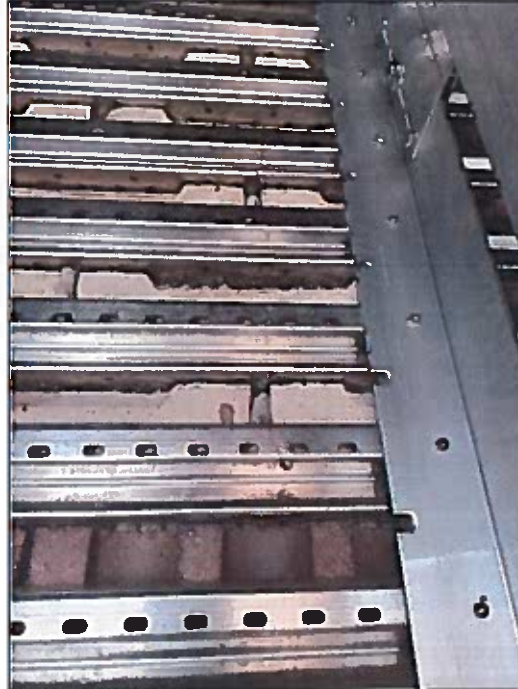
PHOTO 081302

At zero pressure minor water leakage was observed seeping through some of the brick slips and running down the rails.

The water leakage rate and area increased with increased pressure and was across all the brick types. The water was confined to the back of the bricks and rails and ran down to the base of the sample where it would drain out through a ventilated cavity.

INTERNAL VIEW DURING WATER TEST

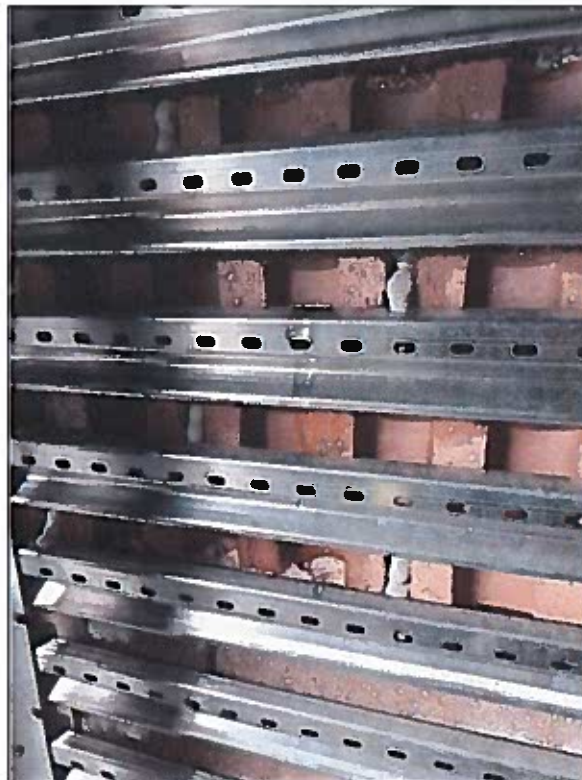
PHOTO 081411

INTERNAL VIEW DURING WATER TEST

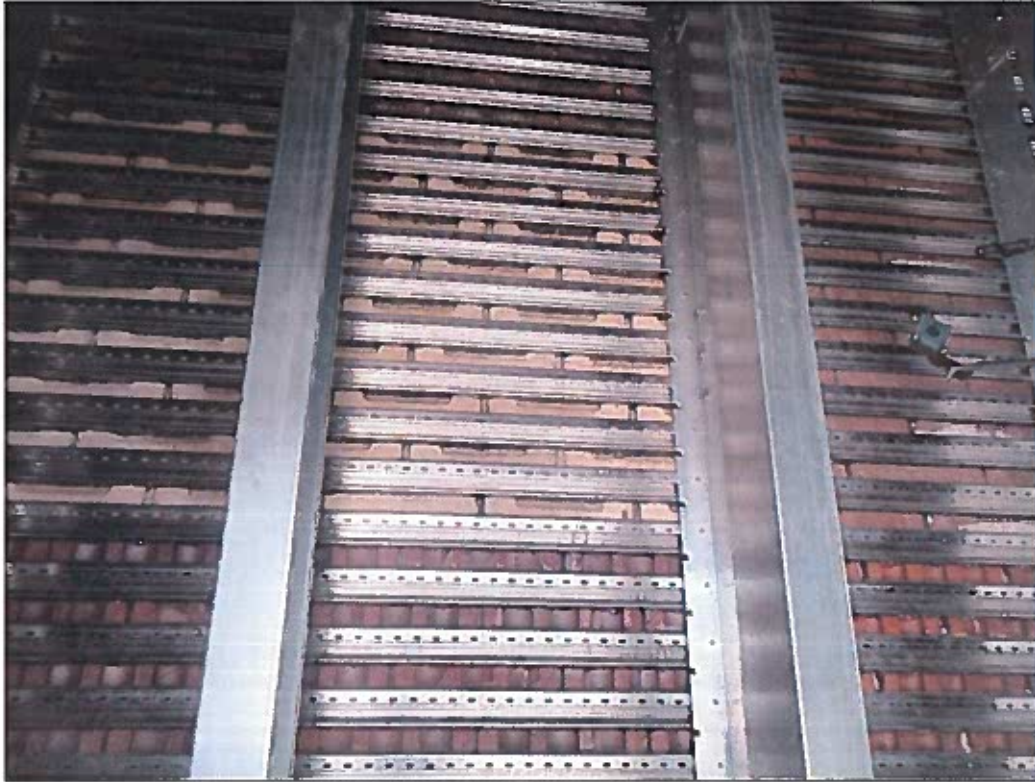
PHOTO 5147

After 1 minute into the test, slow dripping was observed down the back of the bricks/rails.

During the test period the amount of water leakage remained constant and was confined to the back of the tiles and support rails. The water drained out at the base of the sample through drainage holes.

INTERNAL VIEW DURING TEST

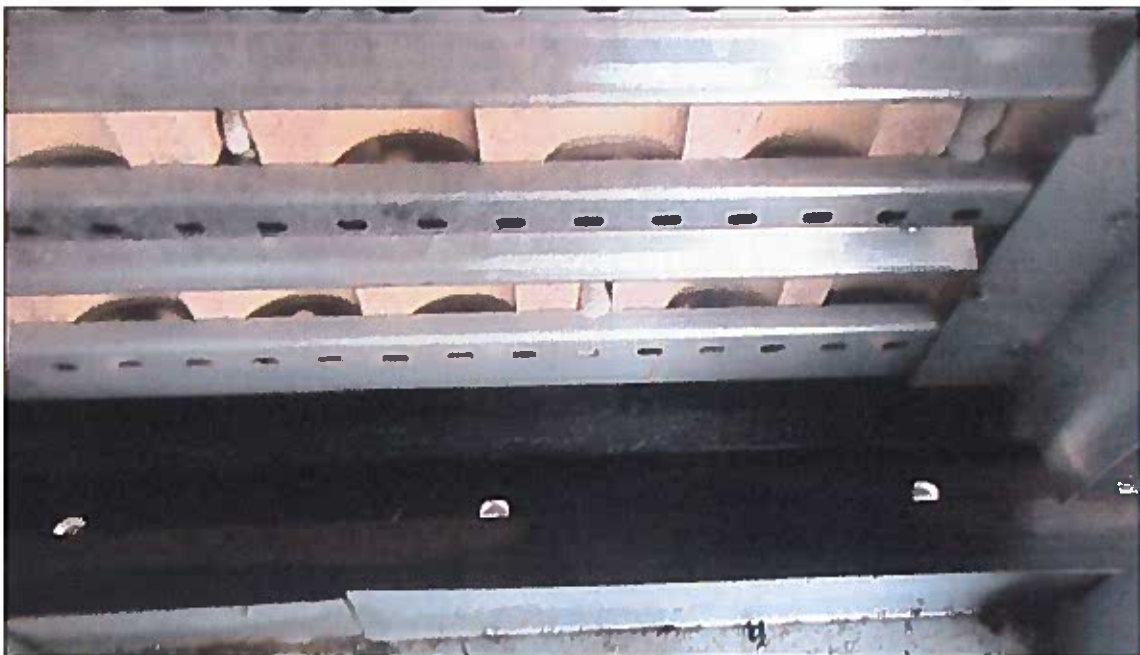
PHOTO 5149

INTERNAL VIEW DURING TEST

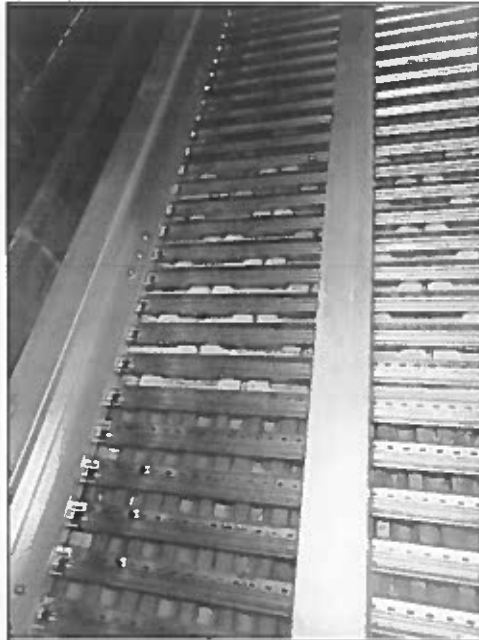
PHOTO 5151

INTERNAL VIEW DURING TEST

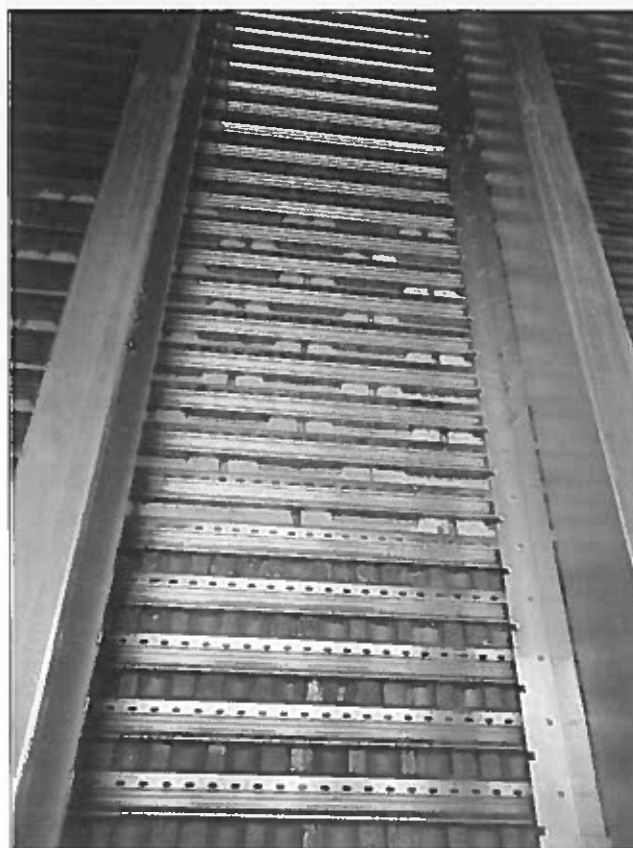
PHOTO 5152

INTERNAL VIEW DURING TEST

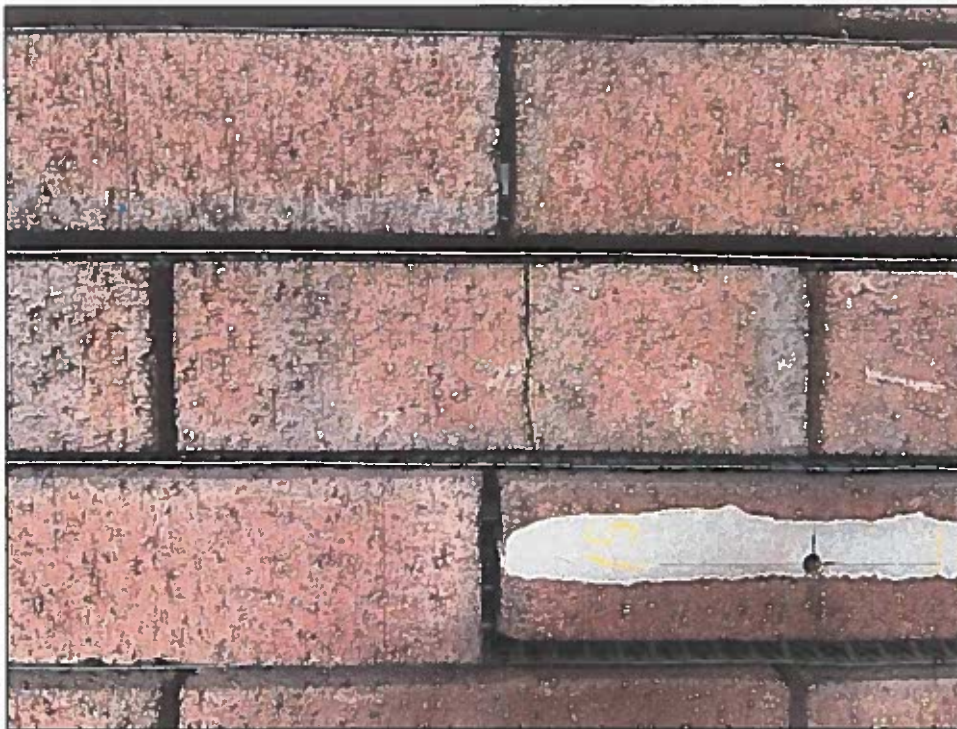
PHOTO IMG\_9310

| Location | Impact energy (J) | Observations | Classification |
|---|---|---|---|
| 1 | 10 | Crack through full height of tile | Low risk |

IMPACT LOCATION 1

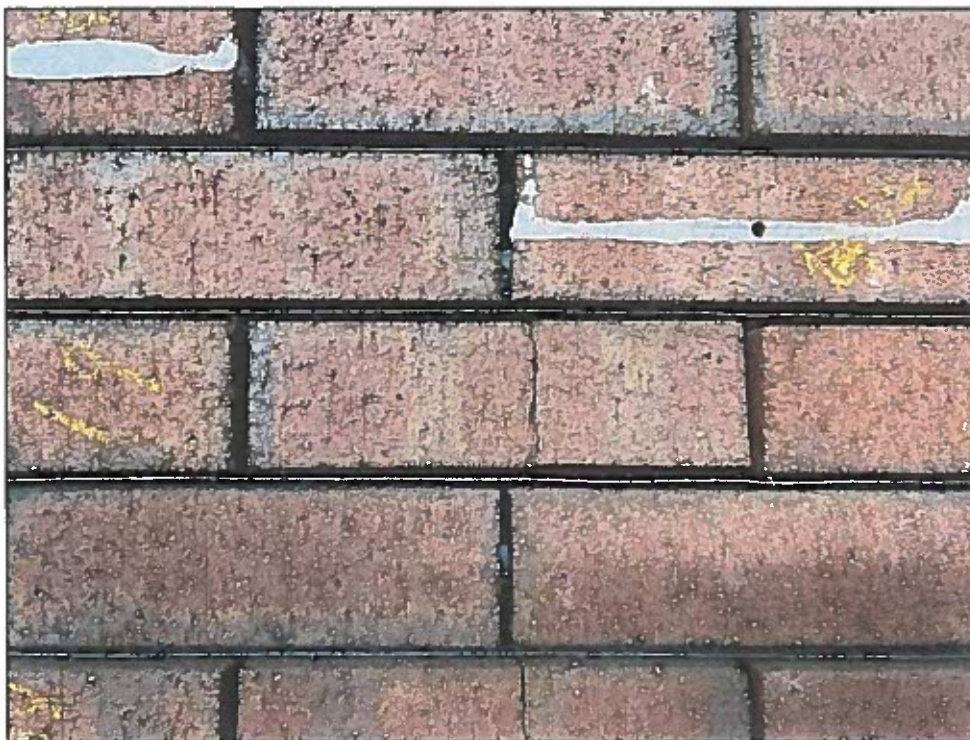
PHOTO IMG\_9312

| Location | Impact energy (J) | Observations | Classification |
|---|---|---|---|
| 2 | 10 | Crack through full height of tile | Low risk |

IMPACT LOCATION 2

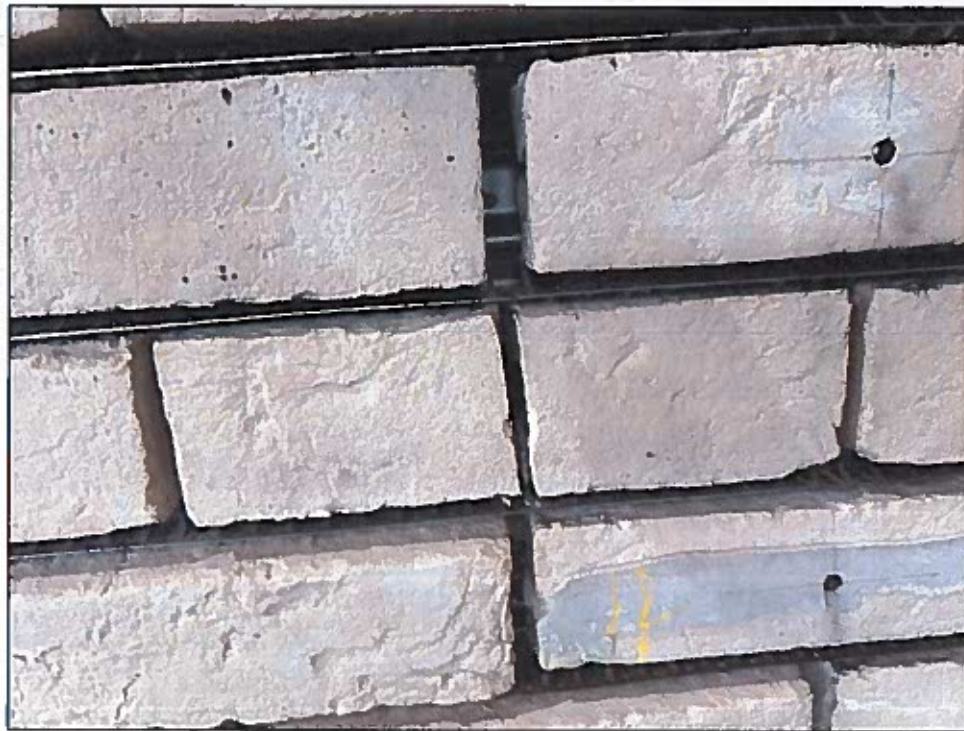
PHOTO IMG\_9314

| Location | Impact energy (J) | Observations | Classification |
|---|---|---|---|
| 3 | 10 | Crack through full height of tile.<br>Small chip to corner of brick | Low risk |

IMPACT LOCATION 3

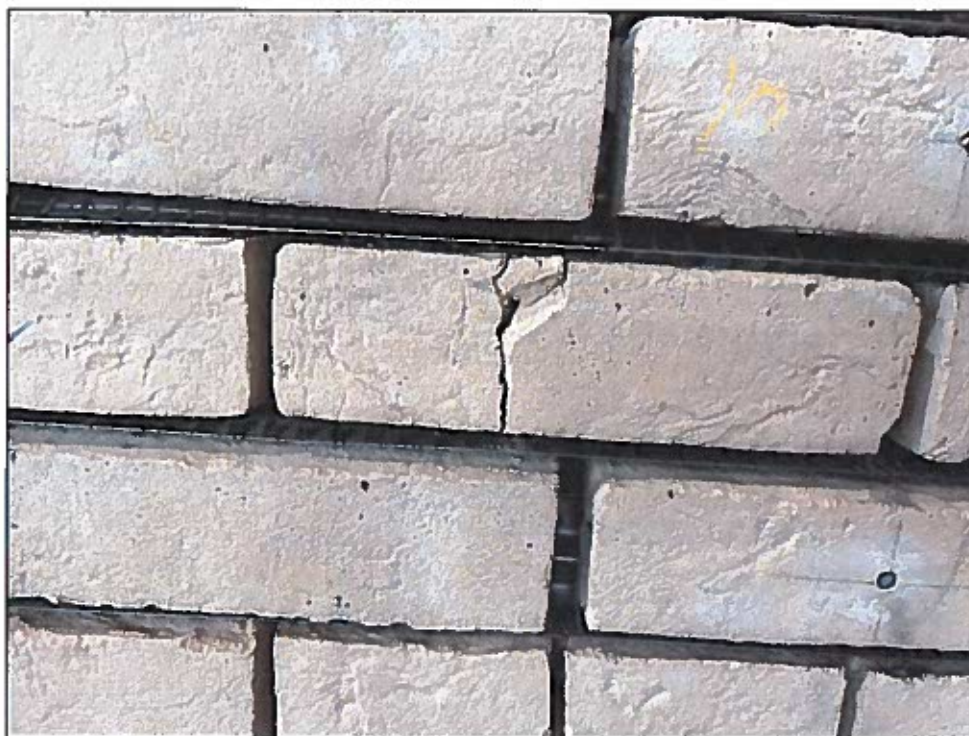
PHOTO IMG\_9316

| Location | Impact energy (J) | Observations | Classification |
|---|---|---|---|
| 5 | 10 | Crack through full height of tile | Low risk |

IMPACT LOCATION 5

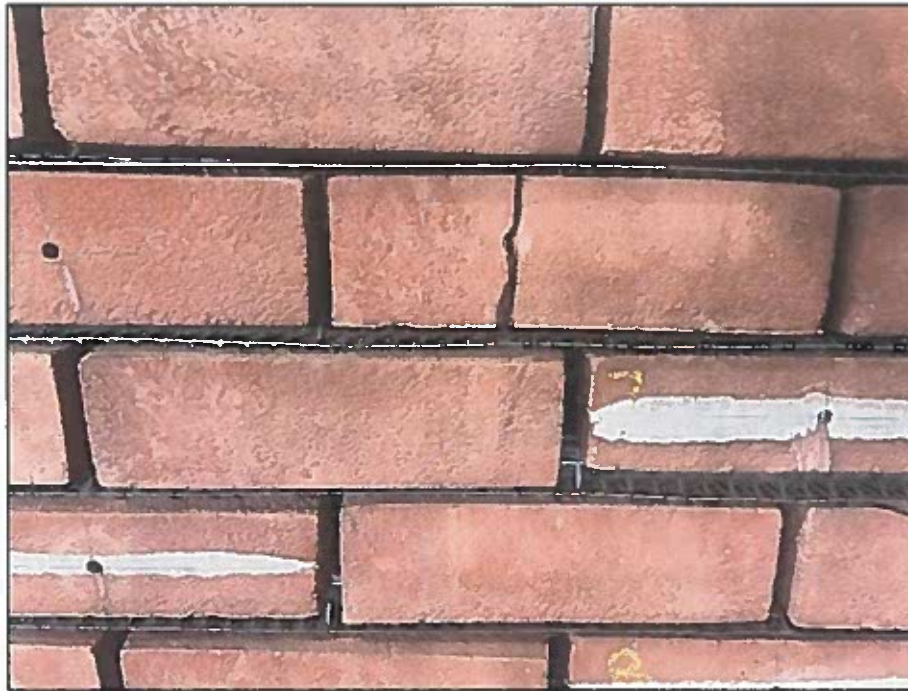
PHOTO IMG\_9319

| Location | Impact energy (J) | Observations | Classification |
|---|---|---|---|
| 6 | 10 | Crack through full height of tile | Low risk |

IMPACT LOCATION 6

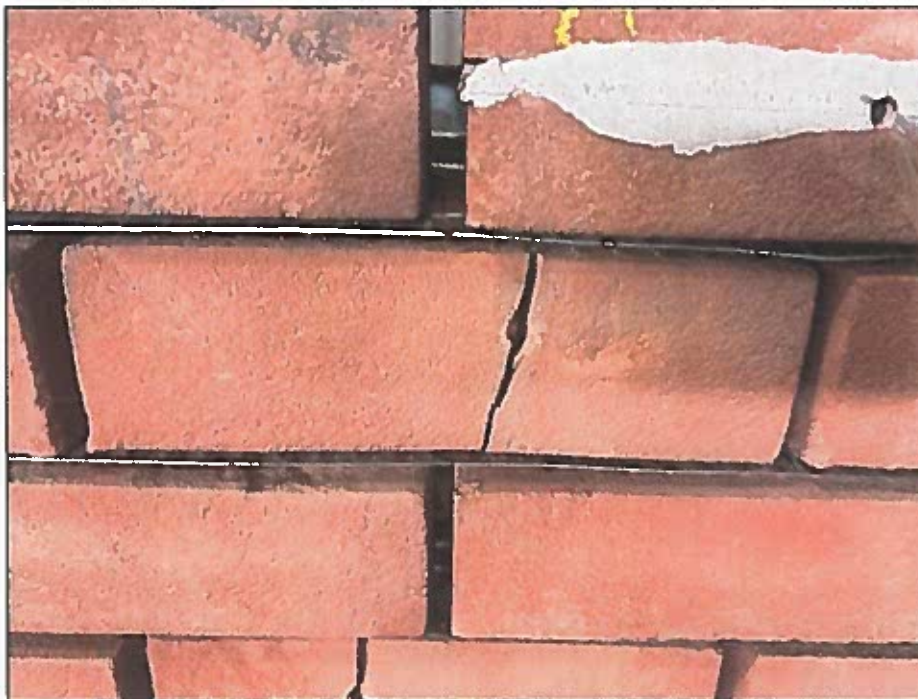
PHOTO 9321

| Location | Impact energy (J) | Observations | Classification |
|---|---|---|---|
| 7 | 10 | Crack through full height of tile | Low risk |

IMPACT LOCATION 7

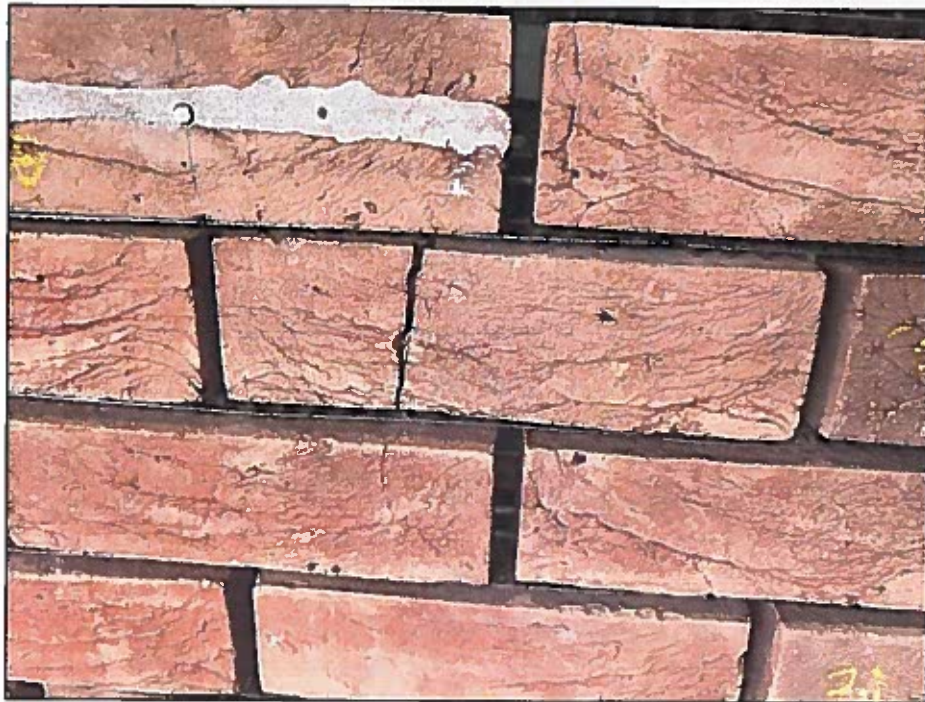
PHOTO IMG\_9323

| Location | Impact energy (J) | Observations | Classification |
|---|---|---|---|
| 8 | 10 | Crack through full height of tile.<br>Small chip to corner of brick (4 g) | Low risk |

IMPACT LOCATION 8

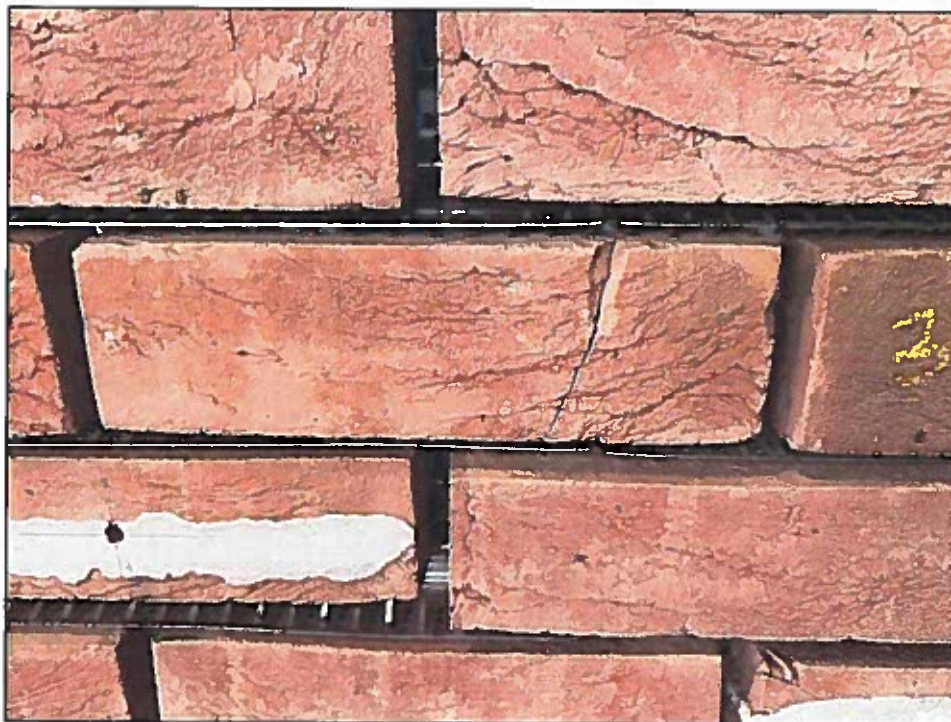
PHOTO IMG\_9325

| Location | Impact energy (J) | Observations | Classification |
|---|---|---|---|
| 9 | 10 | Crack through full height of tile | Low risk |

IMPACT LOCATION 9

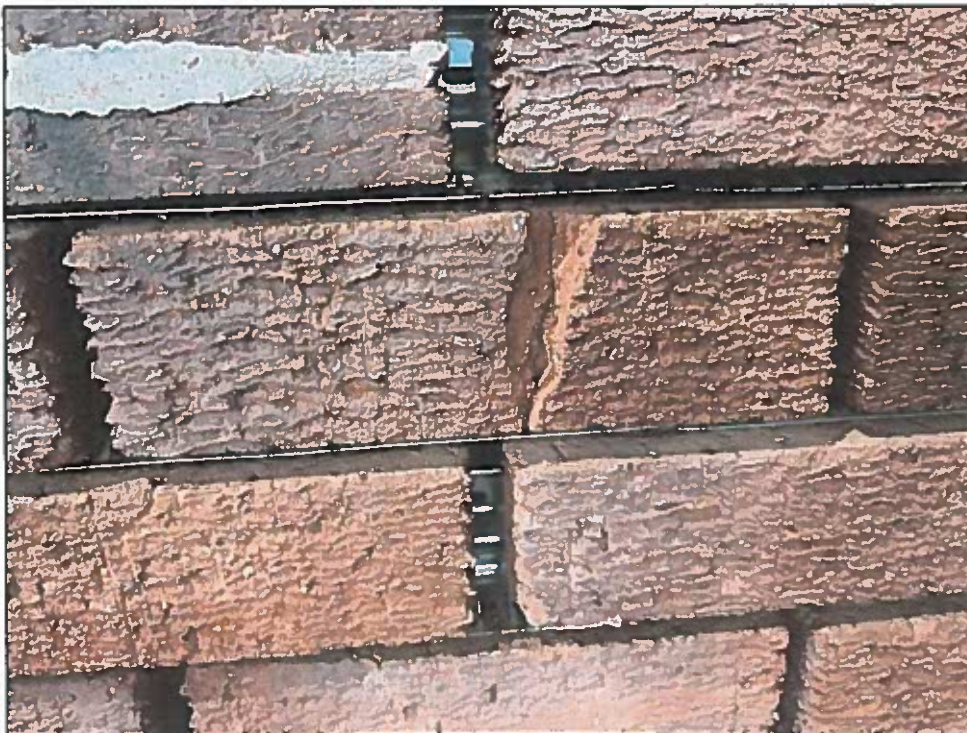
PHOTO IMG\_9331

| Location | Impact energy (J) | Observations | Classification |
|---|---|---|---|
| 11 | 10 | Crack through full height of tile | Low risk |

IMPACT LOCATION 11

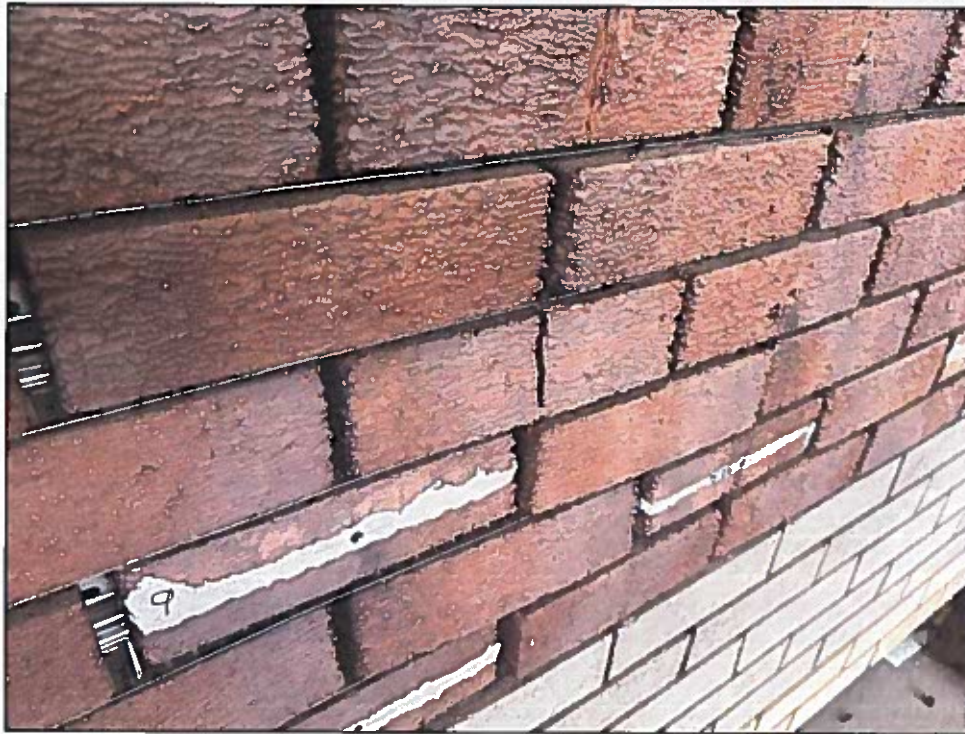
PHOTO IMG\_9336

| Location | Impact energy (J) | Observations | Classification |
|---|---|---|---|
| 12 | 10 | Crack through full height of tile | Low risk |

IMPACT LOCATION 12

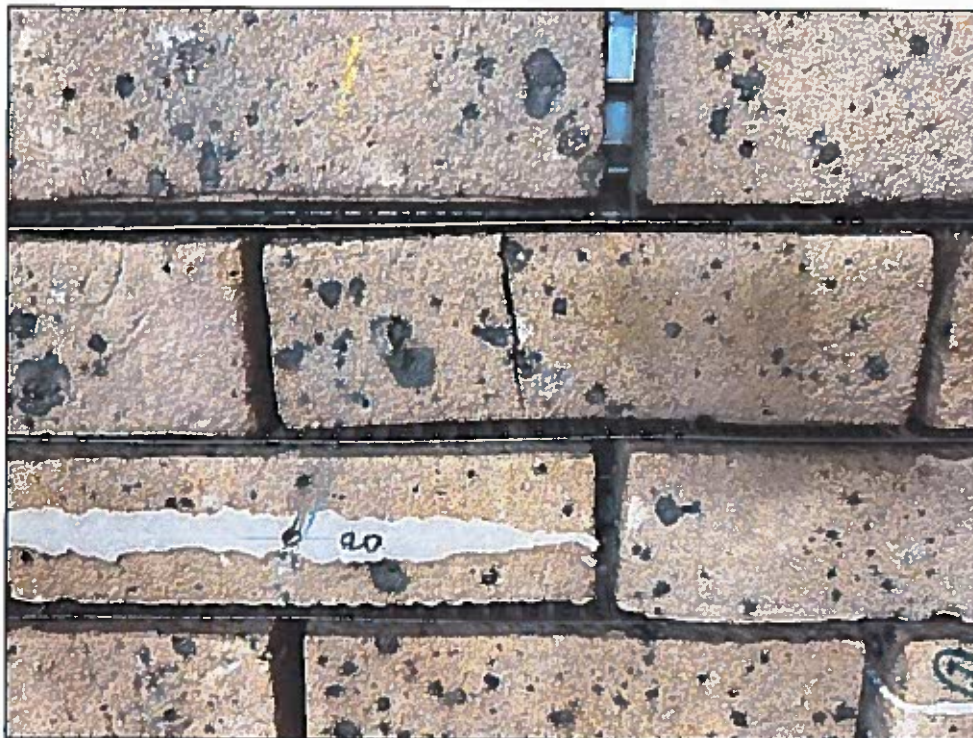
PHOTO IMG\_9338

| Location | Impact energy (J) | Observations | Classification |
|---|---|---|---|
| 13 | 10 | Crack through full height of tile | Low risk |

IMPACT LOCATION 13

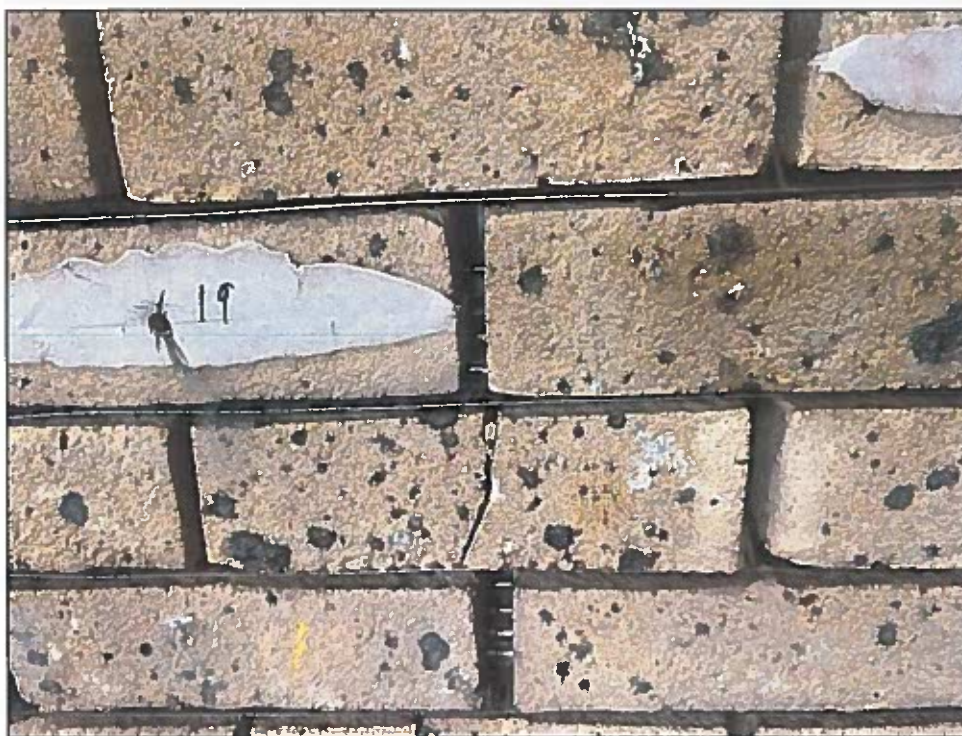
PHOTO IMG\_9340

| Location | Impact energy (J) | Observations | Classification |
|---|---|---|---|
| 14 | 10 | Crack through full height of tile | Low risk |

IMPACT LOCATION 14

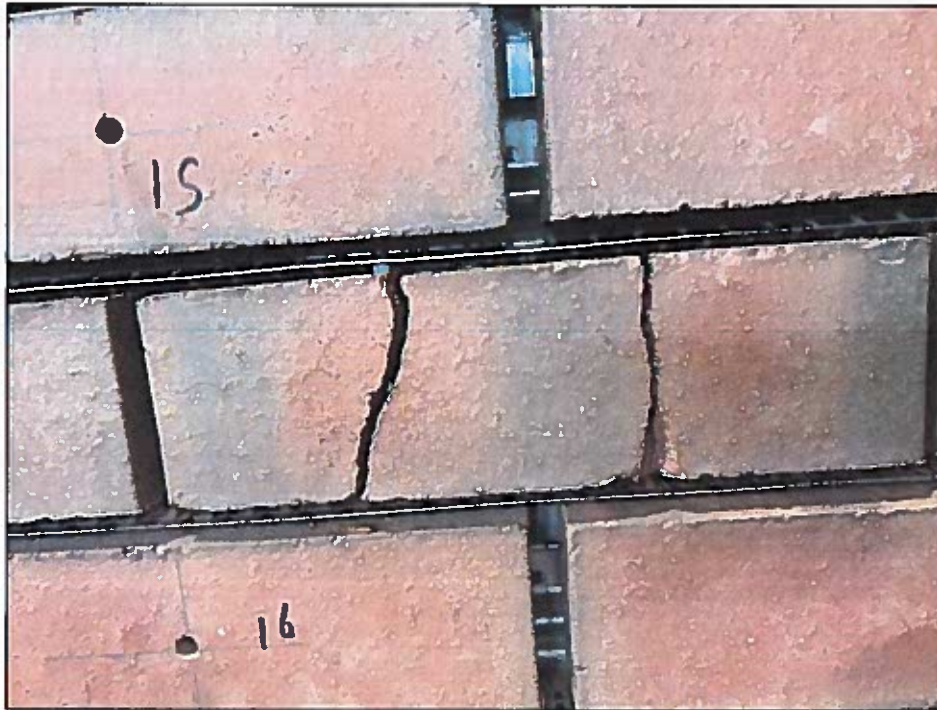
PHOTO IMG\_9344

| Location | Impact energy (J) | Observations | Classification |
|---|---|---|---|
| 16 | 10 | Crack through full height of tile | Low risk |

IMPACT LOCATION 16

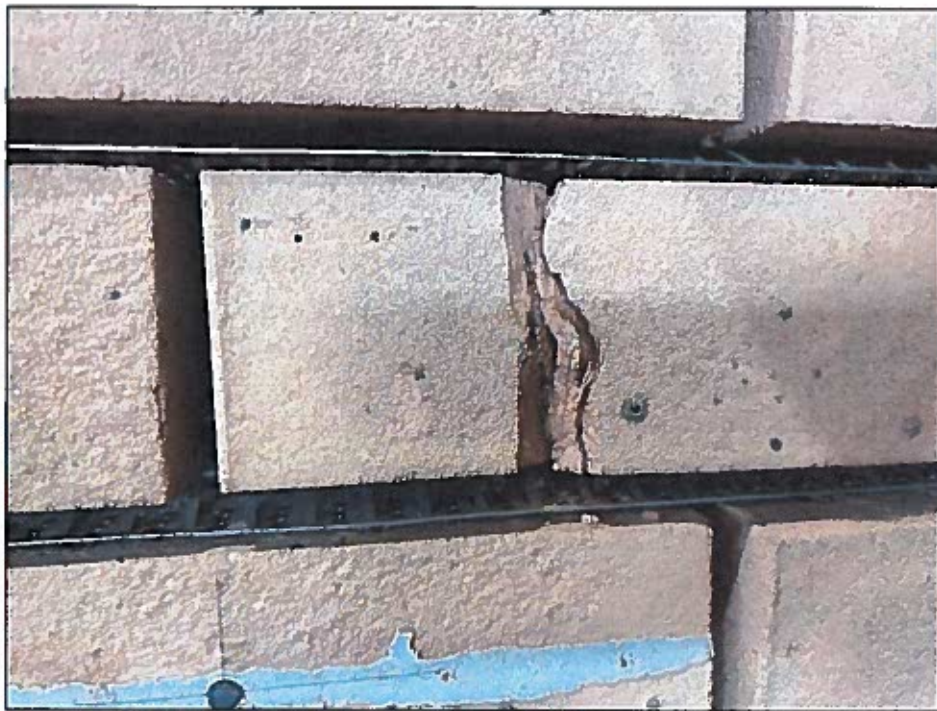
PHOTO IMG\_9349

| Location | Impact energy (J) | Observations | Classification |
|---|---|---|---|
| 17 | 10 | Crack through full height of tile.<br>Small chip to corner of brick | Low risk |

IMPACT LOCATION 17

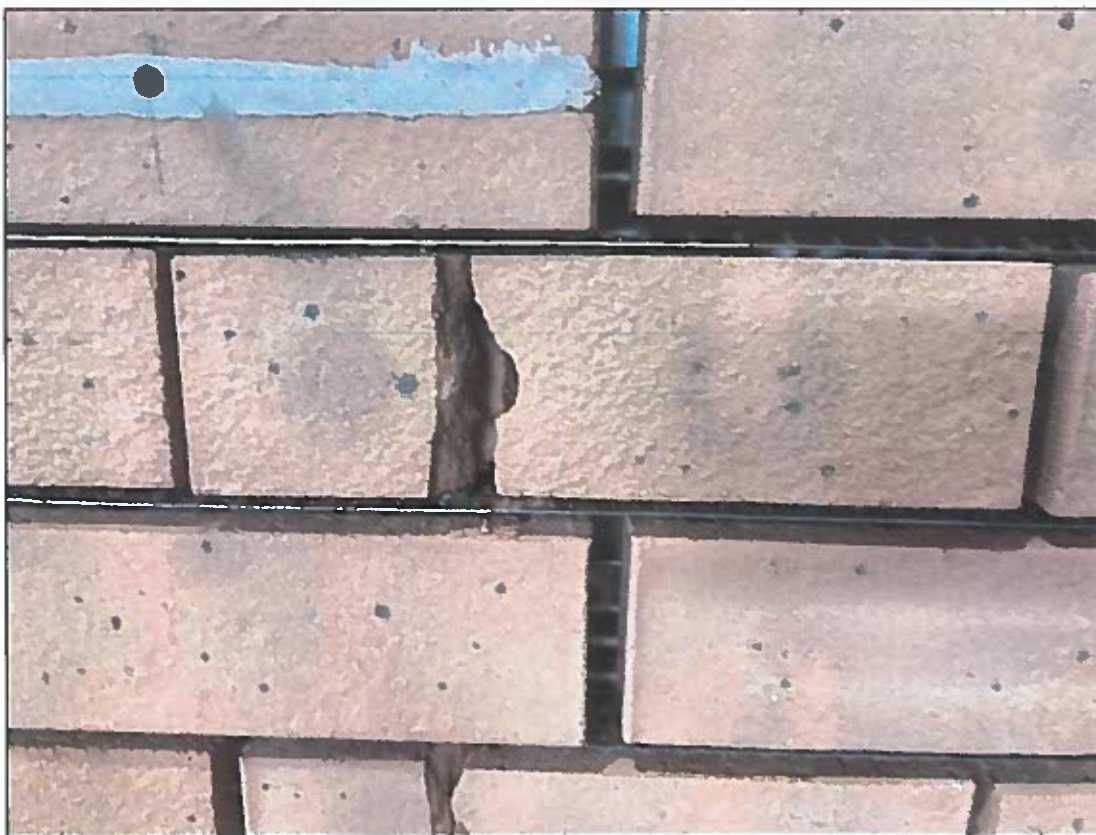
PHOTO IMG\_9354

| Location | Impact energy (J) | Observations | Classification |
|---|---|---|---|
| 18 | 10 | Crack through full height of tile.<br>Small chip to corner of brick (4 g) | Low risk |

IMPACT LOCATION 18

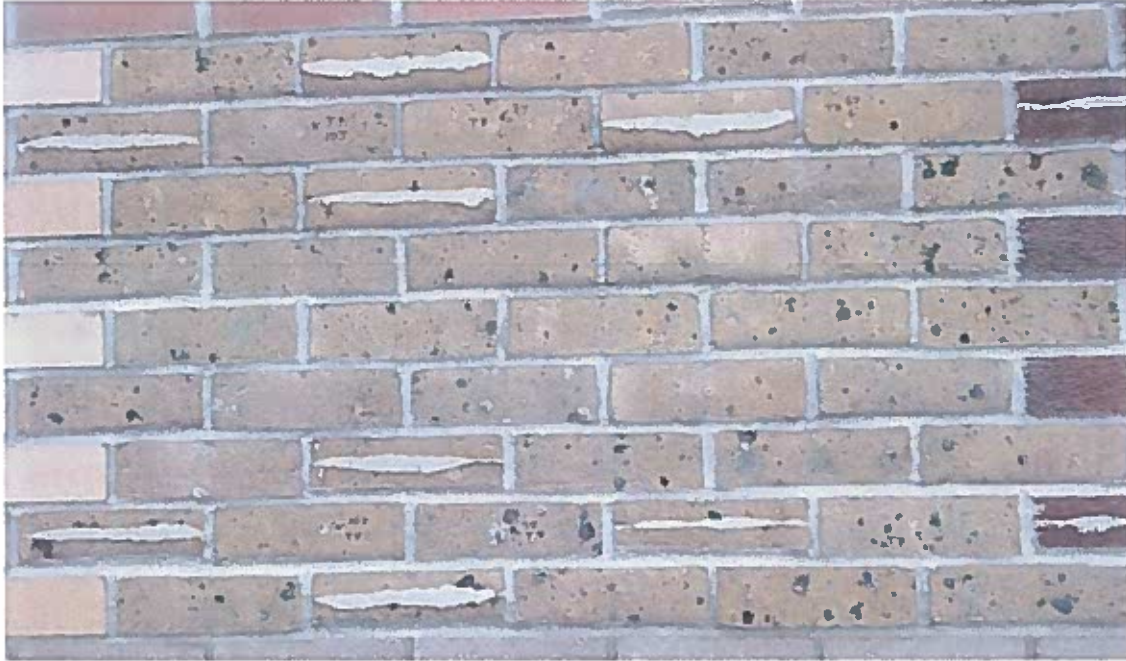
PHOTO 5711

**BRICK TYPE 7 AFTER IMPACT TESTS**

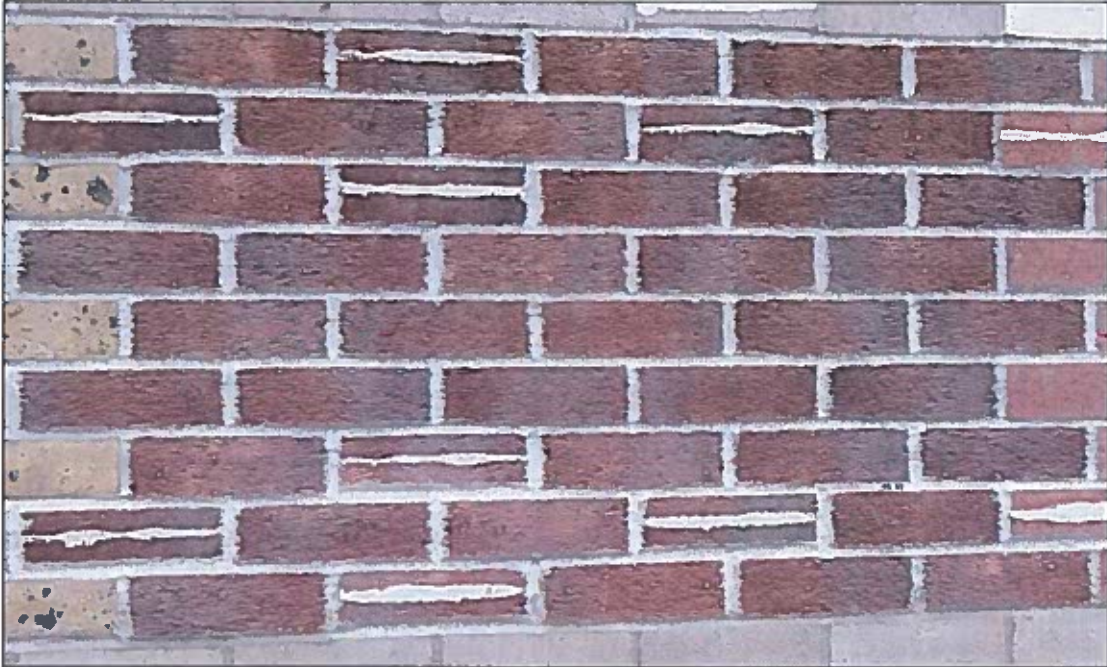
PHOTO 5712

**BRICK TYPE 8 AFTER IMPACT TESTS**

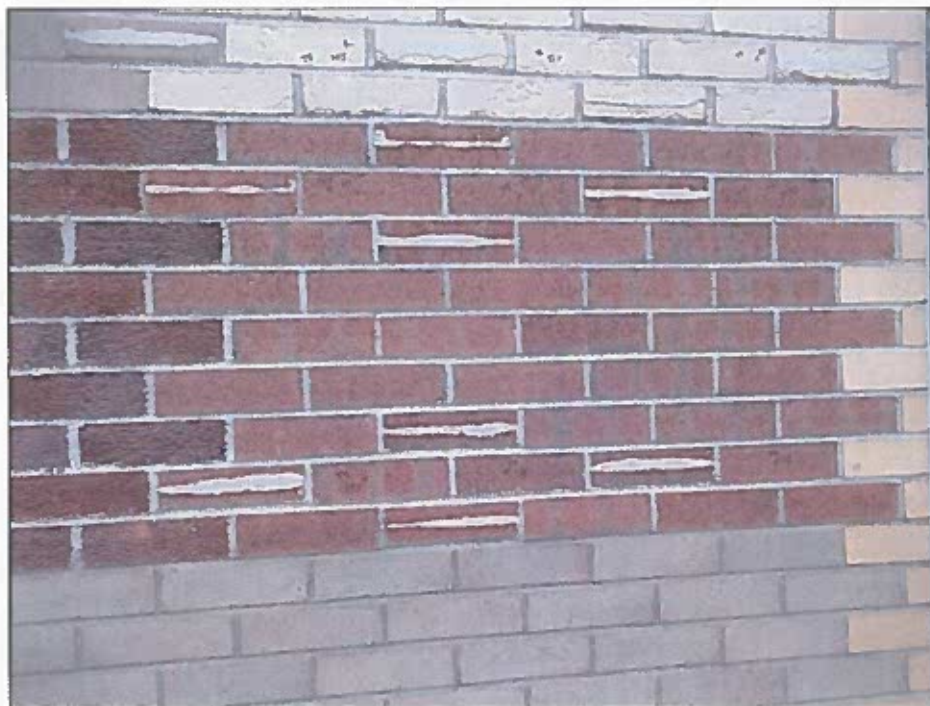
PHOTO 5713

### BRICK TYPE 9 AFTER IMPACT TESTS

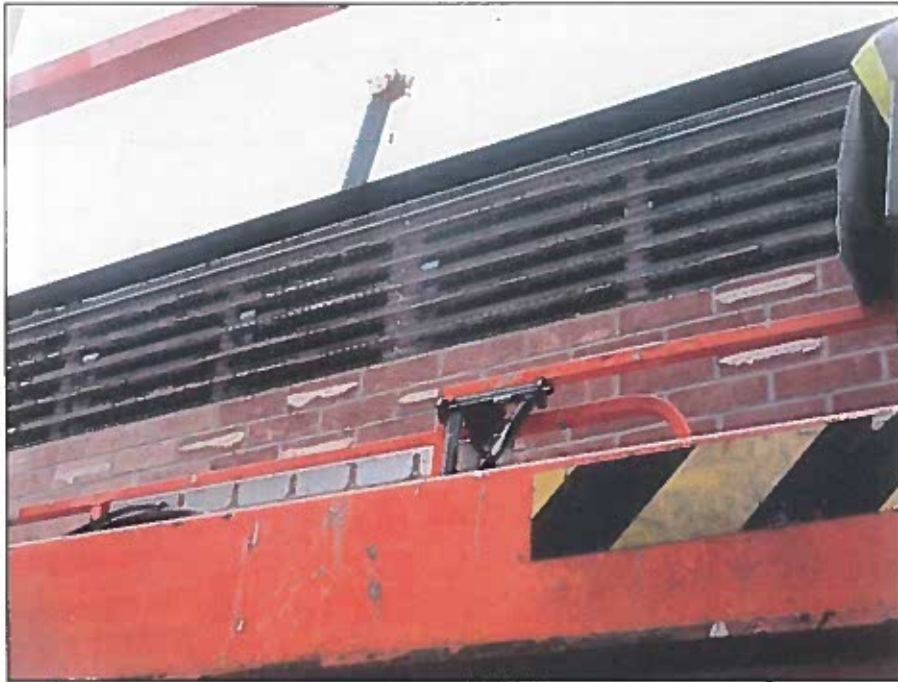
PHOTO 6137

During the dismantling of the sample no discrepancies from the drawings were found.

TEST SAMPLE DURING DISMANTLE
