IMCA Safety Flashes summarise key safety matters and incidents, allowing lessons to be more easily learnt for the benefit of all. The effectiveness of the IMCA Safety Flash system depends on members sharing information and so avoiding repeat incidents. Please consider adding safetyreports@imca-int.com to your internal distribution list for safety alerts or manually submitting information on incidents you consider may be relevant. All information is anonymised or sanitised, as appropriate.

1 Hand and finger injuries

2 Crewmember suspended above deck by lifting equipment

4 Engine failure and subsequent engine room fire

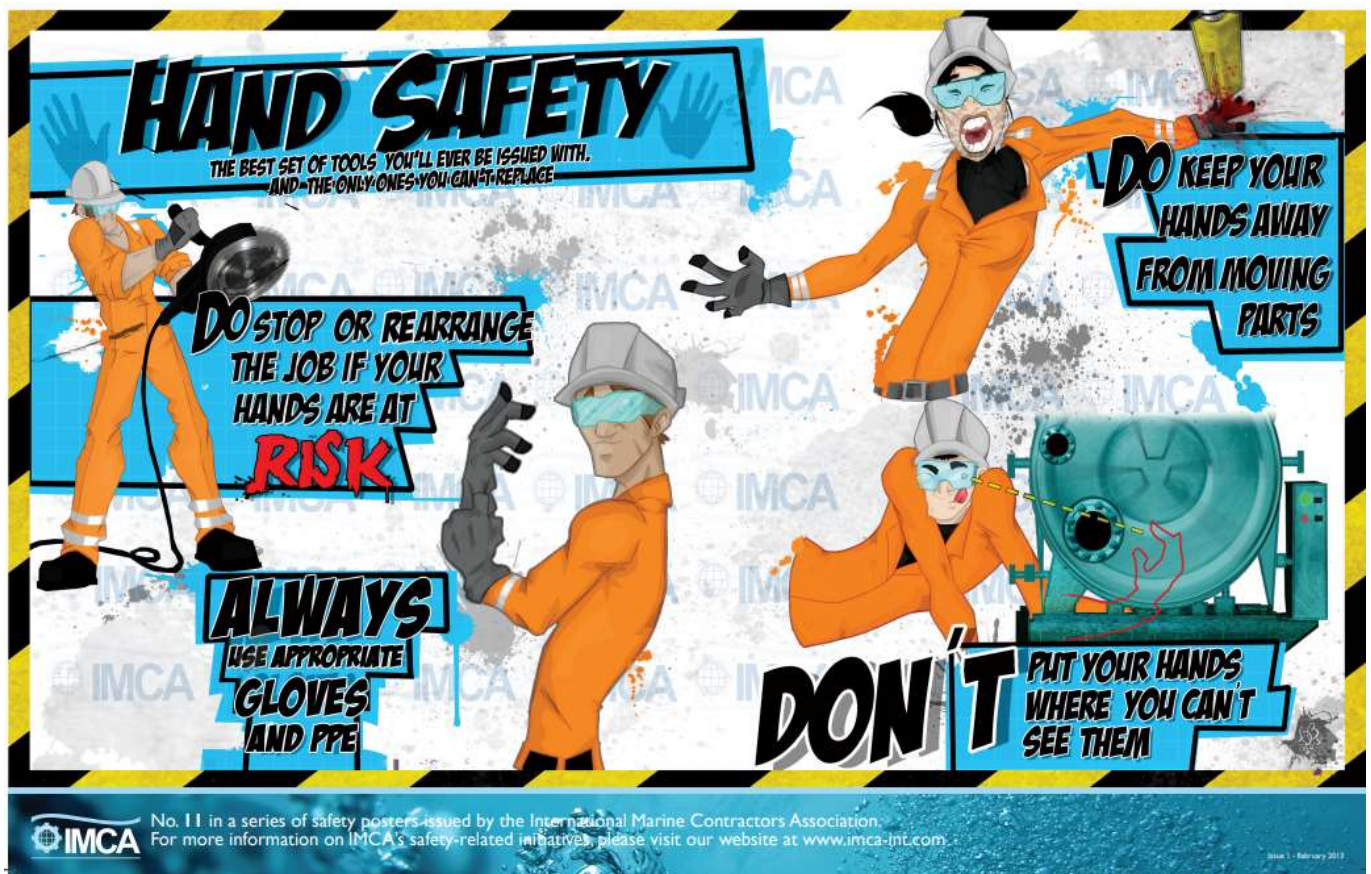
When removing the ceiling plates in the main deck instrument room, a worker cut his hand on a ceiling plate, which had sharp edges. The worker was not wearing gloves – as should have been the case. Wearing gloves would have prevented the injury.

- Watch where you put your hands! It's so easy just to do it – **DON'T! STOP and THINK;**
- PPE is there for a reason – **use it.** Gloves you can replace: fingers and hands, you can't.

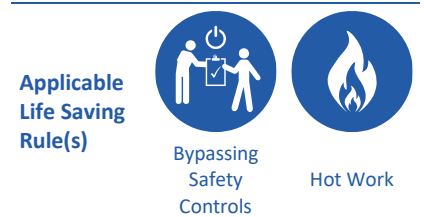
Following inspections on production and well operation sites in the Gulf of Mexico and an analysis of compliance and incident data since 2022, BSSE discovered multiple high potential fires associated with welding and burning operations. Several critical issues were identified requiring attention to ensure the safety and integrity of ongoing operations. In one incident, evidence suggests hot slag from a cutting torch pierced the underside blanket barrier of the living quarters building. The residual heat likely caused the wood subfloor to ignite.

- Hot work being conducted close (less than 10m) from equipment containing hydrocarbons;
- Inadequate housekeeping practices, with material like cardboard boxes found within 10m of hot work areas;
- Tools for fire prevention, such as fire extinguishers and portable gas detectors, not properly identified as necessary;
- Offshore personnel not following safe welding and hot work procedures;
- Inconsistent and infrequent training for personnel engaged in hot work and/or welding – that is persons without training or coding to the appropriate industry standard, were engaging in hot work;
- Hot work permits and Job Safety Analyses (JSAs) listing the same person to perform fire watch **and** perform the hot work!

- Ensure there are no flammable materials or hydrocarbons or other fire hazards nearby when preparing for hot work;

- Ensure the rating, current condition, and placement of fire protection barriers mitigate the potential risk caused by hot work, including personal protective equipment;
- Ensure a heightened level of planning specific to the hazards associated with welding and burning operations – **stop and think for a minute, are we doing this safely?**
- Check that training and competence requirements for persons doing hot work are in place and that they meet appropriate industry standards;
- Hot work operations should be inspected by someone in charge before starting work; adequate supervision and fire watches should be in place throughout;
- Ensure that all persons involved in hot work attend and participate in pre-job JSA meetings and toolbox talks and that they fully understand what is required of them.
