Gas turbine small bore fitting failure

SAFETY ALERT

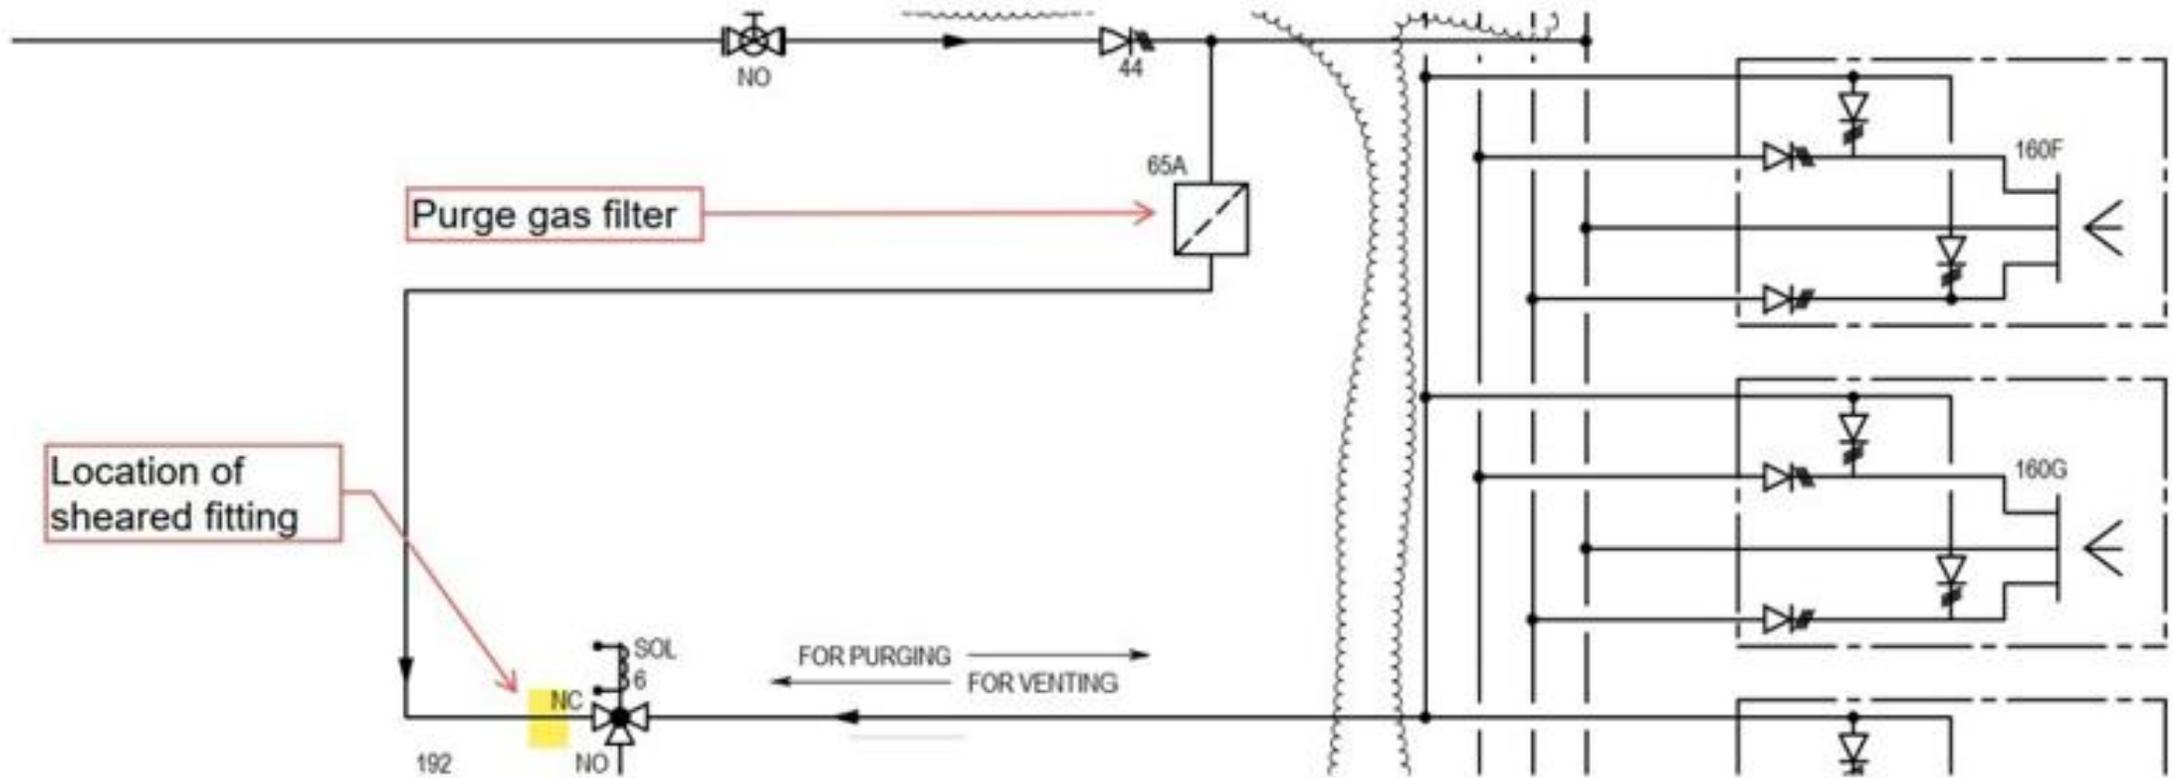
A fuel gas system leak test revealed a failed SBT fitting/ elbow connecting a purge gas filter to a purge valve.

Investigation ongoing but possible contributing factor for the failure is thought to be fatigue induced failure mode due to lack of supports on either the purge gas filter or purge valve or both.

Ensure adequate inspection of small bore connections on gas turbine fuel systems and adequate support of the small bore connections and system components. It is possible original equipment manufacturers may not have installed adequate small bore tubing/component supports and cycle fatigue may mean failure can occur within the package design life.
