Learning from Incidents

80/90ft Wireline Mast Column Stop Plate
falls 65ft / 19.8m (HiPo)

Published by **DROPS** (Dropped Object Prevention Scheme) JUNE 2025

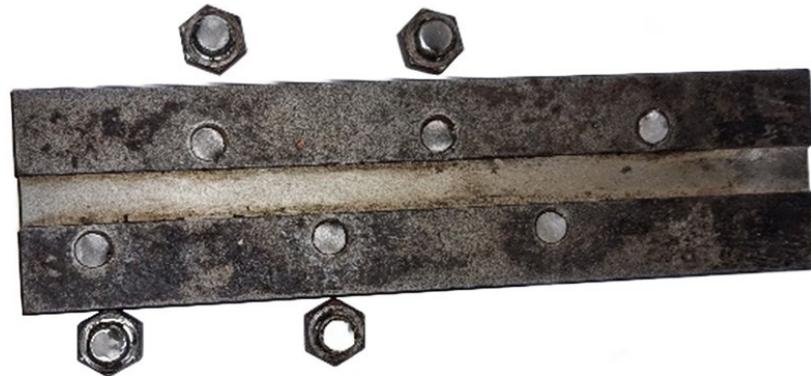
STOP PLATE (25cm x 6.5cm x 1.5cm) & BOLT HEADS

The area was secured and a sweep of the worksite performed, leading to the discovery of a mast column stop plate and four sheared 12mm HEX bolt heads, with a further 2 bolt heads later identified.

The stop plate weighing 1.8 kg had become detached from its position (green mast section shown on right) and dropped 19.8m / 65ft to deck.

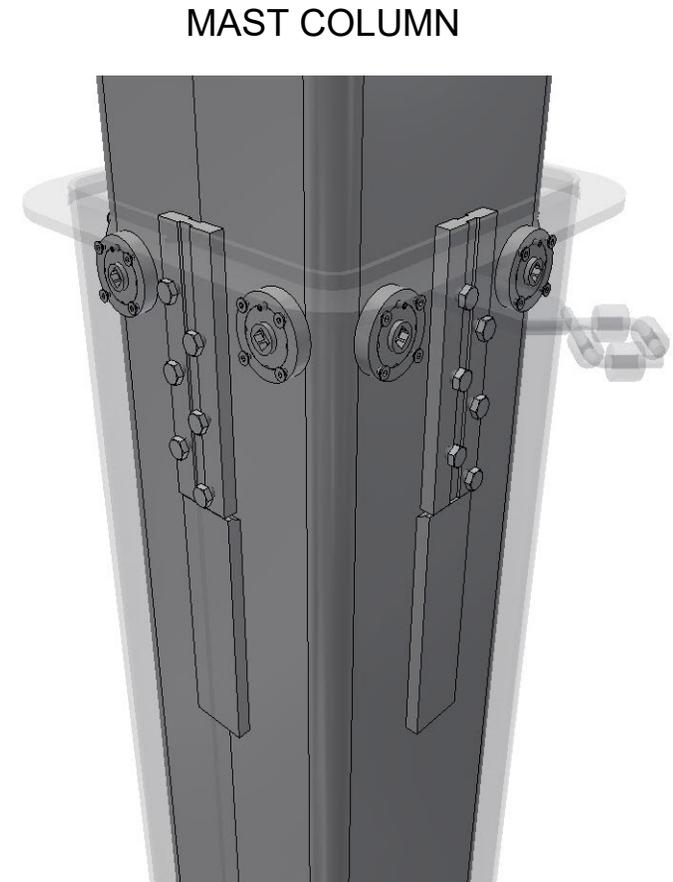
Correct Installation

Design (Plate Orientation Error Trap)

In the incorrect orientation, the plate sits 35mm lower than the other 3 plates on this column.

Due to this, when the mast is erected this stop plate is being impacted alone, without the other 3 being in contact.

35mm was the distance that the telescopic cylinder travelled when the bolts sheared.

In the correct orientation the plate sits flush with the section collar.

In the incorrect orientation it sits below the collar level (by 35mm).

- Refit mast column stop plates with replacement bolts, verify alignment and apply paint to the upper (visible) section of plate to visually confirm correct orientation.
- Update maintenance checklist to ensure that the stop plate orientation is checked during every maintenance activity.
- Produce new maintenance procedure for stripping and rebuilding the mast column to include highlighting the safety-critical nature of the plate orientation.
- Publish technical bulletin for maintenance personnel and made available for reference during any additional inspection.
- **Share learnings through industry initiatives such as DROPS and Step Change in Safety.**
