SUMMARY OF ADVISORY BUILDING SAFETY ASSESSMENTS BY INTERNATIONAL ENGINEERS FOLLOWING THE AUG 14 M7.2 HAITI EARTHQUAKE

Report compiled by SARAID UK

25th August 2021

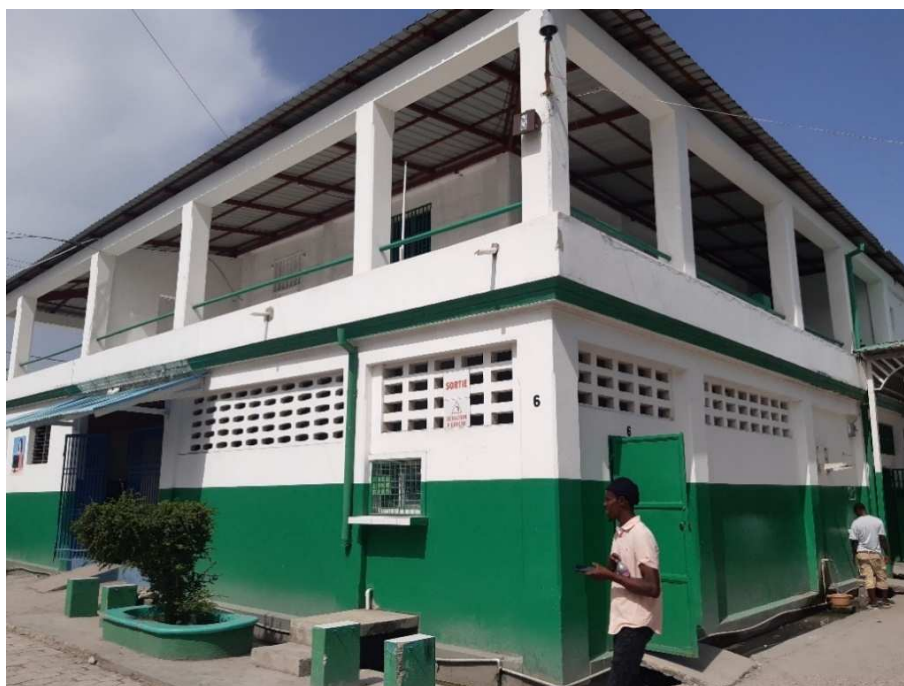
Figure 5 - Building 1

- Damage: There was significant cracking to one of the internal columns. The column was on the left in the room straight ahead of the entrance, as indicated in Figure 6.
- Assessment constraints: We were unable to access any of the upstairs floor and large parts of the ground floor.
- **Recommended restrictions:** Access to the room with the damaged column (it appeared to be an operating theatre) should be prohibited, including the area that is above this room.

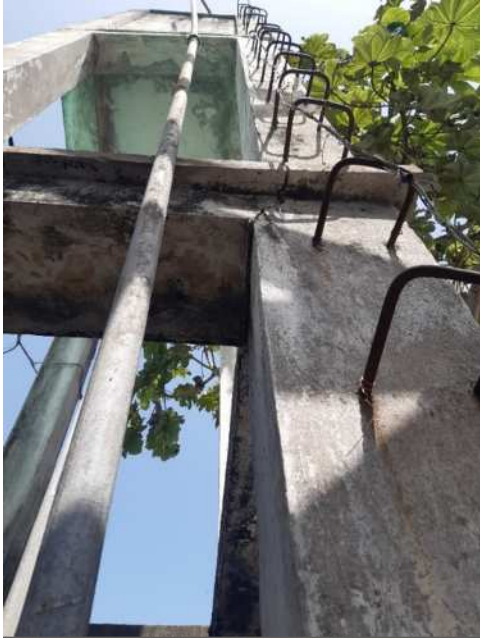
- Damage: Cracking was observed between most of the beam and column joints. There was also spalling on some of the concrete beams although its assumed, due to the condition of the rebar, this was historic damage
- **Recommended restrictions:** Cordon off the damaged water tower to a distance of 1.5 times the height of the tower area

Figure 8 - Building 3, concrete water tower

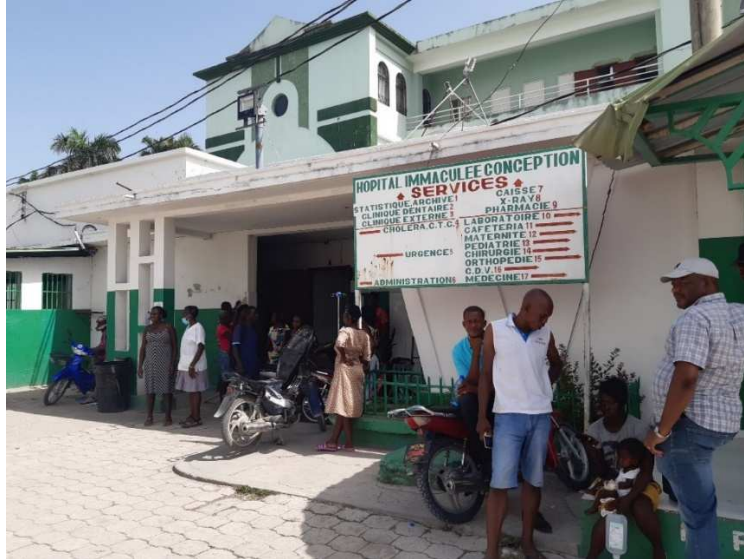
Figure 16 - Building 7

- Damage: Cracking through a beam that is supporting the floor above. Cracking present where the beam changes depth.
- Assessment constraints: We were unable to access any of the upstairs floor. The rear of the building, behind the first set of rooms could not be accessed
- **Recommended restrictions:** Our recommendation is that the building is unsafe to use

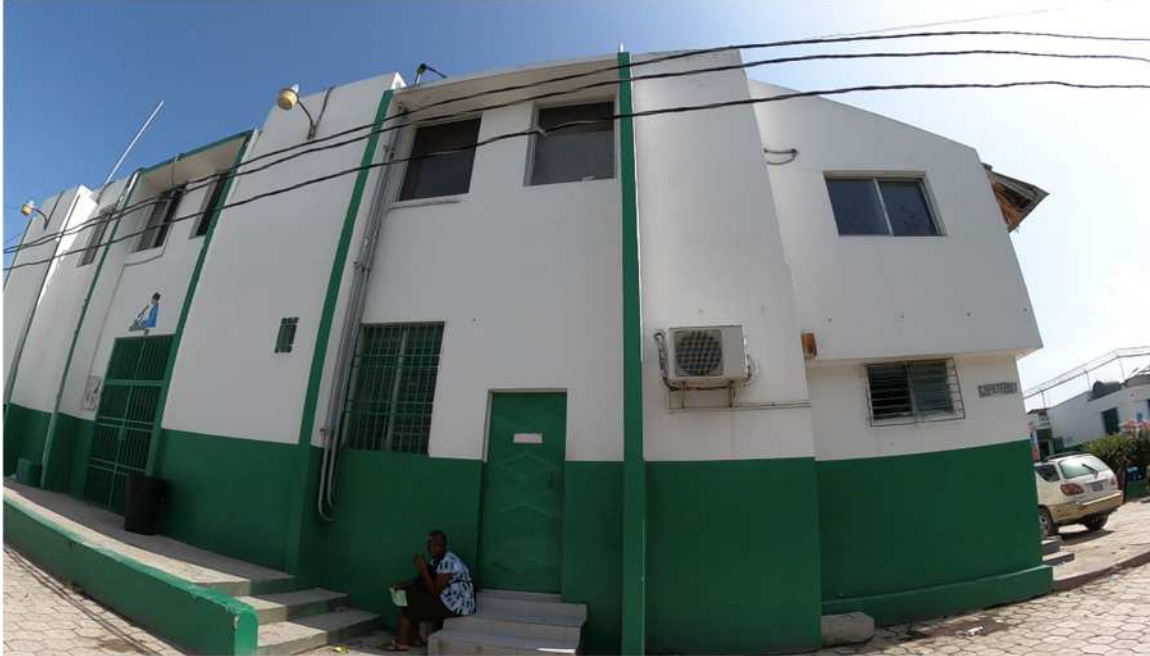
Figure 18 - Building 8

- Damage: This building had no damage that was identified during the assessment
- Assessment constraints: Only the outside of the structure was inspected as we could not gain access
- **Recommended restrictions: None required**

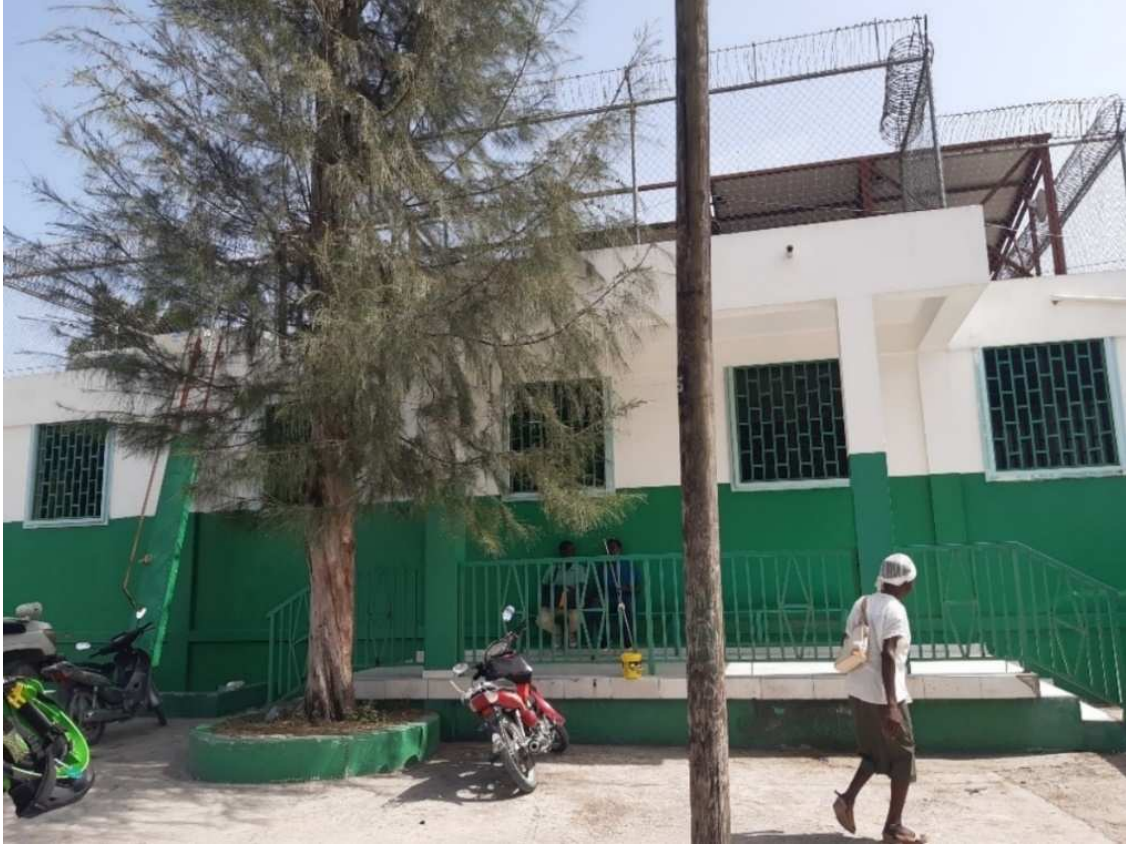
Figure 19 - Building 9

- Damage: There was some mold to one of the ceilings however no structural damage was identified during the assessment
- **Recommended restrictions: None required**

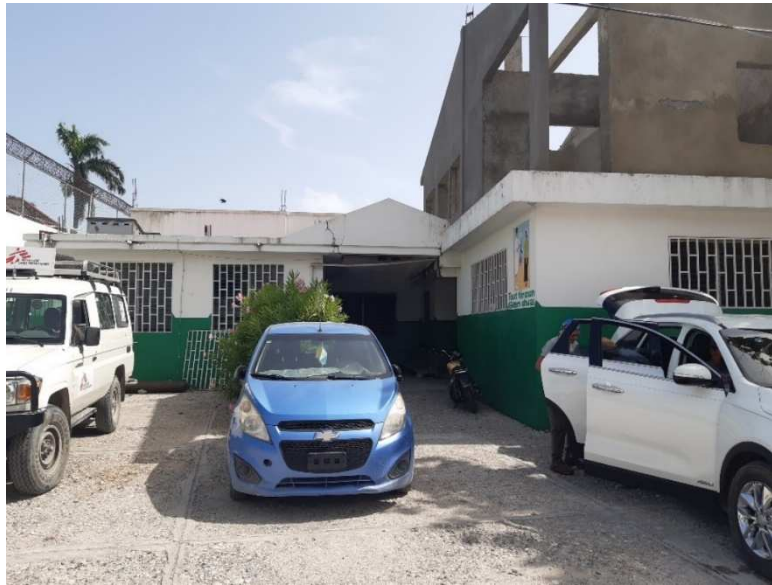
Figure 21 - Building 11

- Damage: A significant crack is present on the entrance arch causing it to be structurally unsafe (see Figure 22). A crack in a supporting beam (see Figure 23). Damage to an external wall that is supported a steel trussed roof. Damage to lintels.
- **Recommended restrictions:** Our recommendation is that the building is unsafe to use

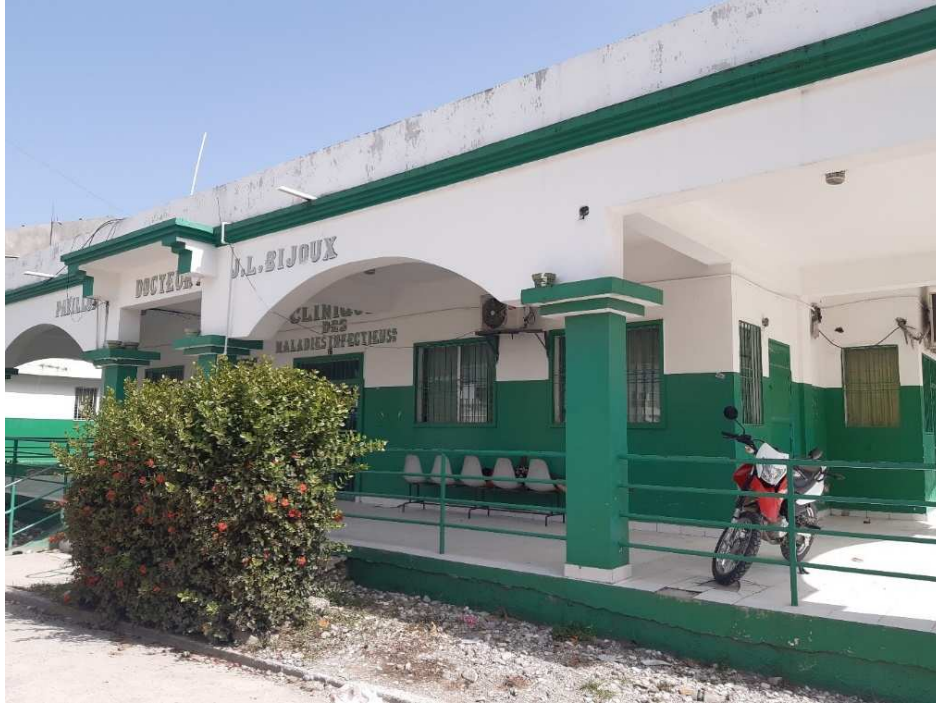
Figure 24 -Building 12

- Damage: This building had no damage that was identified during the assessment
- Assessment constraints: Only the outside of the structure was inspected as we could not gain access
- Recommended restrictions: None required

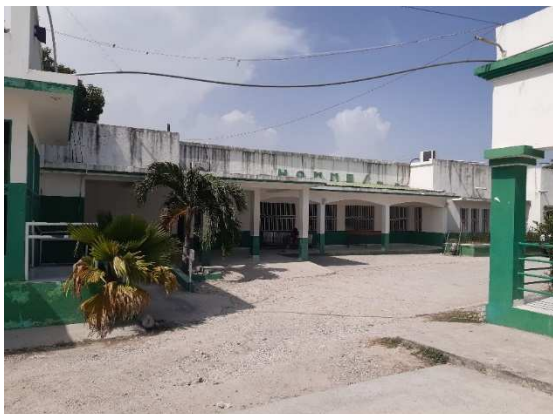
Figure 25 - Building 13

- Damage: The supporting structure to the edge of the entrance overhang was cracked and leaning, see Figure 27.
- Assessment constraints: The area shown in Figure 26 was not accessed.
- **Recommended restrictions:** We advise that the area under the right-hand side of the portico (when looking at the building, Figure 27) should be restricted.

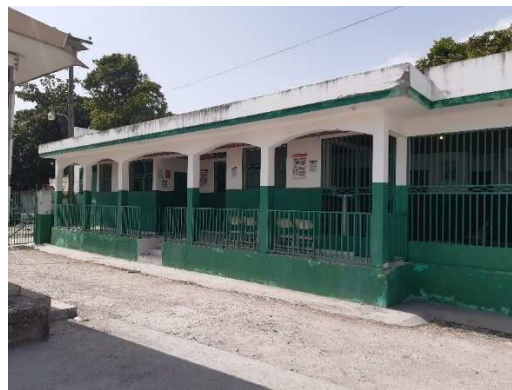
Figure 26 - Area of building 13 that could not be accessed

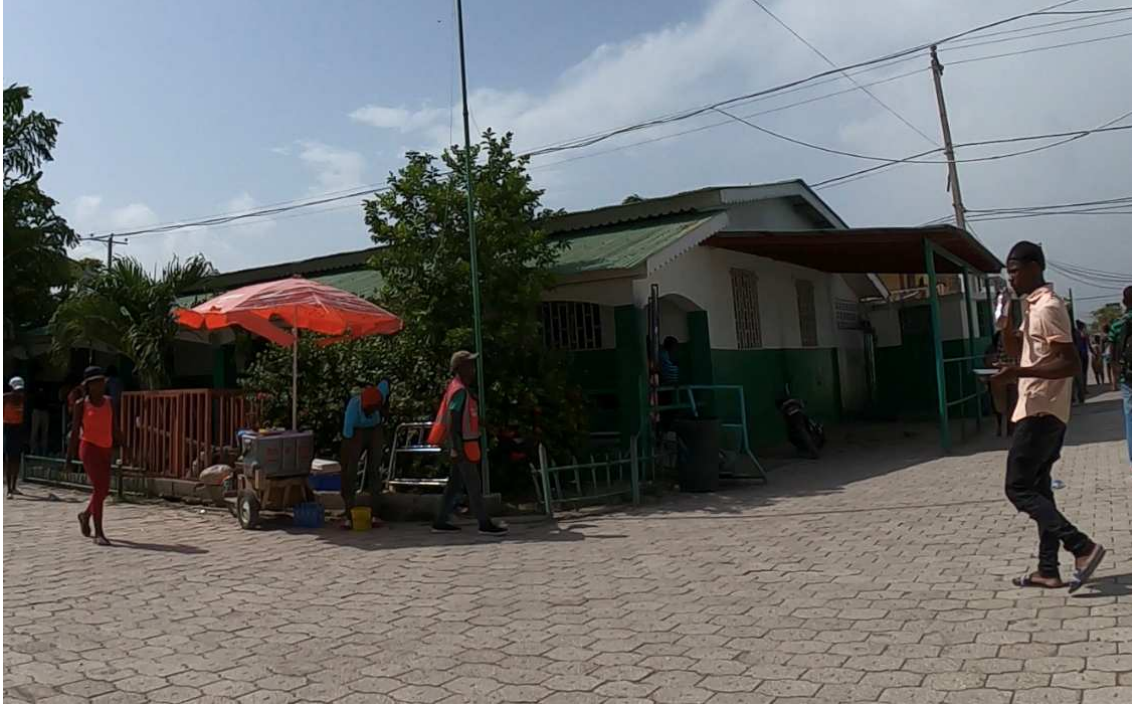
Figure 28 - Building 14

- Damage: This building had no damage that was identified during the assessment
- Assessment constraints: Only the outside of the structure was inspected as we could not gain access
- Recommended restrictions: None required

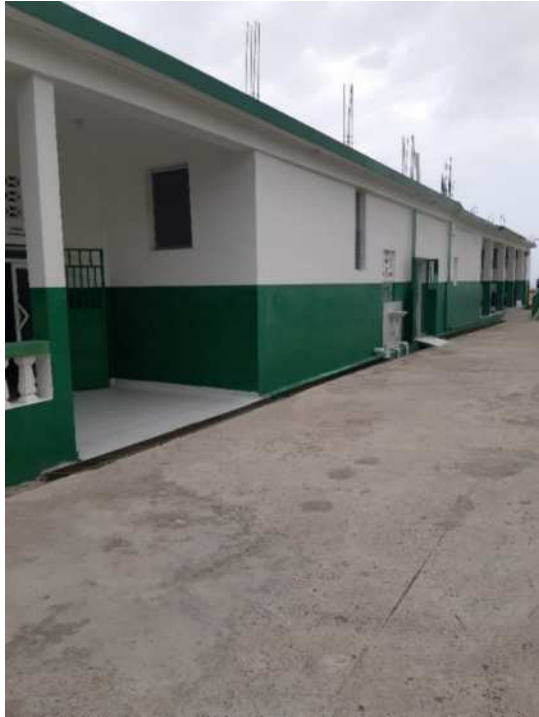
Figure 29 - Building 15

- Damage: Minor cracking to external infill walls, deemed as non-structural damage. Cracking was observed along a movement joint. The structures either side had moved separately from on another and although looks like a significant crack it does not effect the structural integrity of the building.
- **Recommended restrictions: None required**

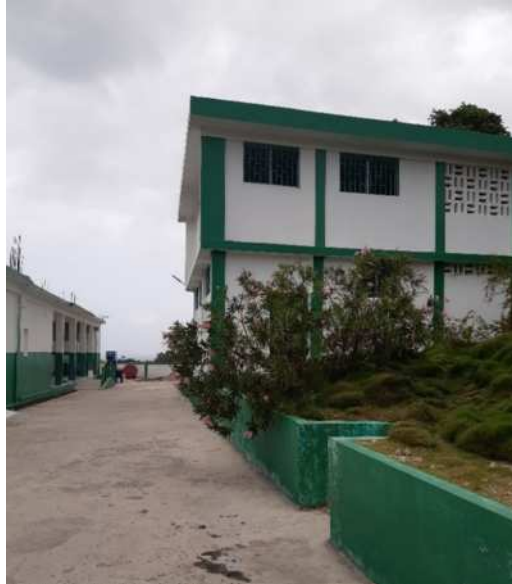
Figure 31 - Building 16

- Damage: This building had no damage that was identified during the assessment
- Assessment constraints: Only the outside of the structure was inspected as we could not gain access
- **Recommended restrictions: None required**

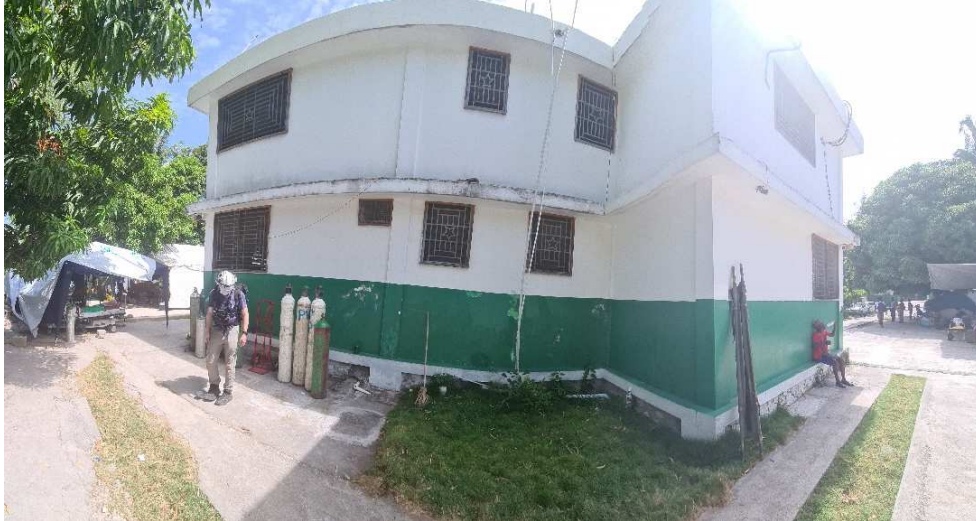
Figure 32 - Building 18

- Damage: This building had no structural damage that was identified during the assessment
- **Recommended restrictions: None required**

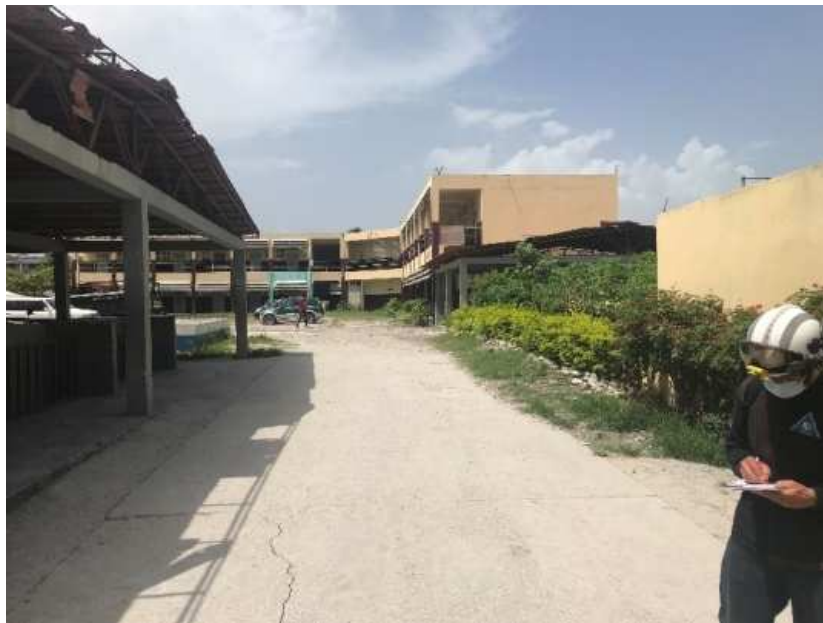
Figure 33 - Building 19

- Damage: With the exception of the junction between legs of the southern classroom block the building is undamaged and users can move readily throughout the premises. At the junction of the building's legs there is an infill section, comprising a reinforced concrete walkway, where relative displacement has resulted in a slight gap at either side. Users can negotiate this without risk.
- **Recommended restrictions: None required**

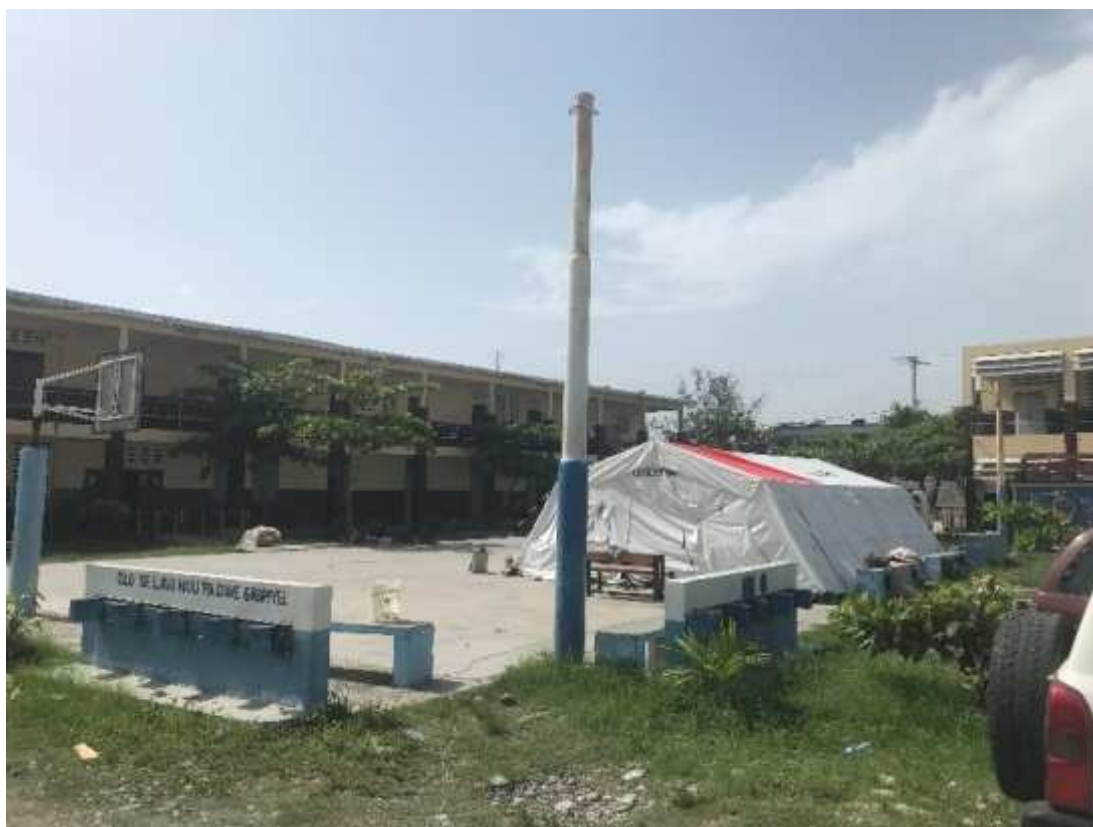
- Damage: The North-East end of this classroom block exhibits structural cracking that is detrimental to the safe use of the facility In the quadrangle between the classroom blocks there is a UNICEF tent which local residents are using as a safe refuge. This is sufficiently distant from the buildings to avoid hazards associated with further seismic events.
- **Recommended restrictions- Access to the building to be restricted until a detailed evaluation confirms whether it is safe for use or needs to be evacuated.**

Figure 35 - UNICEF Tent in school quadrangle

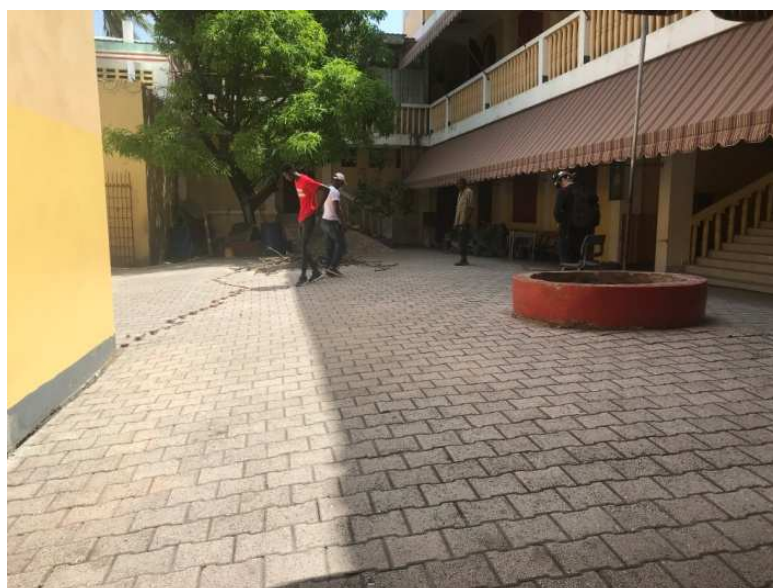
- Damage: The rectangular classroom block encloses a paved courtyard where it is evident that the ground surface has risen significantly above its original level. Also it appears that the building level has dropped relative to the adjacent pavement. Some ponding of surface water around the building reflects these changes. The degree of “ground heave” internally raises concern regarding potential for voiding below the surface that could represent a hazard to users or to circumstances associated with redressing the level differentials. In the south eastern part of the building there is some significant structural cracking of ground floor walls and this appears to relate to the ground movement.
- **Recommended restrictions: Access to the building to be restricted until a detailed evaluation confirms whether it is safe for use or needs to be evacuated.**

Figure 37 - Building 21 courtyard heave

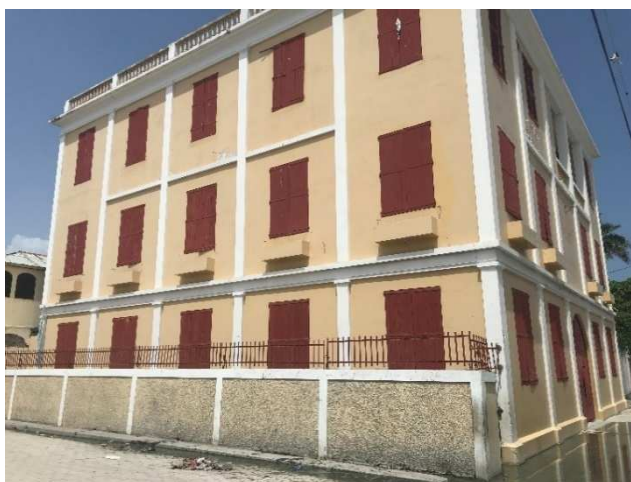
Figure 40 - Building 23

- Damage: Inspection of the building externally and from within did not reveal structurally significant damage. The condition of this classroom block permits continued use. - There is some limited evidence of downward displacement relative to the adjacent street which has resulted in some ponding of surface water.
- **Recommended restrictions: None required.**

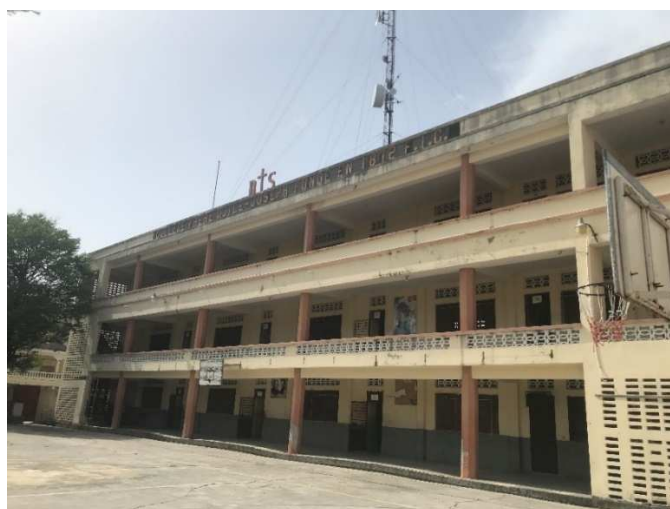
Figure 43 - Building 26

- Damage: The classroom block does not exhibit any significant structural that would limit its use.
- Recommended restrictions: None required.

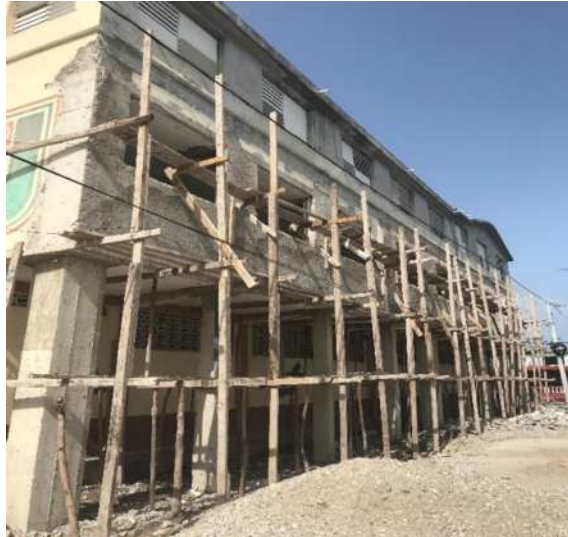
Figure 44 - Building 27

- Damage: There are instances of minor cracking around stairs and on the ground floor but these are not structurally significant. The recent development of the building above the adjacent pavement area exhibits no ill-effects of seismic effects.
- Recommended restrictions: None required.

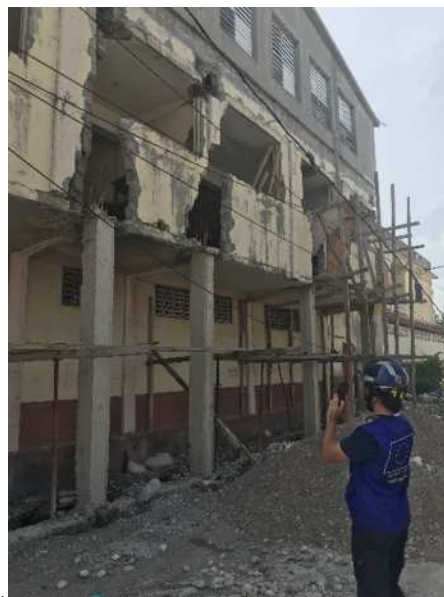
Figure 45 - Building 28

- Damage: The FIC college building, seen beyond the scaffolded structure, may need to have structural repairs subject to the outcome of further inspection when access can be arranged.
- Recommended restrictions: Access to the building to be restricted until a detailed evaluation confirms whether it is safe for use or needs to be evacuated.

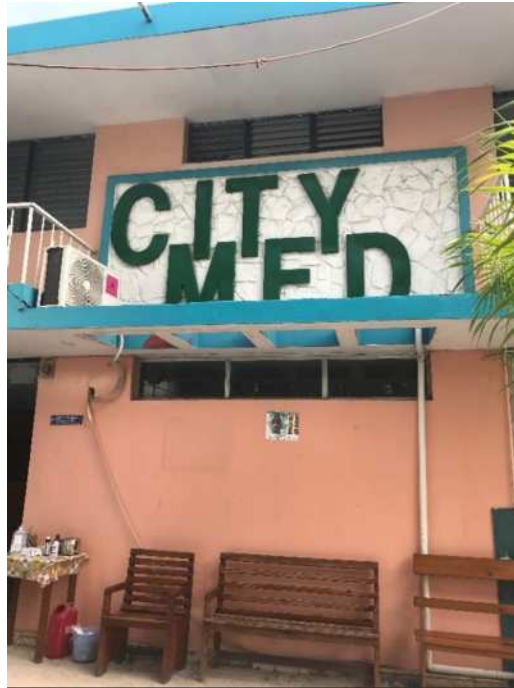
Figure 46 - Building 29

- Damage: External examination of this clinic showed no signs of damage.
- **Recommended restrictions: None required**

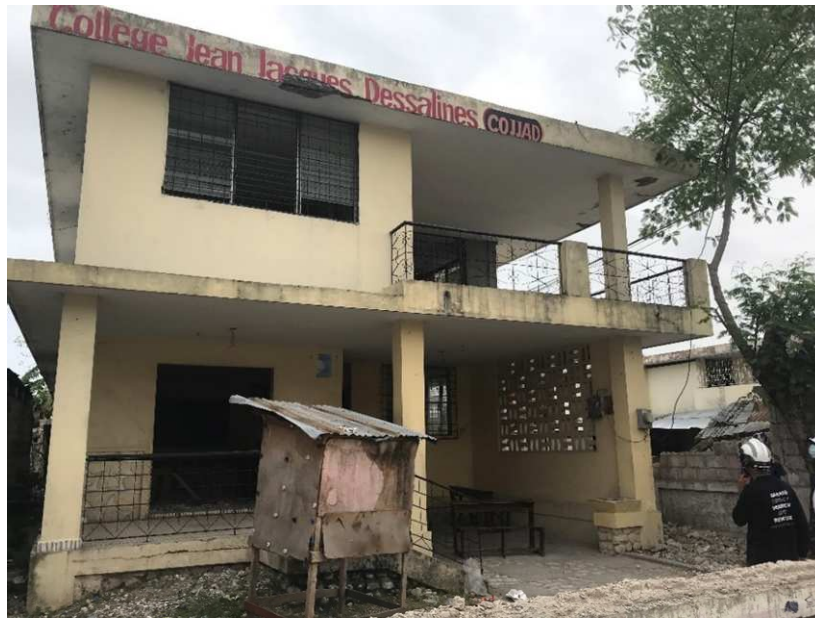
Figure 48 - Building 31

- Damage: The condition of the College building is free from significant damage that would curtail its use.
- Recommended restrictions: None required for the building. However the adjacent boundary wall exhibits significant damage and access around it should be prohibited.

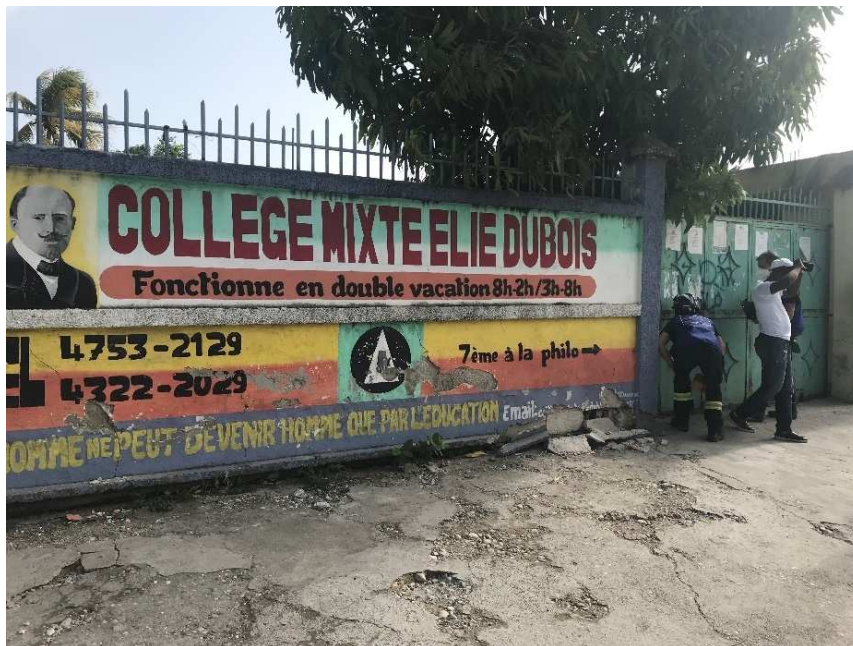
Figure 49 - Building 32

- Damage: Access for inspection was limited but sufficient external viewing was made to enable recommendation unrestricted use of the college building.
- Recommended restrictions: None required.

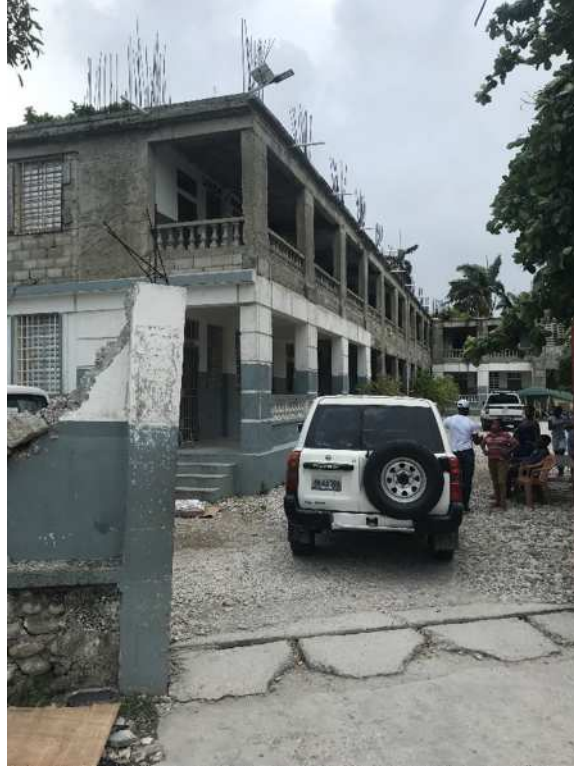
Figure 50 - Building 33

- Damage: No visible damage was discernible for this particularly robust construction.
- Recommended restrictions: None required.

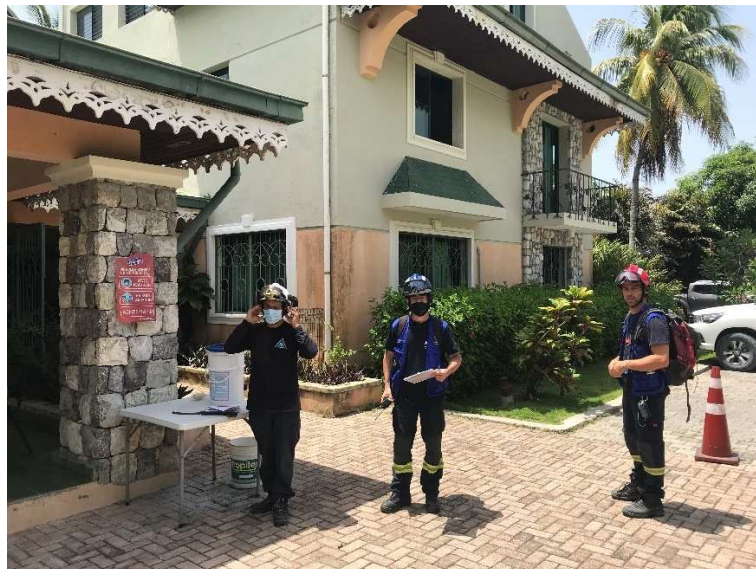
Figure 51 - Building 34

- Damage: Limited nature of identified cracking is not a concern for safety of buildings.
- Recommended restrictions: None required. However, presence of clients' tents close to buildings is risky in case of falling debris during aftershocks and should be prohibited.

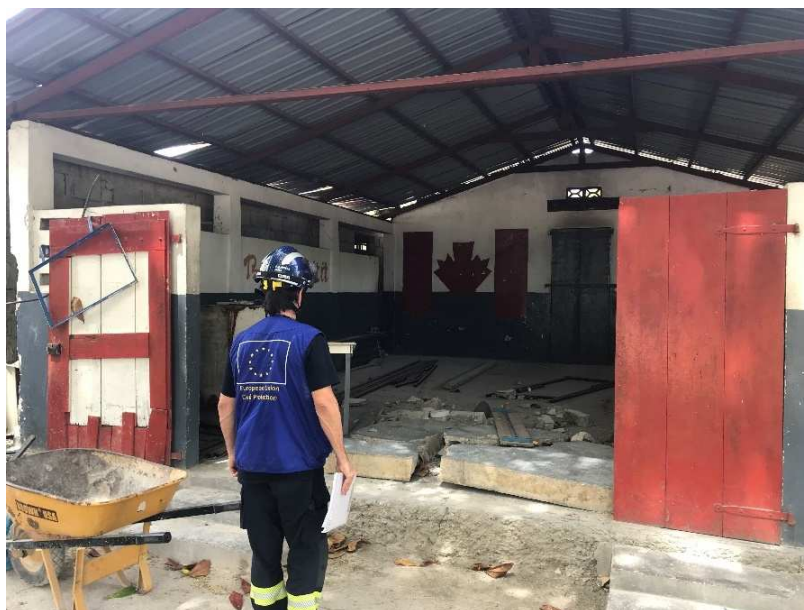
Figure 53 - Building 36

- Damage: The extent of structural damage to this particular facility building is minor.
- **Recommended restrictions:** Continued use is acceptable subject to removal of loose material.

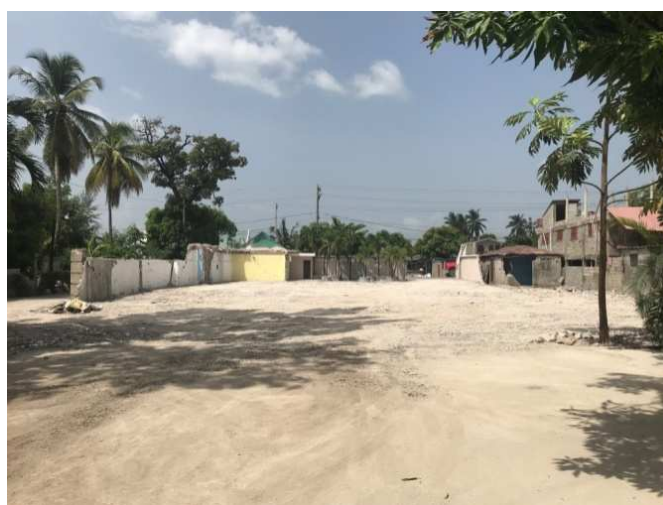
The major 4-storey building structure that had been constructed approx 10 years ago has been demolished and cleared from site shortly after the 2021 earthquake event.

Figure 56 - Building 39 - destroyed by earthquake and subsequently cleared from site

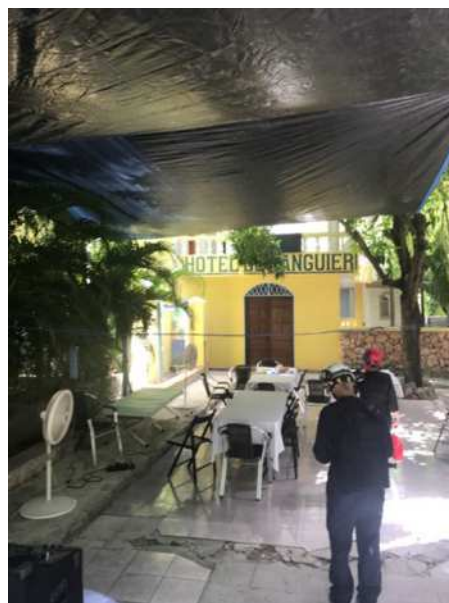
Figure 60 – Building 42

- Damage: The recently constructed extension to hotel exhibits negligible damage and remains in usable condition.
- Recommended restrictions: None required.

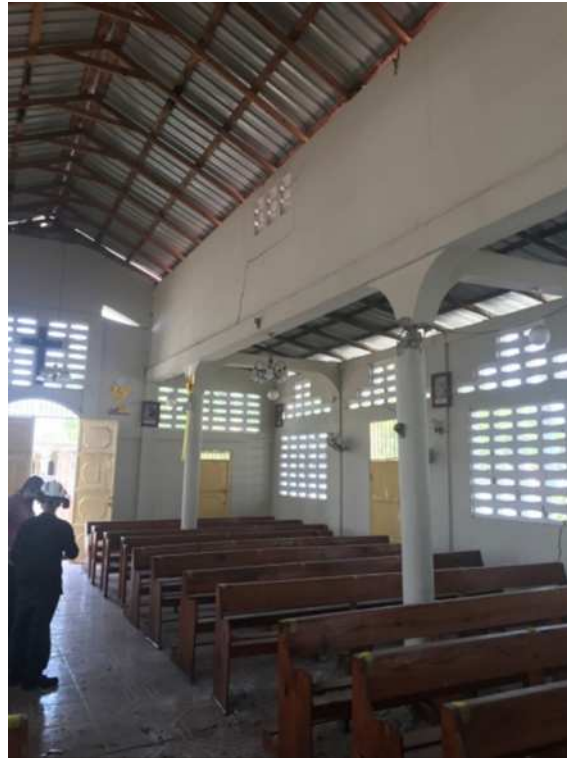
Figure 63 - Building 44

- Damage: The central column that supports the east side of the roof has lost its structural integrity and the deep spanning beam above has developed a shear crack.
- Recommended restrictions: Access to the building to be restricted and **people should be excluded from the area on the east side of the central aisle.**

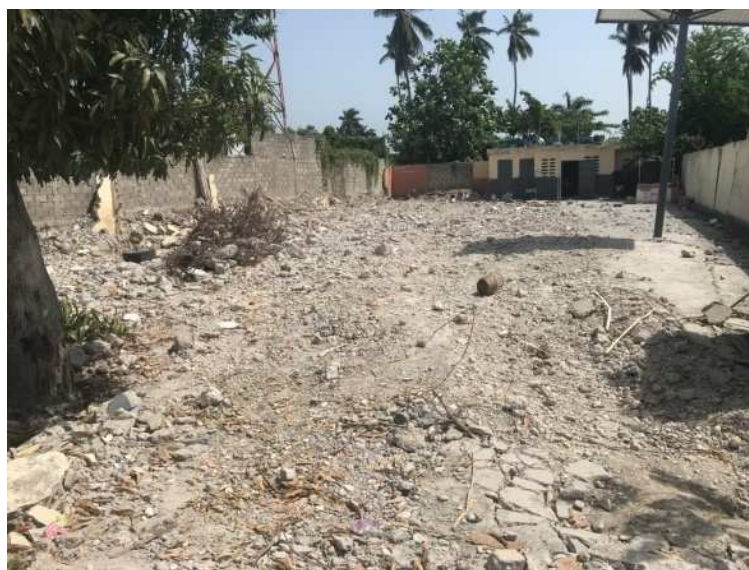
Figure 64 - Building 45

Building 45 - School Adjacent to St Therese (Education) - Red

- Damage: The collapsed building that was adjacent to the St Therese church has been cleared.

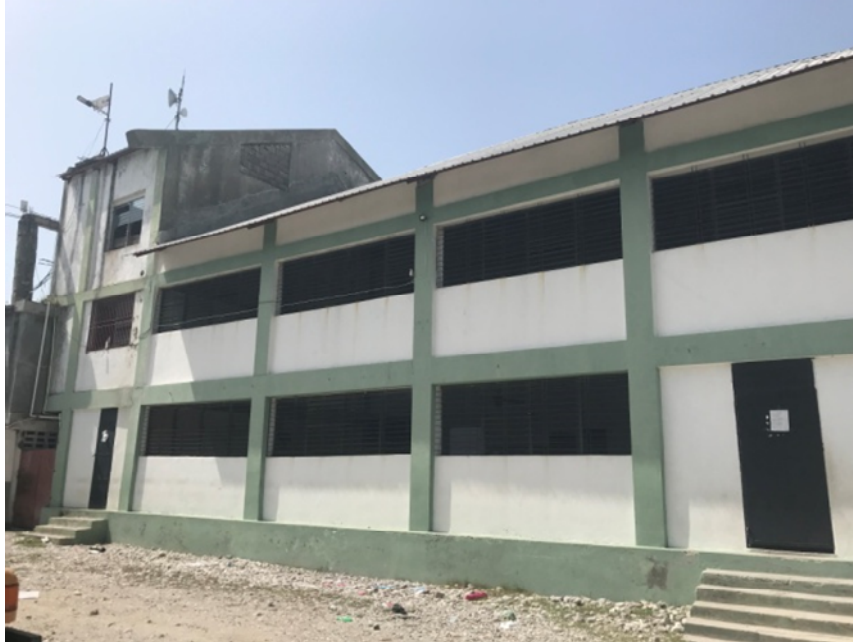
Figure 65 - Building 46

Building 46 - School Eglise Lutherienne (Education)- Green

- Damage: The building shows no external signs of significant damage.
- Assessment constraints: The large and recently built church on the school site was inaccessible for assessment.
- Recommended restrictions: None required.

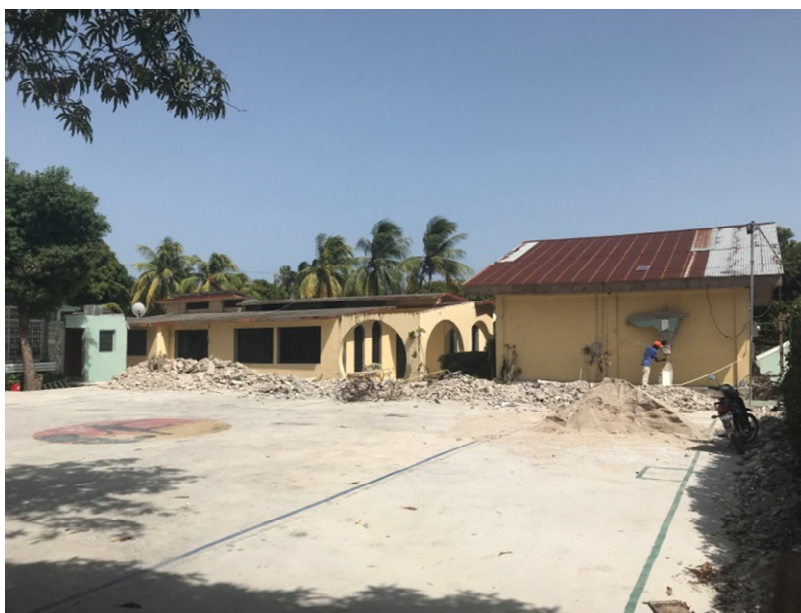
Figure 66 - Building 47

Building 47 - School CEM Ecole (Education) – Green

- Damage: The ancillary building that bordered the school's recreation area has collapsed completely. No further visible damage observed.
- Recommended restrictions: None required.

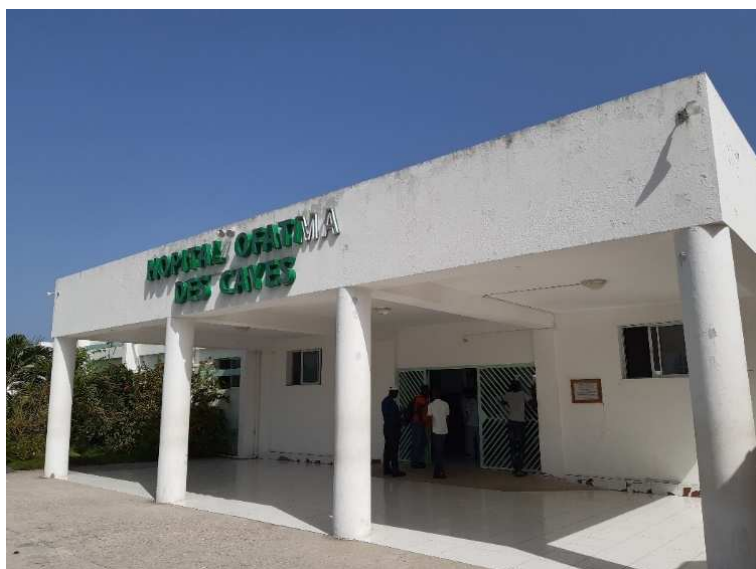
Figure 67 - Building 48

- Damage:
 - o Cracking along a movement joint was visible (see Figure 68), this does not affect the structural integrity of the building.
 - o Cracking around a column head and the surrounding slab was visible (see Figure 70).

- o A second movement joint, to the right of the reception area as you walk in, has cracked. This has left a 2m cantilever on the external corridor where there is no secondary column on the other side of the movement joint. Although the cantilever it-self hadn't appeared to result in any damage, there is loose debris between the movement joint which could cause harm (see Figure 68).

- o A column on the left wing had some cracks on it that appeared on both sides (see Figure 71). It was unclear if this was just to the plaster however it was agreed there's a risk this could be structural damage. A small extension had subsided.

- **Recommended restrictions: External corridor to the left as you walk from reception to the courtyard (with cracking on the ceiling) should be cordoned off. The external corridor with the damaged column to be cordoned off. Extension that has subsided to be cordoned off.**
