RESULTS OF THE MGB LANDSLIDE AND FLOOD ASSESSMENT (1:10,000 SCALE) OF PARTS OF BOSTON IN THE PROVINCE OF DAVAO ORIENTAL

MUNICIPALITY OF BOSTON, DAVAO ORIENTAL

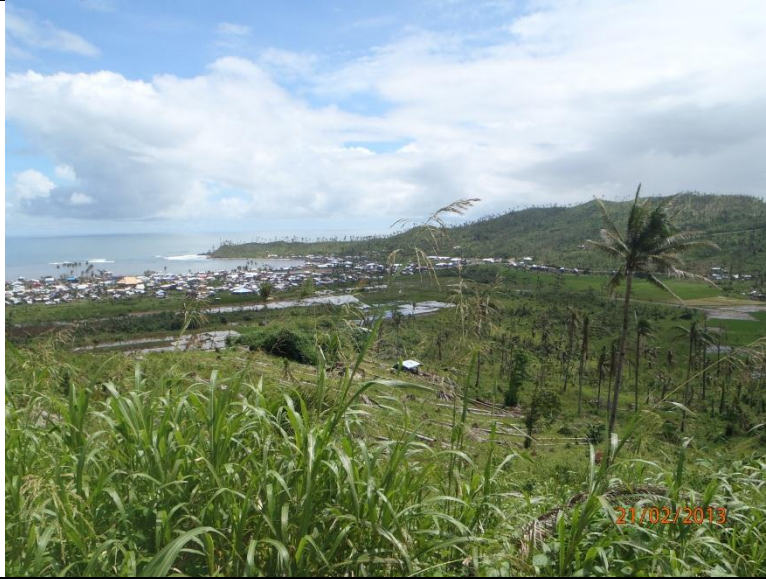
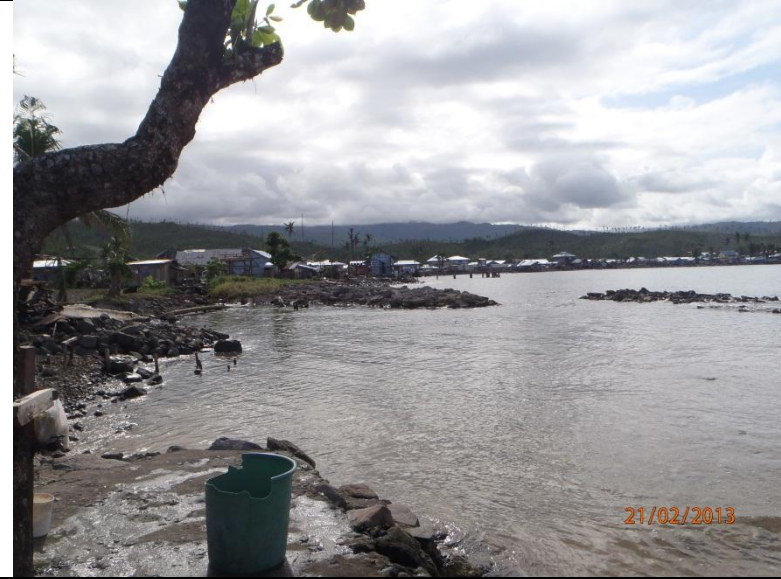
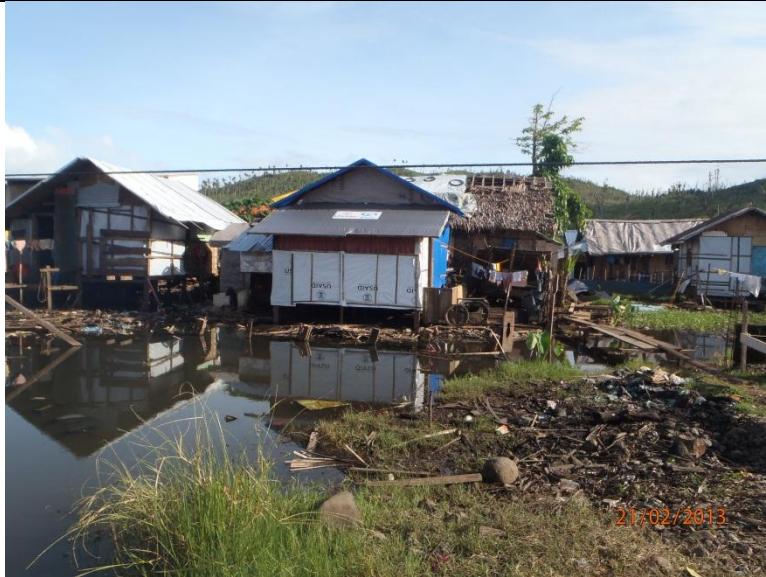
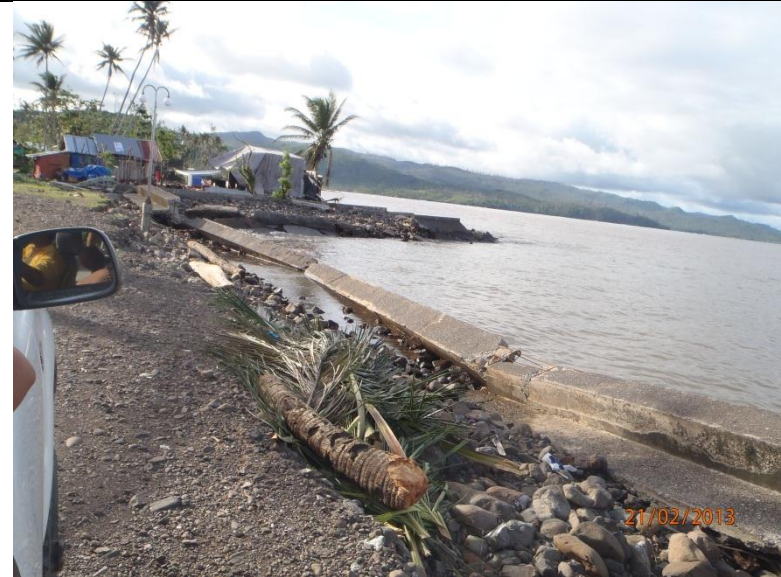
POBLACION			
Dahlia	Low	High	
Maripusa	Moderate		<ul style="list-style-type: none"> • Observe signs of ground movement such as cracks and seepages • Report to MGB and LGU
Santan	Low	Low	<ul style="list-style-type: none"> • Monitor rapid rise in canal waters
Rosal	Low	High	<ul style="list-style-type: none"> • Relocation of residents close to the shoreline
Camia	Low	High	<ul style="list-style-type: none"> • Relocation of residents close to the shoreline
Kalipayan	Low	High	<ul style="list-style-type: none"> • Relocation of residents close to the shoreline
Sampaguita	Low	Moderate	<ul style="list-style-type: none"> • Establish early warning systems
Daisy	Low	Moderate	<ul style="list-style-type: none"> • Establish early warning system
