B.6 Philippines – 2011 – ‘Transitional-Shelter’

Summary information

Shelter Description

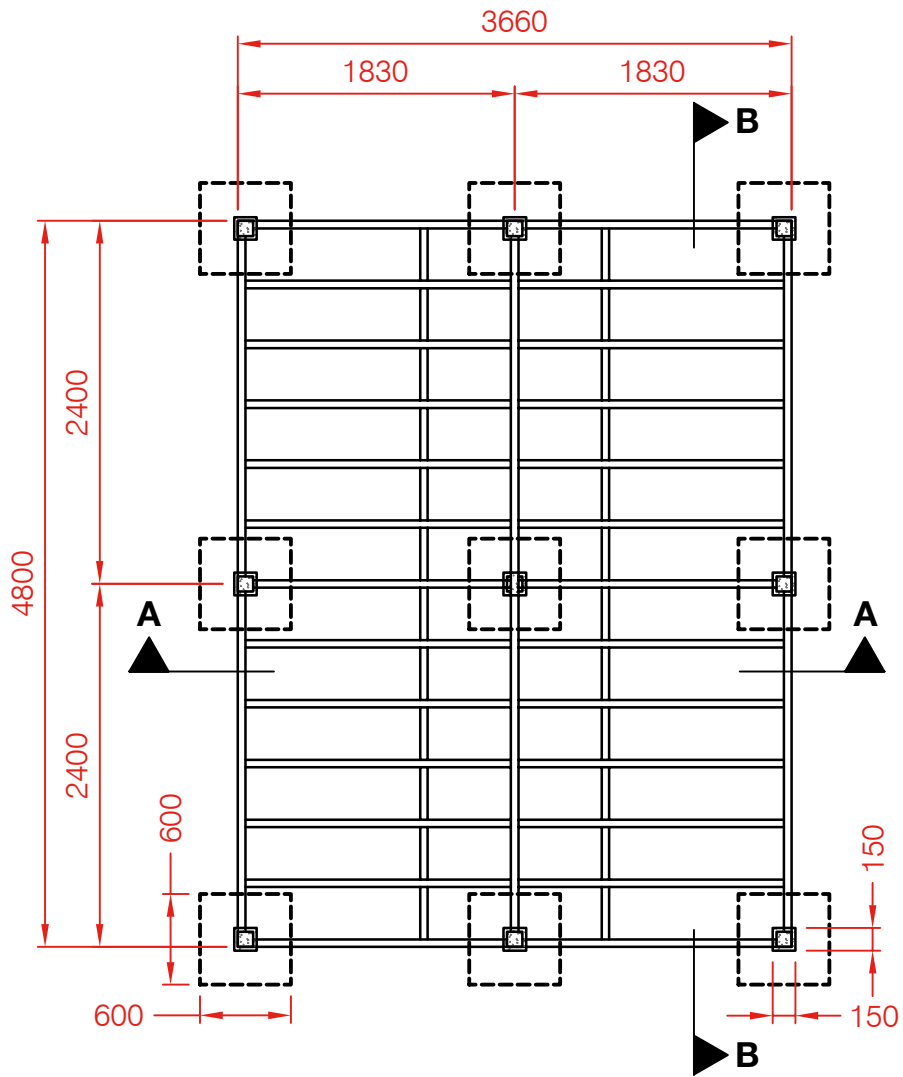
Floor plan

This shelter is a rectangular structure with a single pitch roof and a covered floor area of approximately 4.8m x 3.7m. The shelter is supported on concrete piers and footings such that the first floor is raised approximately 750mm above grade. The floor and roof are framed with coconut wood beams and joists. The floor is plywood and the roof is corrugated metal roofing. The exterior walls consist of amakan (woven panels of bamboo or palm leaves) fastened to the coconut wood frame. The light weight wood frame can be lifted off the concrete piers and moved to a different location by a small number of people. As designed, the shelter has one door and two windows.
