Slickline hand jarring results lost time injury

Hand jarring during slickline operations

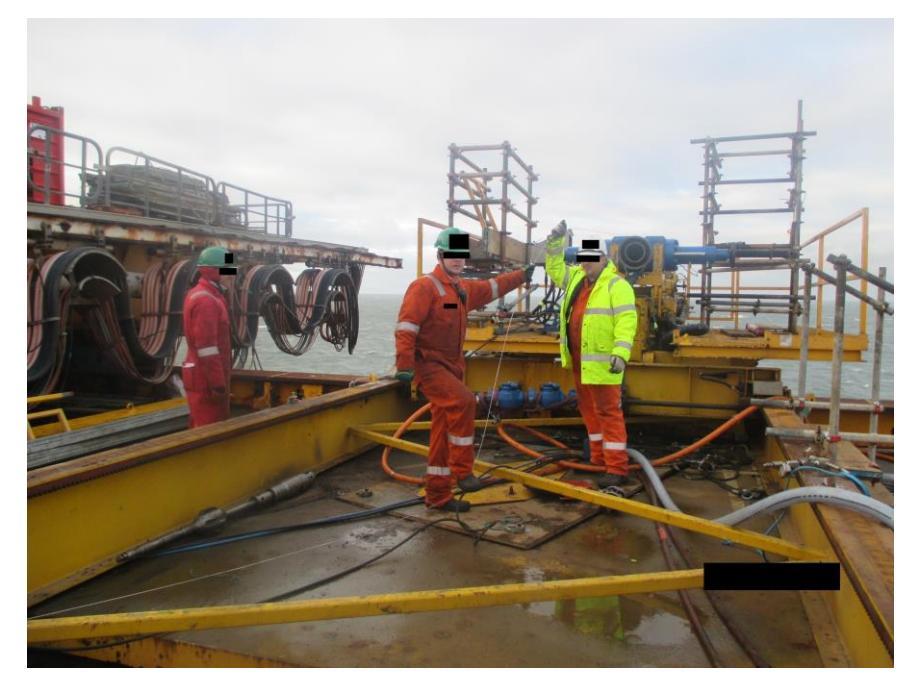
At the time of incident, the injured person (IP) was in the process of hand jarring the wireline and in doing so had placed his right foot on top of the horizontal section of the wire to apply downward pressure. At the same time, he pulled the vertical section of the wire with his hand in order to jar the wire. As he carried out the 1st jar, the tool string, which weighed 130kg, dislodged from a hung up point in the wellbore and dropped a further 2-3ft. This caused the wire at surface to come under tension and spring upwards 3ft causing the IP's right foot to move upwards which in turn caused him to twist and fall over.

The IP's resulting injury was a double fracture to the lower leg.

- Wireline impacts on IP's lower leg causing the stored kinetic energy from the wire to travel through his leg, resulting in a double fracture to his tibia/leg bone
- Operator placed foot on top of wire to assist in jarring operations

- Vendor's procedures amended to include statement on correct body position for hand jarring operations
- Specific hand jarring risk assessment added to permit pack and permit to work system
- Improved training on the risks associated with hand jarring

- Site / task specific risk assessment to be carried out by the team prior to commencing hand jarring
- Only hands to be placed to on wire during jarring operations
- No other body part (including legs) to be place on, over or under the wire
- Jarring only to take place between unit and bottom sheave and not in the vertical position
- Operator to be in a position to pull wire back so that a sudden tension will result in the wire moving away from the operator
- Operator to be positioned a safe distance from the sheave to prevent entrapment with sheave
- Suitable level work site for operators free of potential tripped hazards to be provided
