SAFETY ALERT

During routine checks an Oxygen quad was found connected to a compressor seal system instead of Nitrogen.

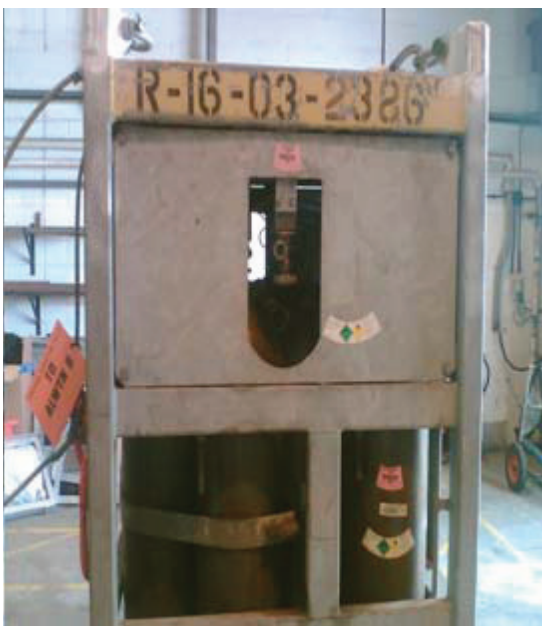
Front View

- The Oxygen Quad had been dispatched in error from the supplier who had been given an order for Nitrogen.
- There was adequate labelling on the side of the quads but not the front and back where the fittings were located. When sat next to each other the side signage is not visible; the front signage only has two small labels as indicated in the attached photos..
- The fittings on the nitrogen quad and oxygen quad are the same type.

1. Supply company's QA/QC procedures modified.
2. Oxygen Packs to be re-labeled with 250 x 250 Compressed Gas and Oxidizing agent labels on the outlet side of the Pack along with the named content at connection fitting.
3. Consider using 300Barg N2 Bottles which have a different connection fittings to other compressed gasses in this field.

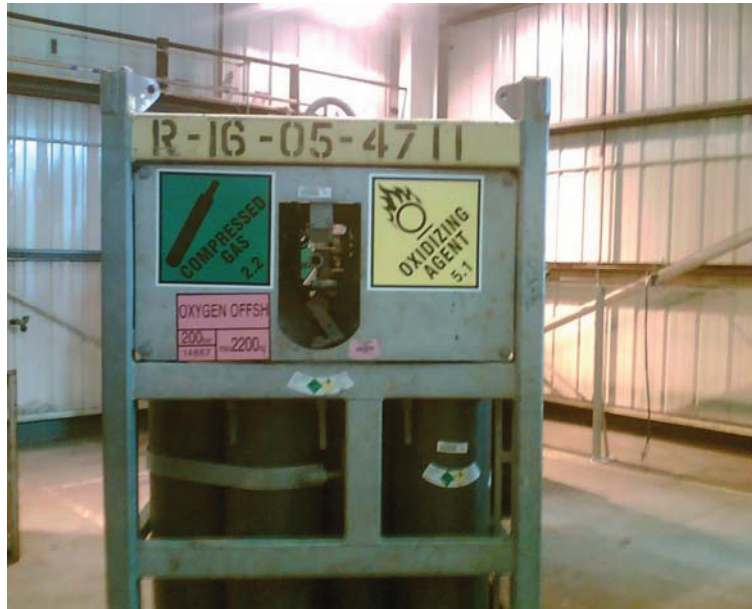
Modified labeling system

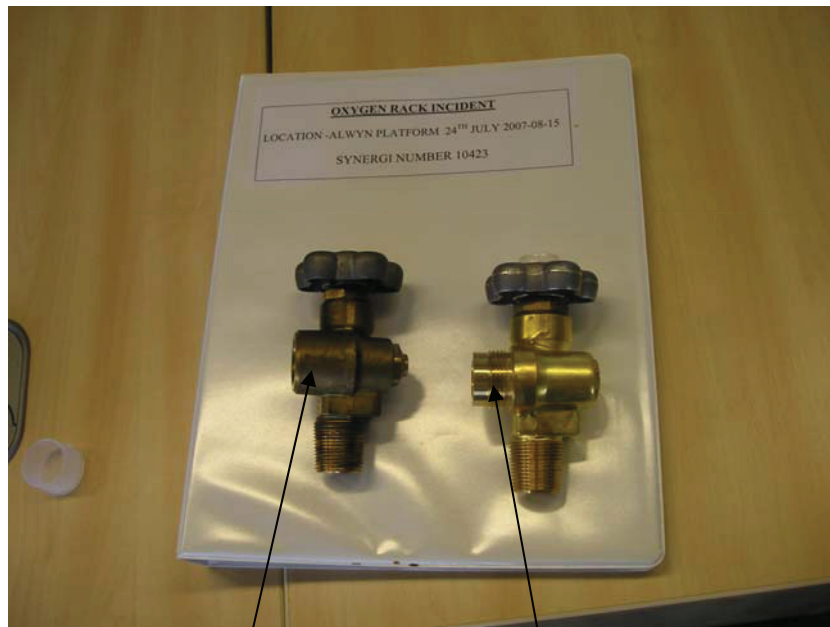
200 bar connection v 300 bar connection
